**Fire Performance Testing of an External Cladding System**  
**BS 8414-1:2015 + A1:2017**

**Test Report**

Report No. : DLR1448 Rev.0

Sample : Kooltherm K15 100mm - 3mm Aluminium Cassette

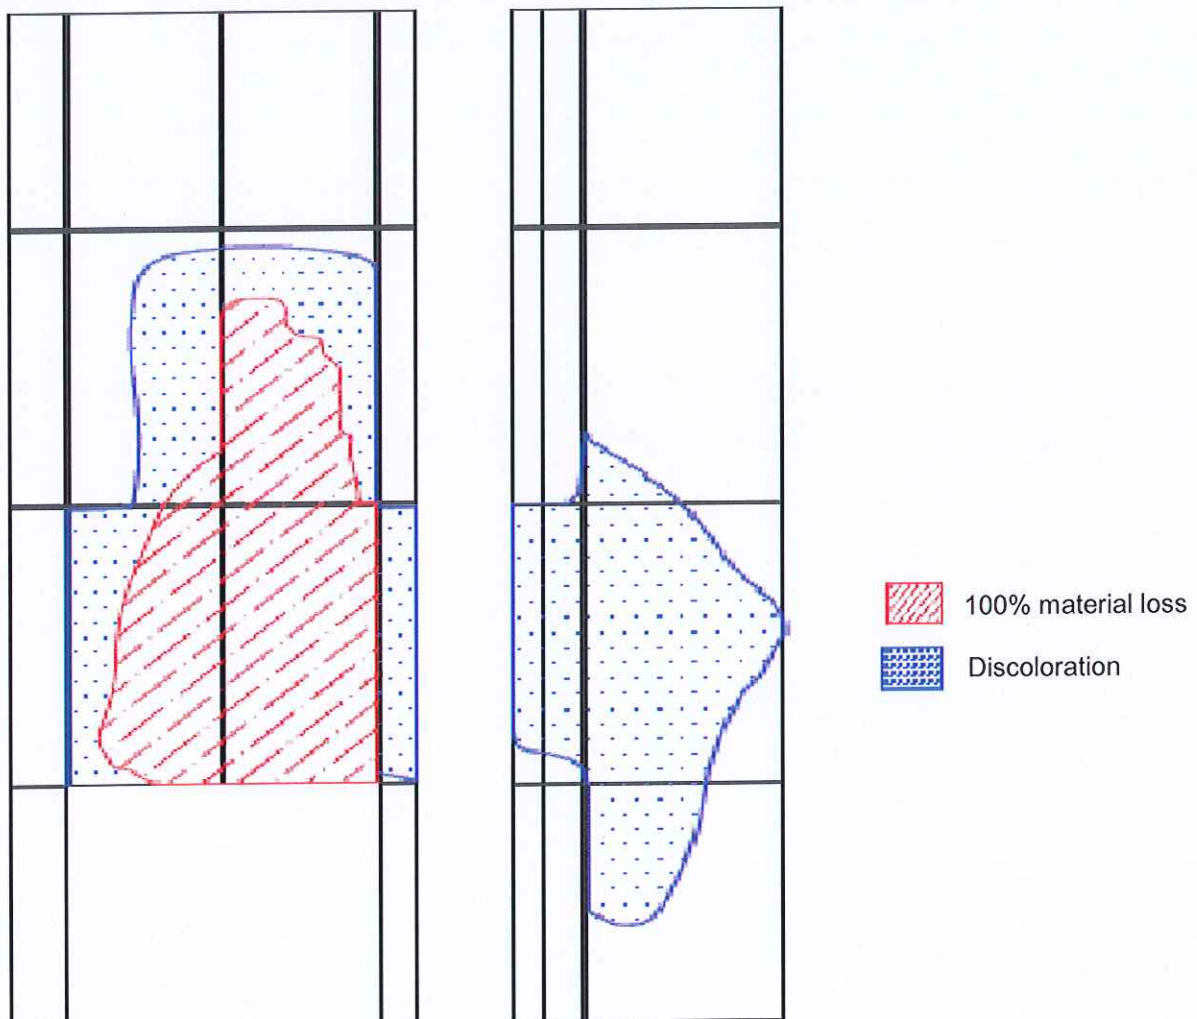
**Figure 8 Area Map Showing the Condition of the aluminium panels after the Test**

Sl. No.	Components	Observation	Photo Reference
1	Aluminium panels	<ul style="list-style-type: none"> <li>Approximately 28% (5m<sup>2</sup>) of complete material loss on main wall aluminium panels.</li> <li>No material loss on wing wall aluminium panels.</li> <li>Approximately 19% (3.4m<sup>2</sup>) of discolouration on main wall aluminium panels.</li> <li>Approximately 28% (3.6m<sup>2</sup>) of discolouration on main wall aluminium panels.</li> </ul> <p>Panels M1, M7, M11, M14-W7 corner &amp; W8 - No damage was observed.</p> <p>Panel M2-W1 corner – Minor discolouration.</p> <p>Panel M3 - Minor discolouration at the corner. No other damage was observed</p> <p>Panel M4 - Approximately 50% of the panel was consumed in fire, the remaining was distorted, discoloured and buckled.</p> <p>Panel M5 - 100% of the panel was consumed in fire.</p> <p>Panel M6-W3 corner - 90% of the panel was discoloured and the 1<sup>st</sup> coating was burned.</p> <p>Panel M8 - Approximately 10% of the panel was consumed in fire, the remaining was distorted, discoloured and buckled.</p> <p>Panel M9 - Approximately 60% of the panel was consumed in fire, the remaining was distorted, discoloured and buckled.</p> <p>Panels M10-W5 corner, M12 &amp; M13 – Minor discolouration.</p> <p>Panel W2- Approximately 25% of the top coating was burned and discoloured.</p> <p>Panel W4 - Approximately 85% top coating was burned and discoloured and buckled.</p> <p>Panel W6 - Minor discolouration.</p>	<p>DLP C2753B/0005</p> <p>See Figure 8 in this section for area details.</p>

- Approximately 5m<sup>2</sup> of the total aluminium panels was completely consumed by fire.
- Approximately 7m<sup>2</sup> of the total aluminium panels was discoloured.

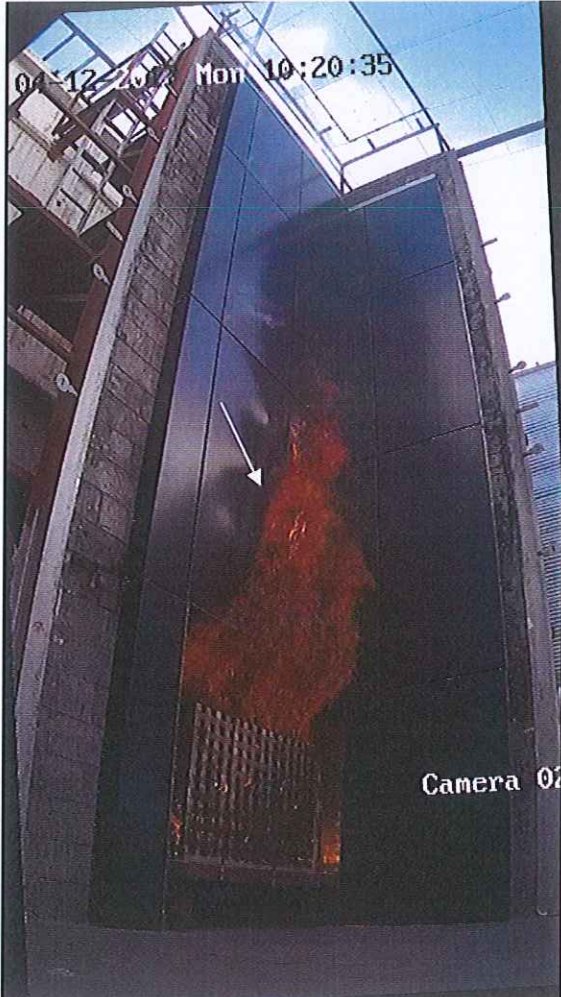
DLP C2753B/0001      1<sup>st</sup> layer of coating started to burn.

10:20:21	190	Flames reached 2000mm above the combustion chamber.	-
10:20:35	152	1 <sup>st</sup> layer of coating of panels M4 & M5 started to burn.	DLP C2753B/0001

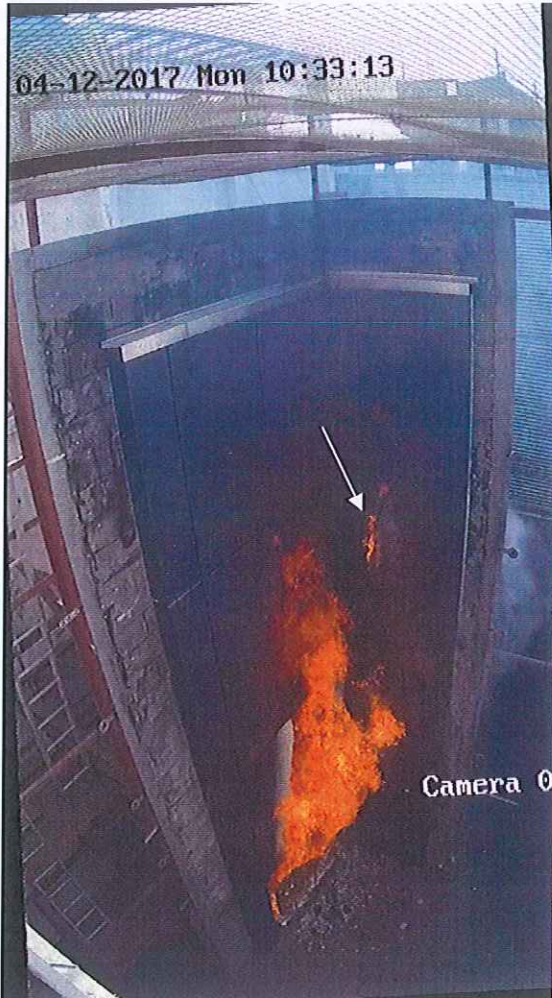
DLP C2753B/0003 Continuous flame observed on W5 & W6 vertical joint.

Time	Seconds	Observation	Photo Reference
10.31.39	868	Flames observed between panes W2 & W3 horizontal joint.	-
10.33.13	962	Sustained flame observed on panels W5 & W6 vertical joint.	DLP C2753B/0003

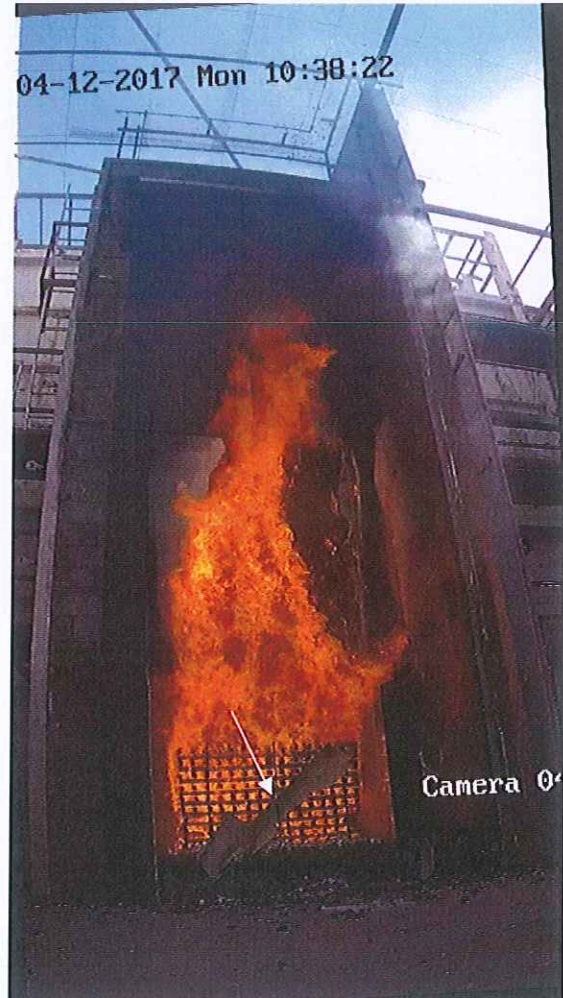
DLP C2753B/0004 Panel M5 fell from the main wall.

10.38.22	1271	Panel M5 fell from the main wall.	DLP C2753B/0004
10.39.38	1347	Kooltherm K15 insulation behind panels M4, M5, M8 & M9 was exposed as charcoal.	-

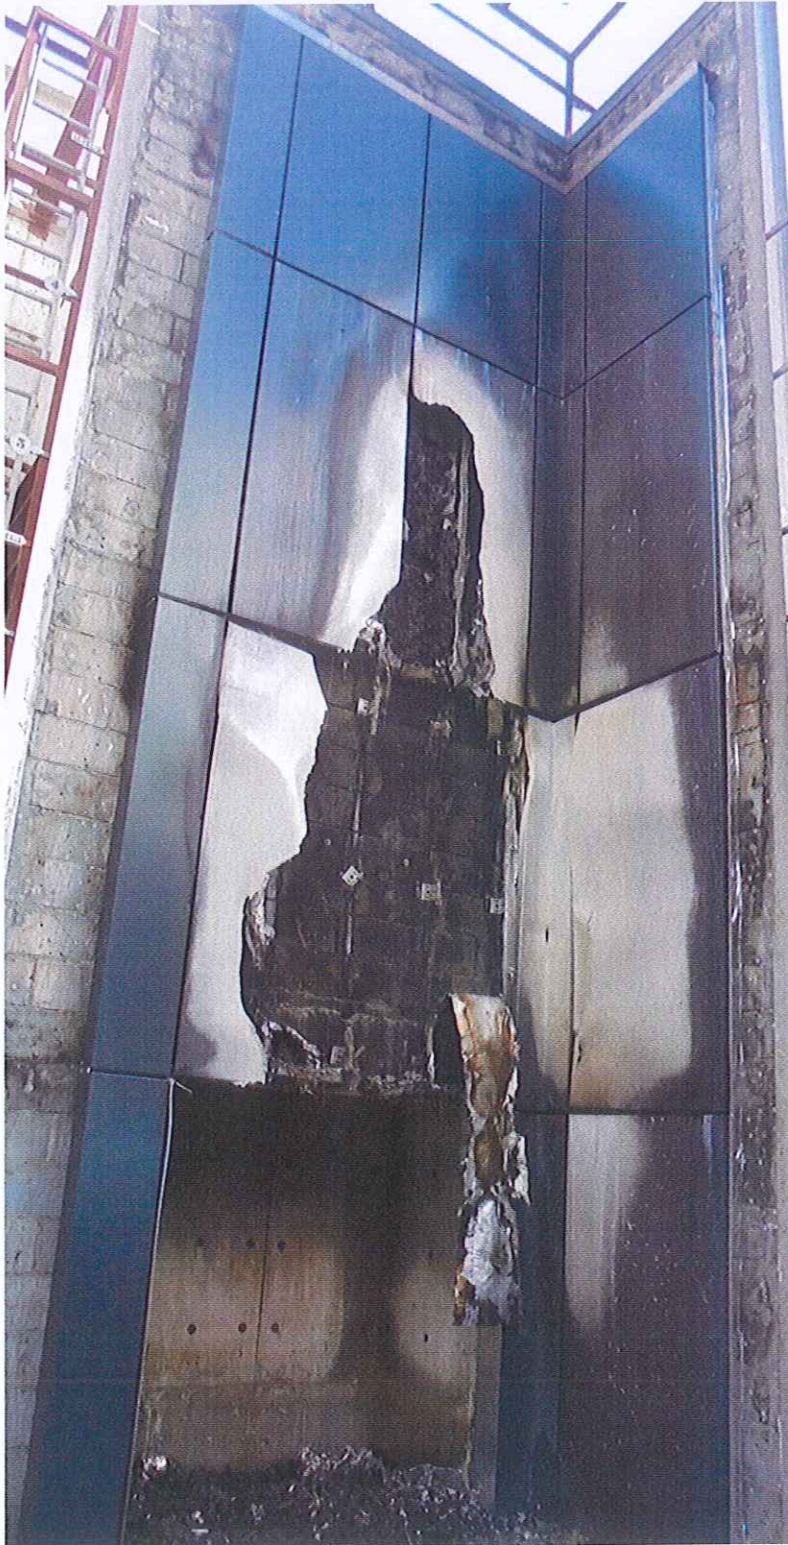
DLP C2753B/0005

View of the sample after the test completion

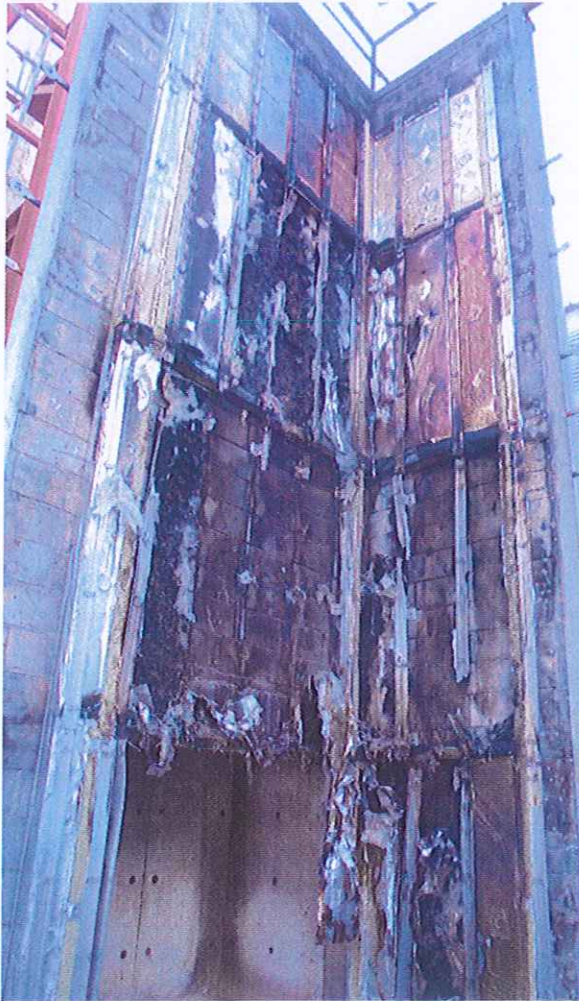
3	Insulation	<p>100% damage on Kooltherm K15 insulations and core wall was exposed behind panels M4, M5, M6-W3, M9 &amp; M10-W5.</p> <p>Insulation behind panels W2, W4 &amp; W6 were charred and exposed as charcoal.</p> <p>Discoloration was observed to insulations behind panels M1, M3, M7, M11, M12, M14-W7 &amp; W8.</p>	DLP C2753B/0007
4	Railing	<p>Railings behind panels M4, M5, M6-W3, W4, M8 &amp; M9 were melted. Railings behind panels M1, M3, M7, M11, M12, M13, M14-W7 and W8 were discoloured.</p> <p>Railings behind panels M2-W1 &amp; W2 were buckled and discoloured.</p>	DLP C2753B/0007

Sl. No.	Components	Observation	Photo Reference
5	Bracket	100% of the brackets behind panels M4, M5 & M6-W4 were damaged. All other brackets were discoloured and were in place without damage.	DLP C2753B/0007.

View of the sample  
without panels

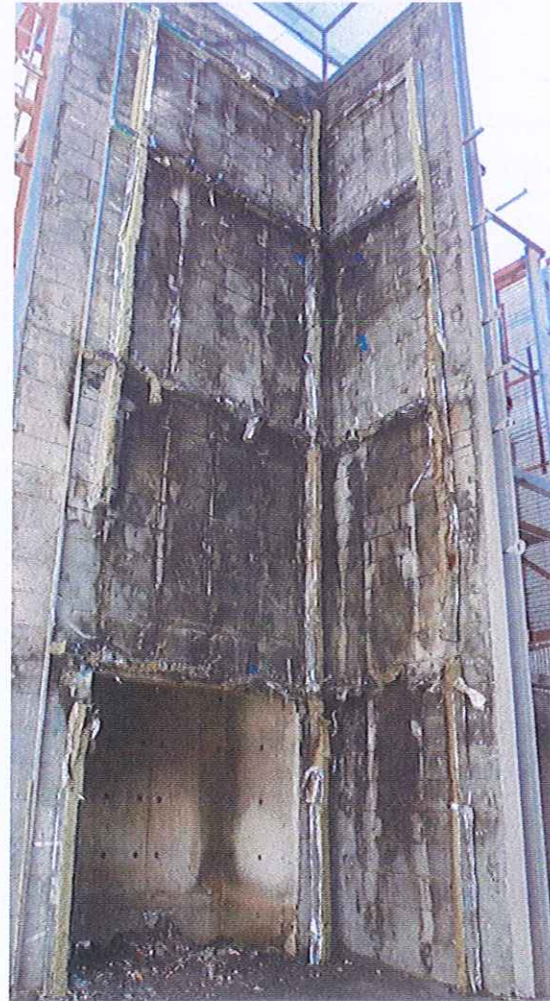
DLP C2753B/0008

Sl. No.	Components	Observation	Photo Reference
2	Cavity barrier	<p><b>Horizontal intumescent cavity barrier:</b></p> <p>The 1<sup>st</sup> horizontal cavity barrier above the combustion chamber was activated. Melted aluminium and middle core of the panel debris fell onto the barrier and was compressed by its weight. Material loss and damage was observed.</p> <p>The 2<sup>nd</sup> horizontal cavity barrier at 2330mm above the combustion chamber was activated. The expanded intumescent layer was not present on the main wall during dismantling.</p> <p>The 3<sup>rd</sup> horizontal cavity barrier at 4660mm above the combustion chamber on main wall and wing wall was activated. No material loss was observed.</p> <p>The 4<sup>th</sup> horizontal cavity barrier at 6274mm above the combustion chamber on main wall and wing wall was activated. No material loss was observed.</p> <p><b>Vertical cavity barrier:</b></p> <p>Minor discolouration to the vertical cavity barrier extending between panel M1 and the combustion chamber.</p> <p>Buckling and minor material loss on vertical cavity barrier extending between the combustion chamber and panel M2.</p> <p>Minor discolouration to the vertical cavity barrier on wing wall.</p>	DLP C2753B/0006, DLP C2753B/0007 & DLP C2753B/0008.

View of the cavity  
barriers

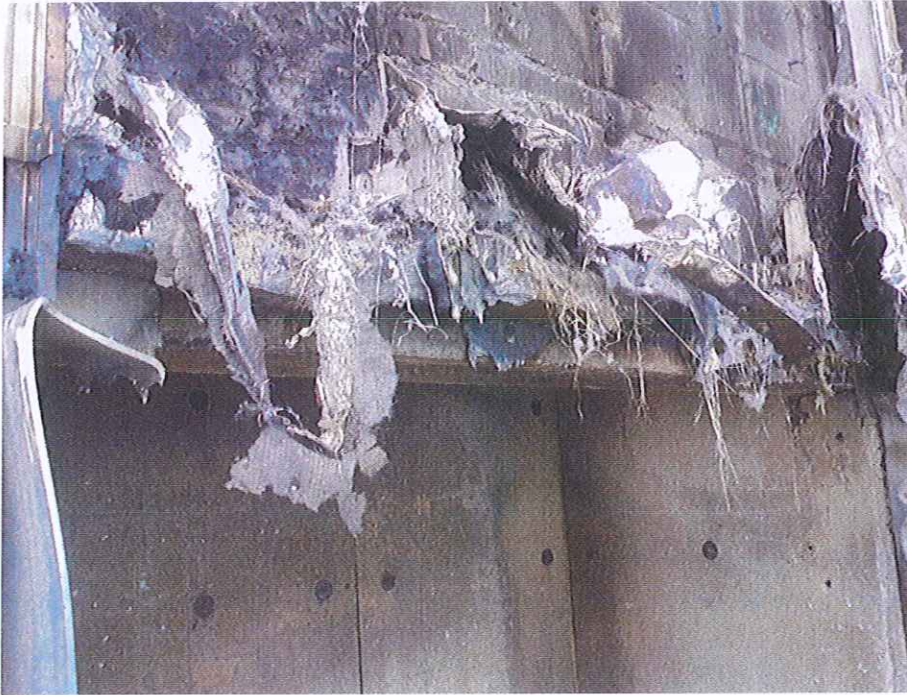
DLP C2753B/0006

Cavity barrier at the top of combustion chamber
