REACTION TO FIRE TEST REPORT No EUI - 18 - FF - 000131

Test Standard: **BS 8414-2:2015+A1:2017** – Fire performance of external cladding systems
Part 2: Test method for non-loadbearing external cladding systems fixed to and supported by a structural steel frame

Product referenced: Façade system incorporating 90 mm Kooltherm K15 Rainscreen and 90 mm K15 Black Kingspan Insulation, cavity and Branco Michaela Granite stone cladding panels

Test sponsor : KINGSPAN INSULATION LTD
Bree Industrial Estate, Castleblayney
Co Monaghan
AK75 X966, Ireland

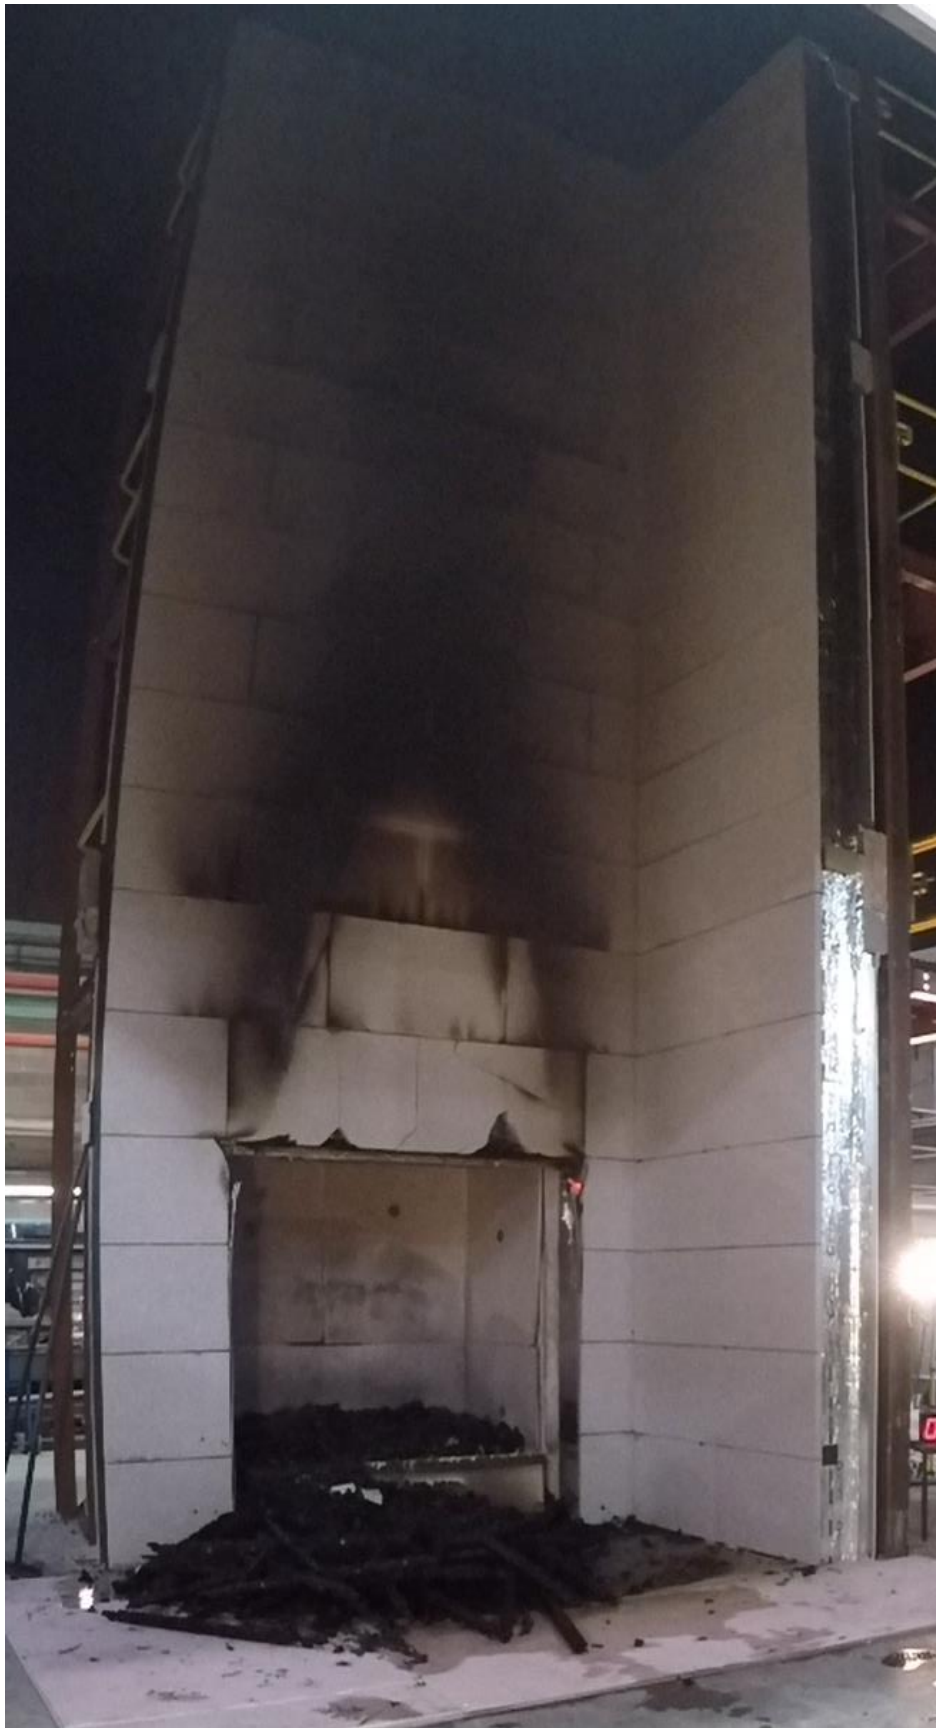
On the main face of the cladding system, all panels were in-place after testing. Some cracks were observed on three panels located just above the combustion chamber's opening. Discolouration was observed up to a height of 3000 mm.

Figure 4.15. Cladding system just after the fire test (60 min 01 sec after ignition of the crib).

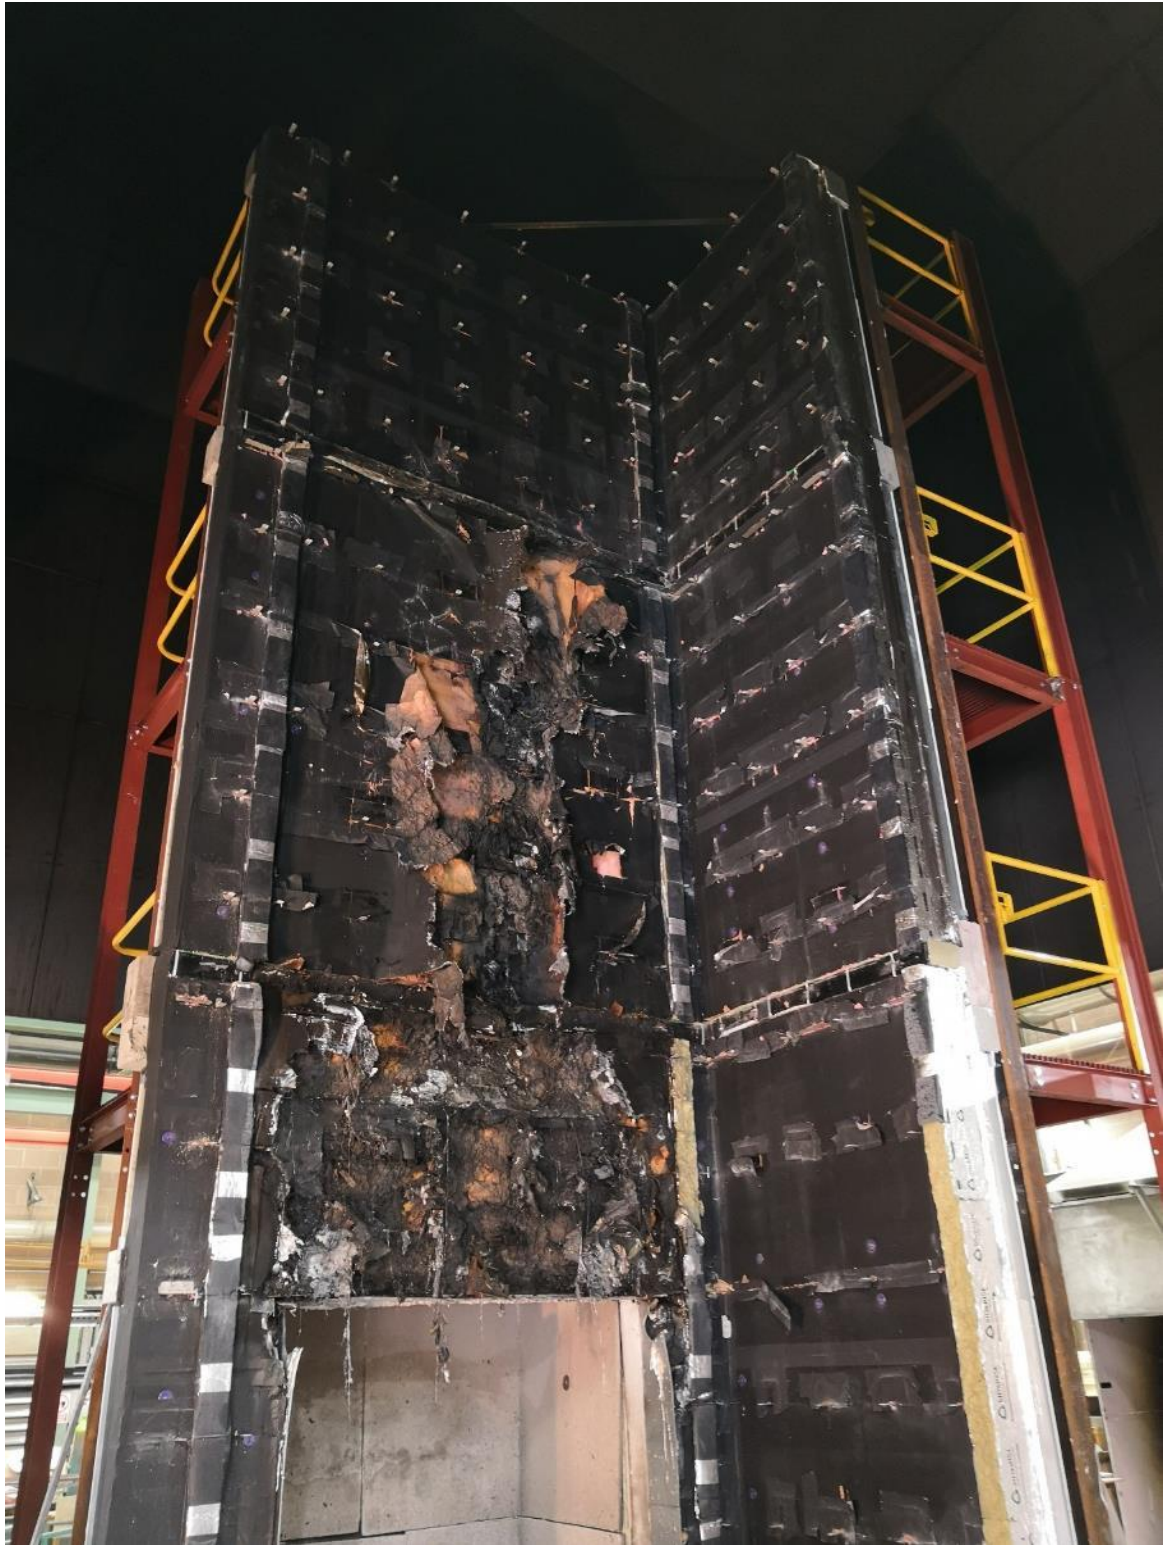
The reference Kooltherm K15 Rainscreen insulation layer on the main face was intact and in place after testing. There was no charring or damage observed on it. However, the layer of reference K15 Black insulation was charred and partially burnt on the area just above the combustion chamber up to a height of approx. 2500 mm above the chamber. That area was confined in the space between the two vertical barriers of the main face. Higher areas were without any damage or burnt being observed.

Figure 4.16. Post-examination damage. Insulation mainly charred and burnt above the combustion chamber on the main face; intact on the wing face. Vertical fire stop barriers in-place with some damage on the one located right of the chamber.

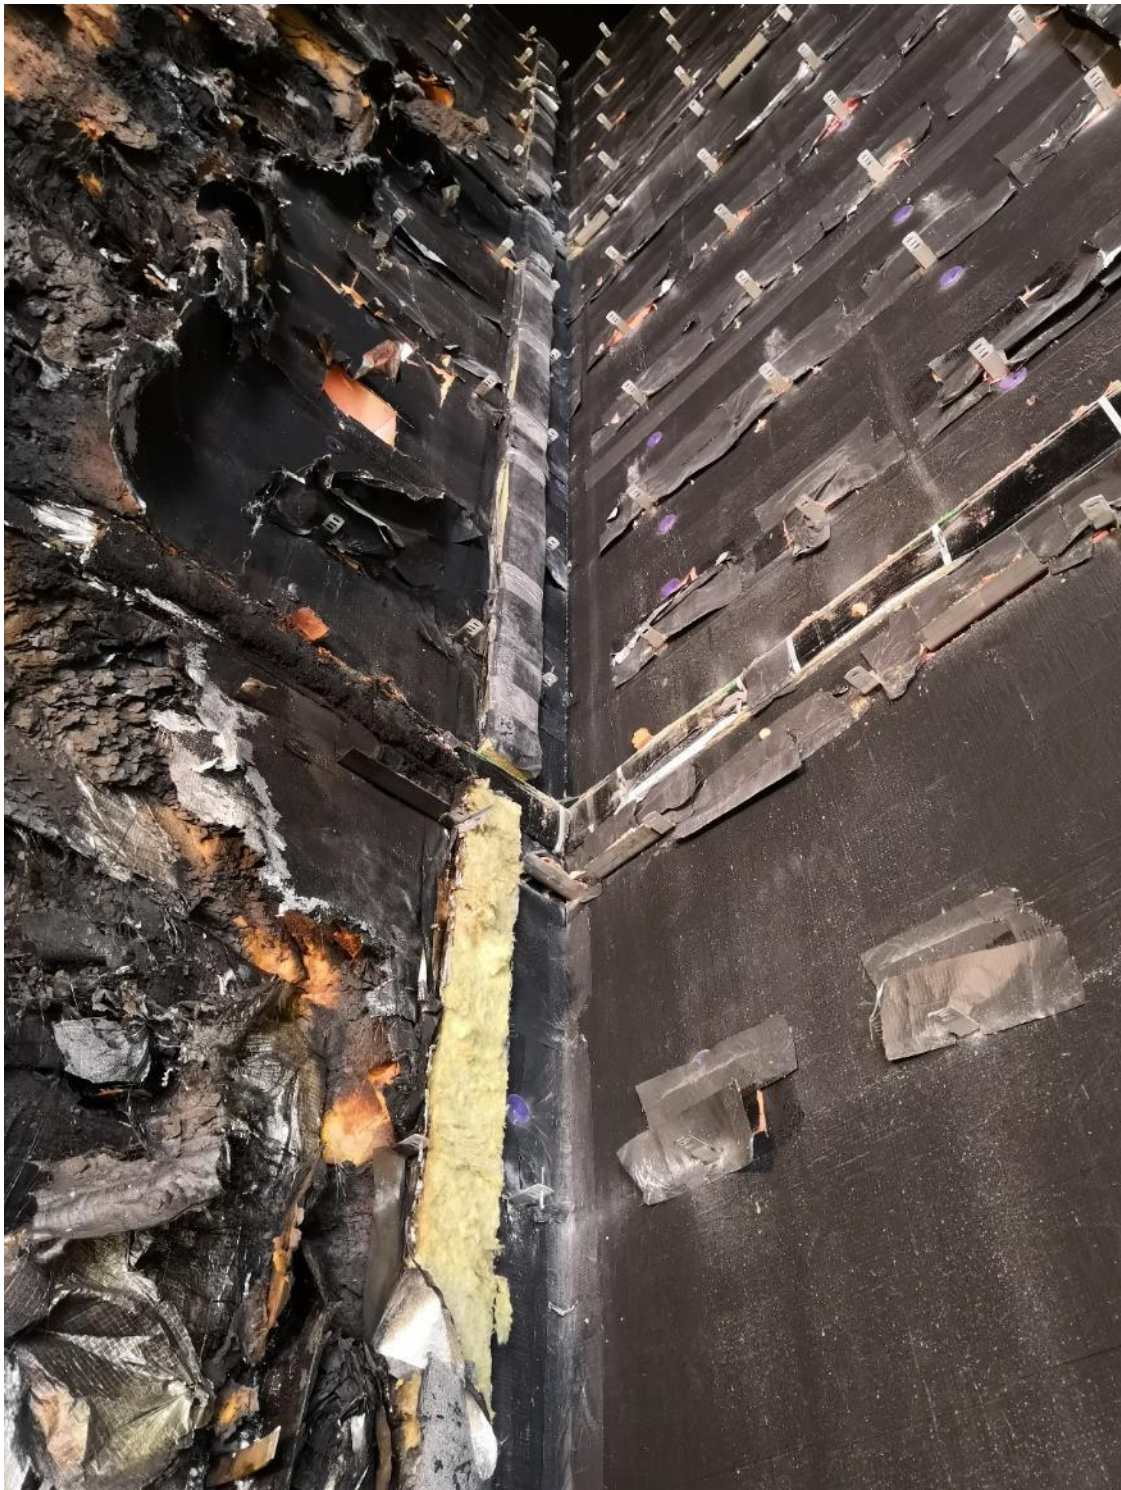
The vertical fire stop barriers were in place after the test without major damage. Only the right hand side vertical fire stop barrier was suffered some damage above the combustion chamber up to the bottom horizontal fire stop barrier.

Figure 4.17. Post-examination damage. Vertical fire stop barrier located on the corner of the system. Damage observed up to first horizontal fire stop barrier; rest in place without any damage.

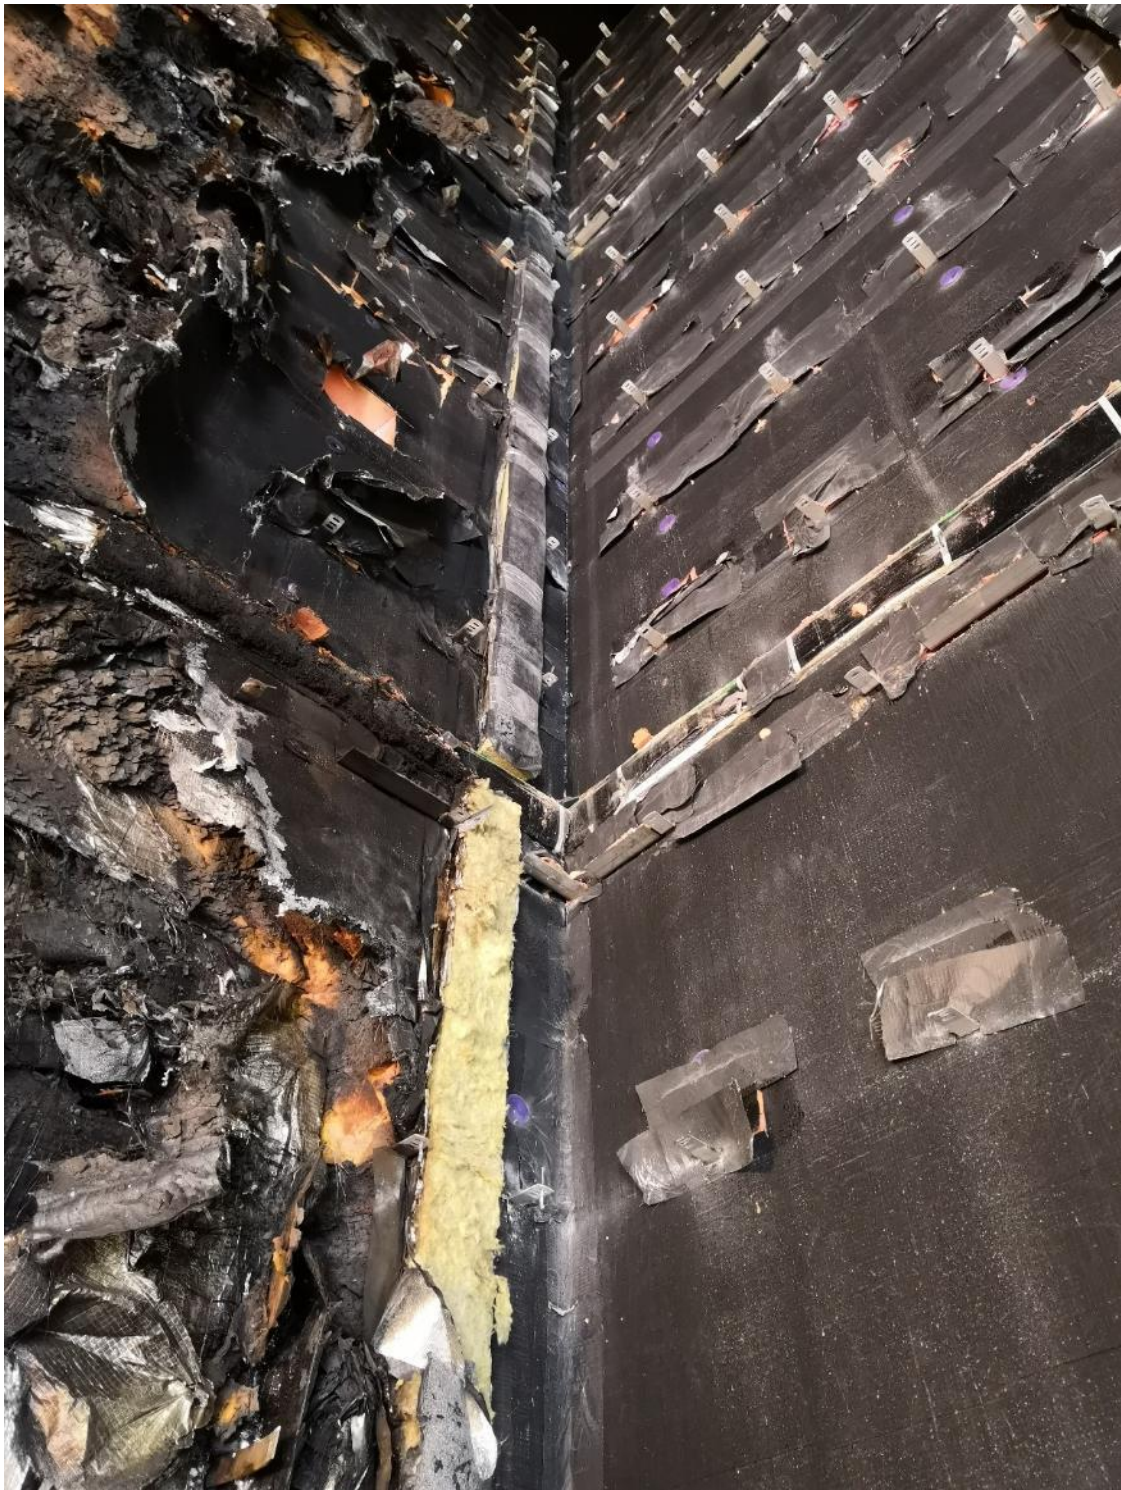
Figure 4.18. Post-examination damage. Vertical fire stop barrier located on the corner of the system. Damage observed up to first horizontal fire stop barrier; rest in place without any damage.

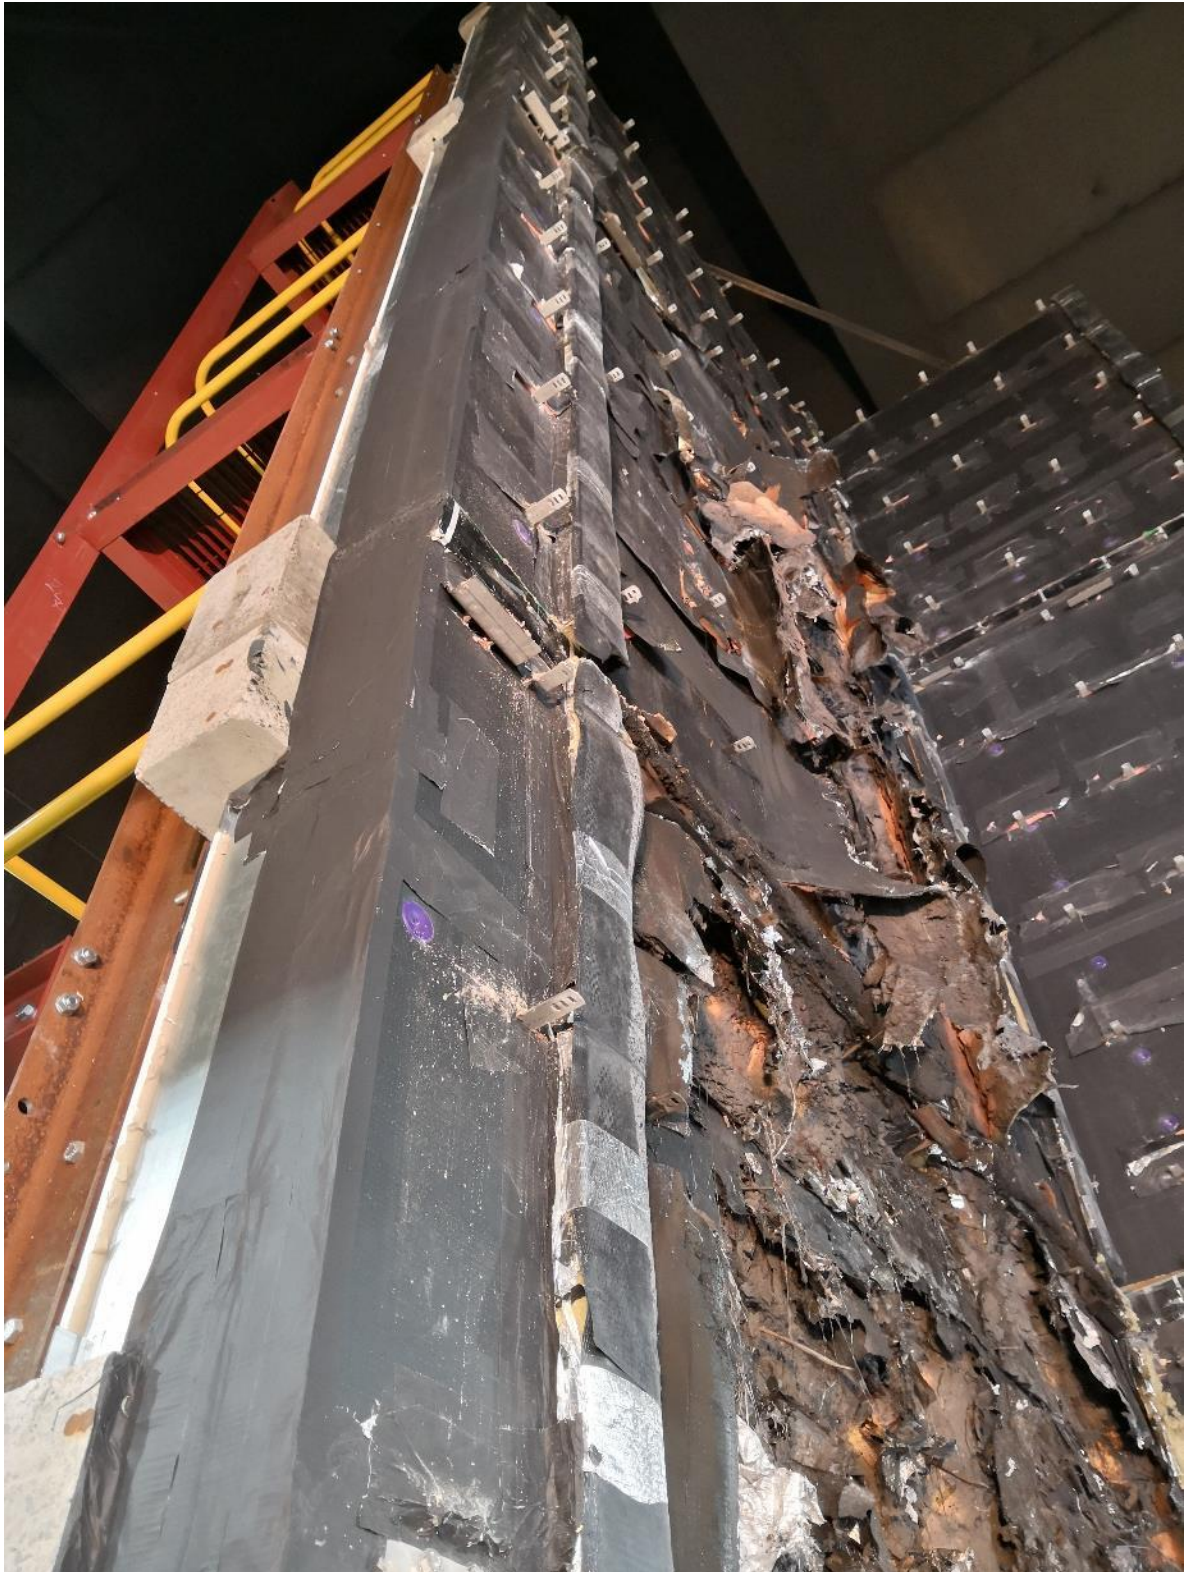
Figure 4.19. Post-examination damage. Vertical fire stop barrier located on the left-hand side edge of the system's main face. No damage observed; in-place and intact.

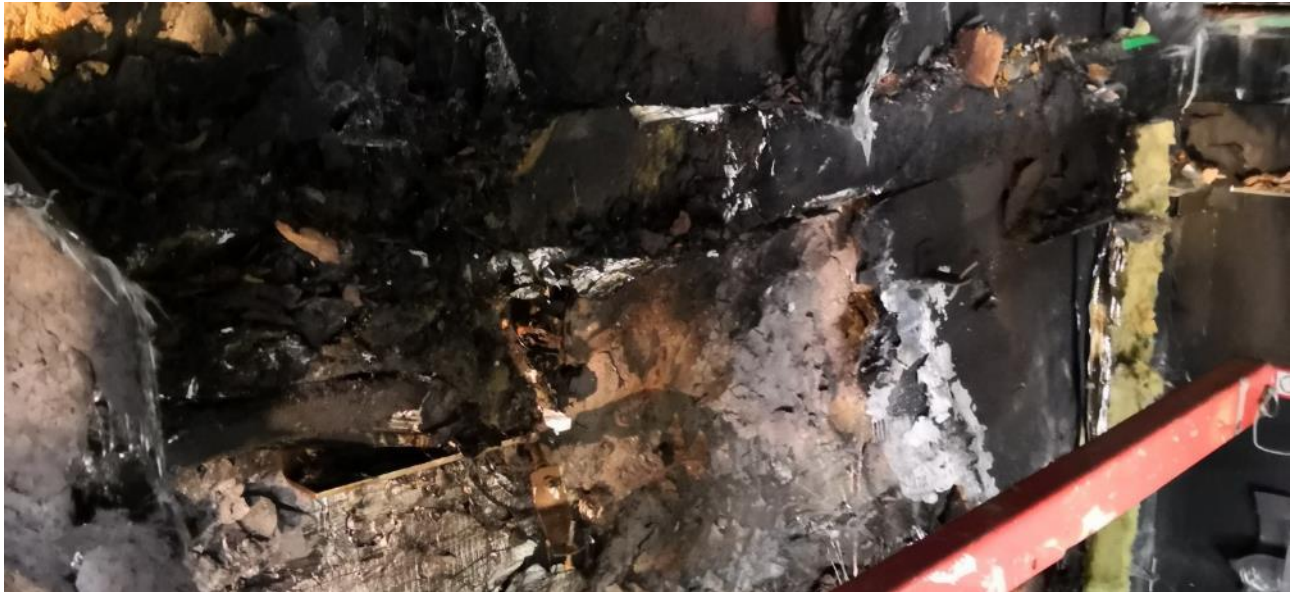
The bottom horizontal fire stop barrier installed was activated during the test along the two vertical fire stop barriers. It was partially damaged as about 15% was detached from the system. Only about 10% was intact; on the left hand side edge of the system's main face. The middle one was partially activated but was still in place without suffering any major damage. The top horizontal fire stop barrier was in place without been activated and without any damage or detachment.

Figure 4.20. Post-examination damage. Photo of the bottom horizontal fire barrier installed on the main face. Fully activated and partially detached (especially above the chamber).

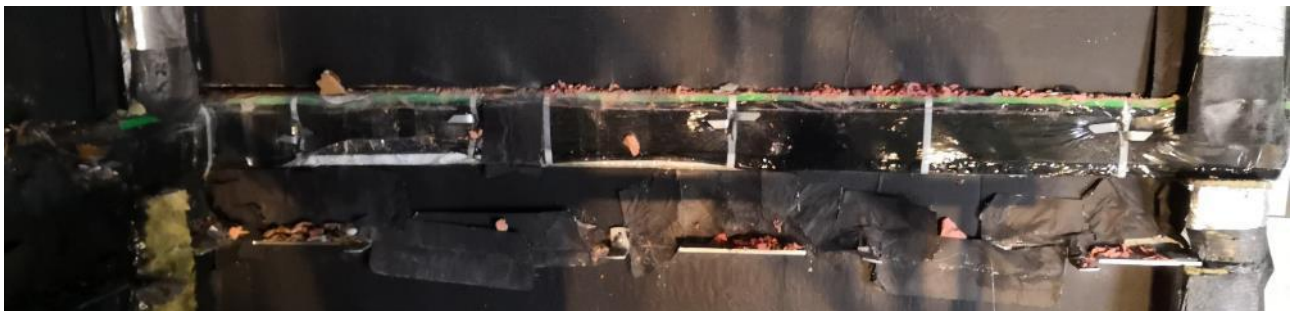
All horizontal fire stop barriers were not activated and in-place after testing without any damage observed.

Figure 4.21. Post-examination damage. Photo of the bottom horizontal fire barrier installed on the wing face. In-place and without been activated.

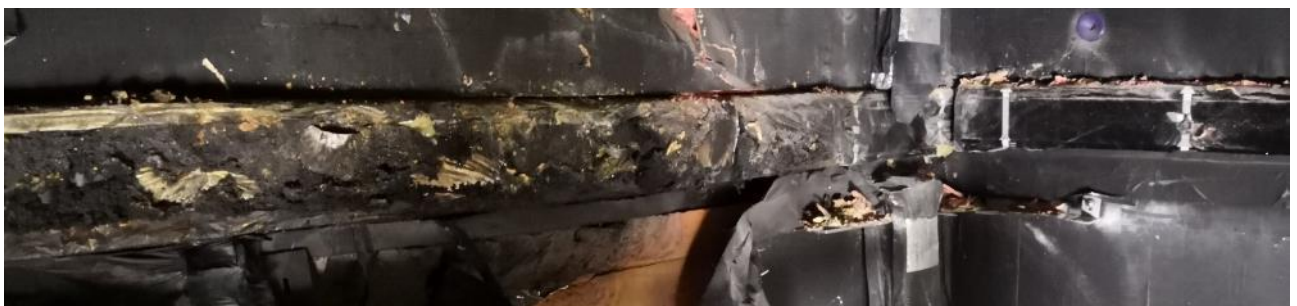
Figure 4.22. Post-examination damage. Photo of the middle horizontal fire barrier installed on both faces. Partially activated on the main face but in-place; not activated or detached on the wing face.

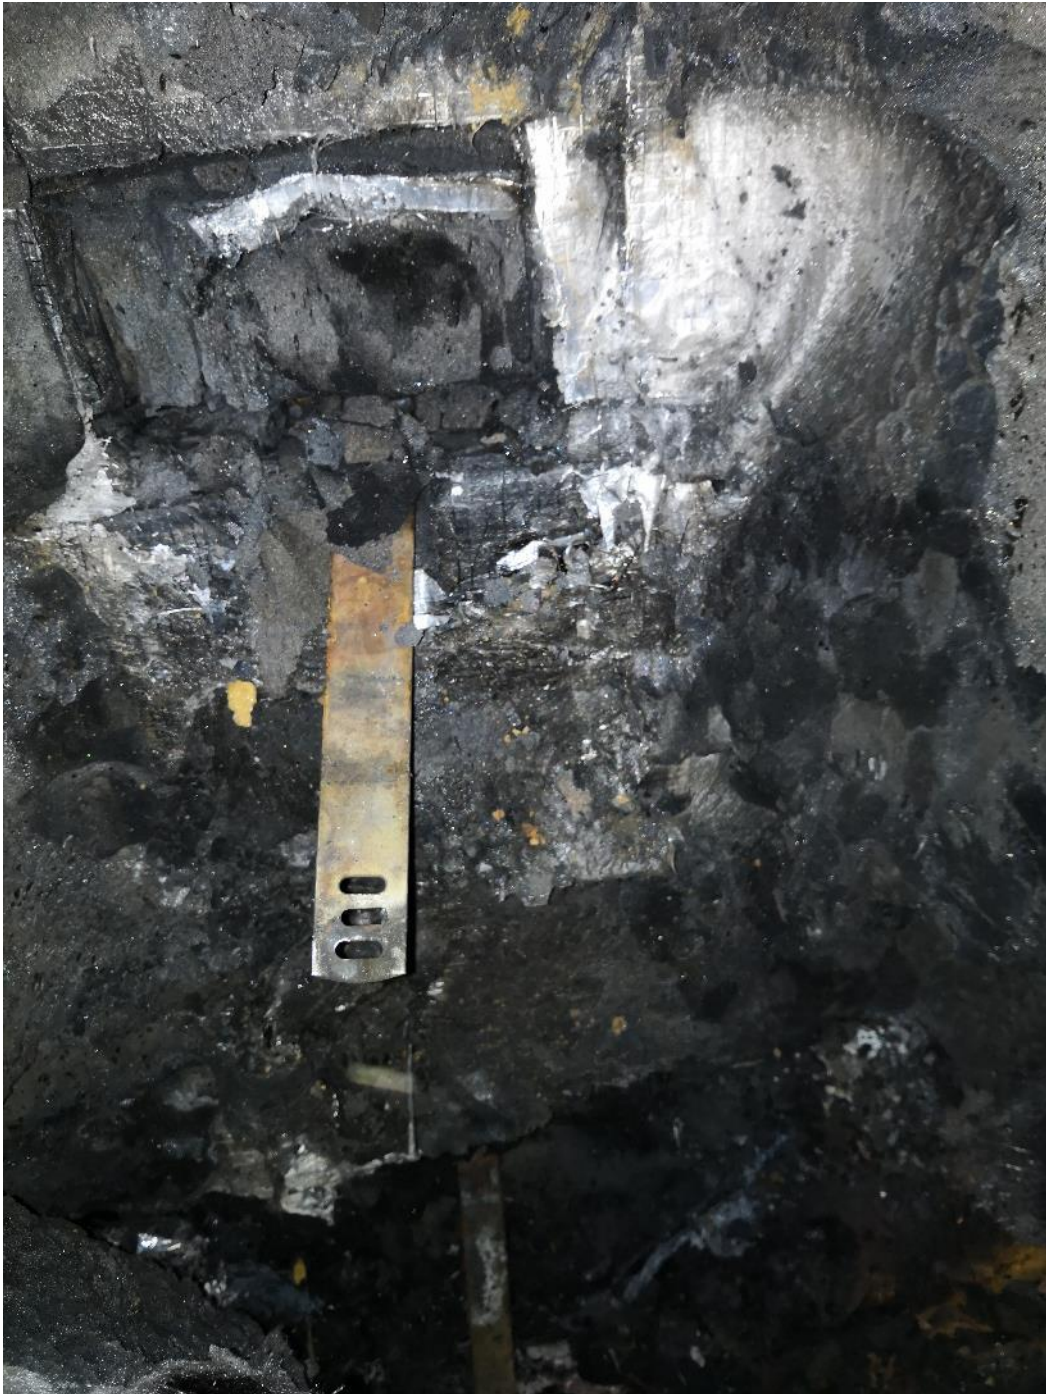
Brackets and restraints were intact and in place after the test. Some minor discolouration only observed on the ones just above the chamber's opening on the main face.

Figure 4.23. Post-examination damage. Photo of one bracket located just above the combustion chamber. No damage except discoloration observed.

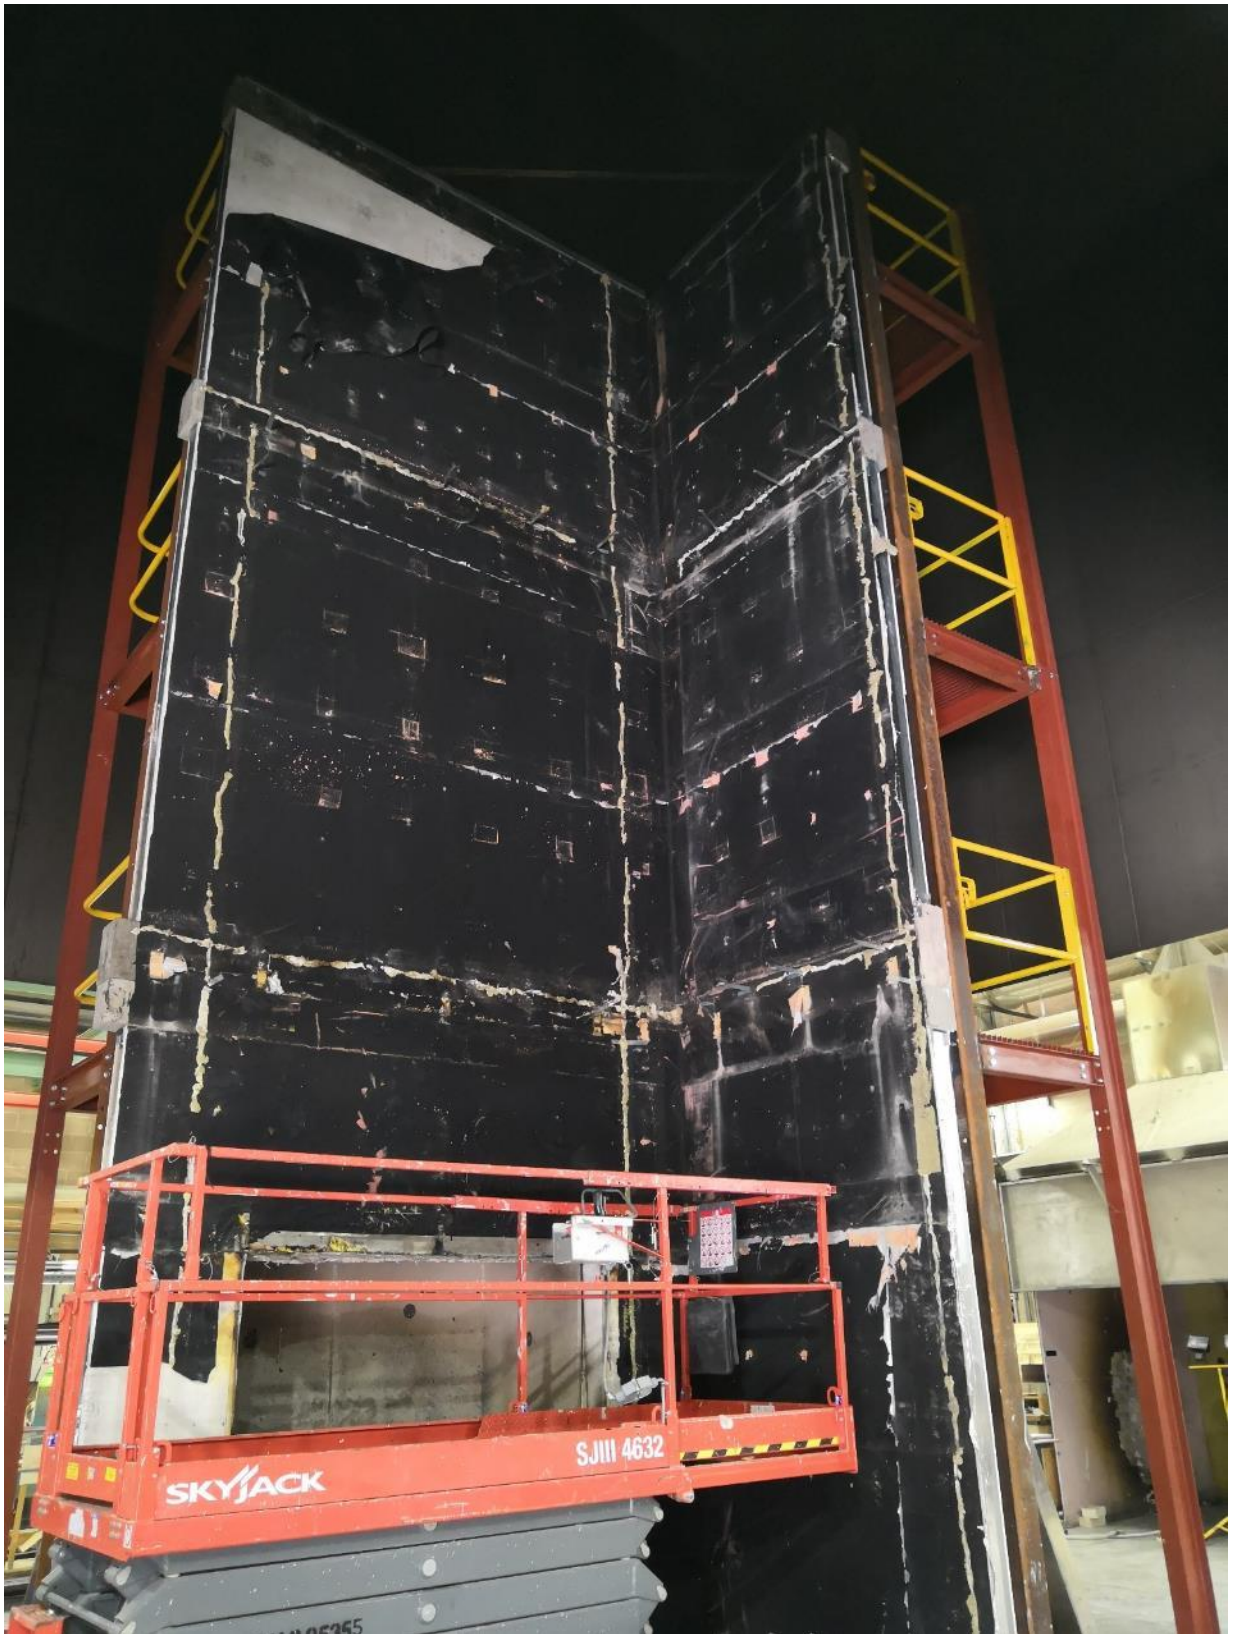
The waterproof membrane was in place and intact after testing. No damage was noted after removing the insulation layer from the system.

Figure 4.24. Post-examination damage. Waterproof membrane intact and in place after removing insulation layer from system.

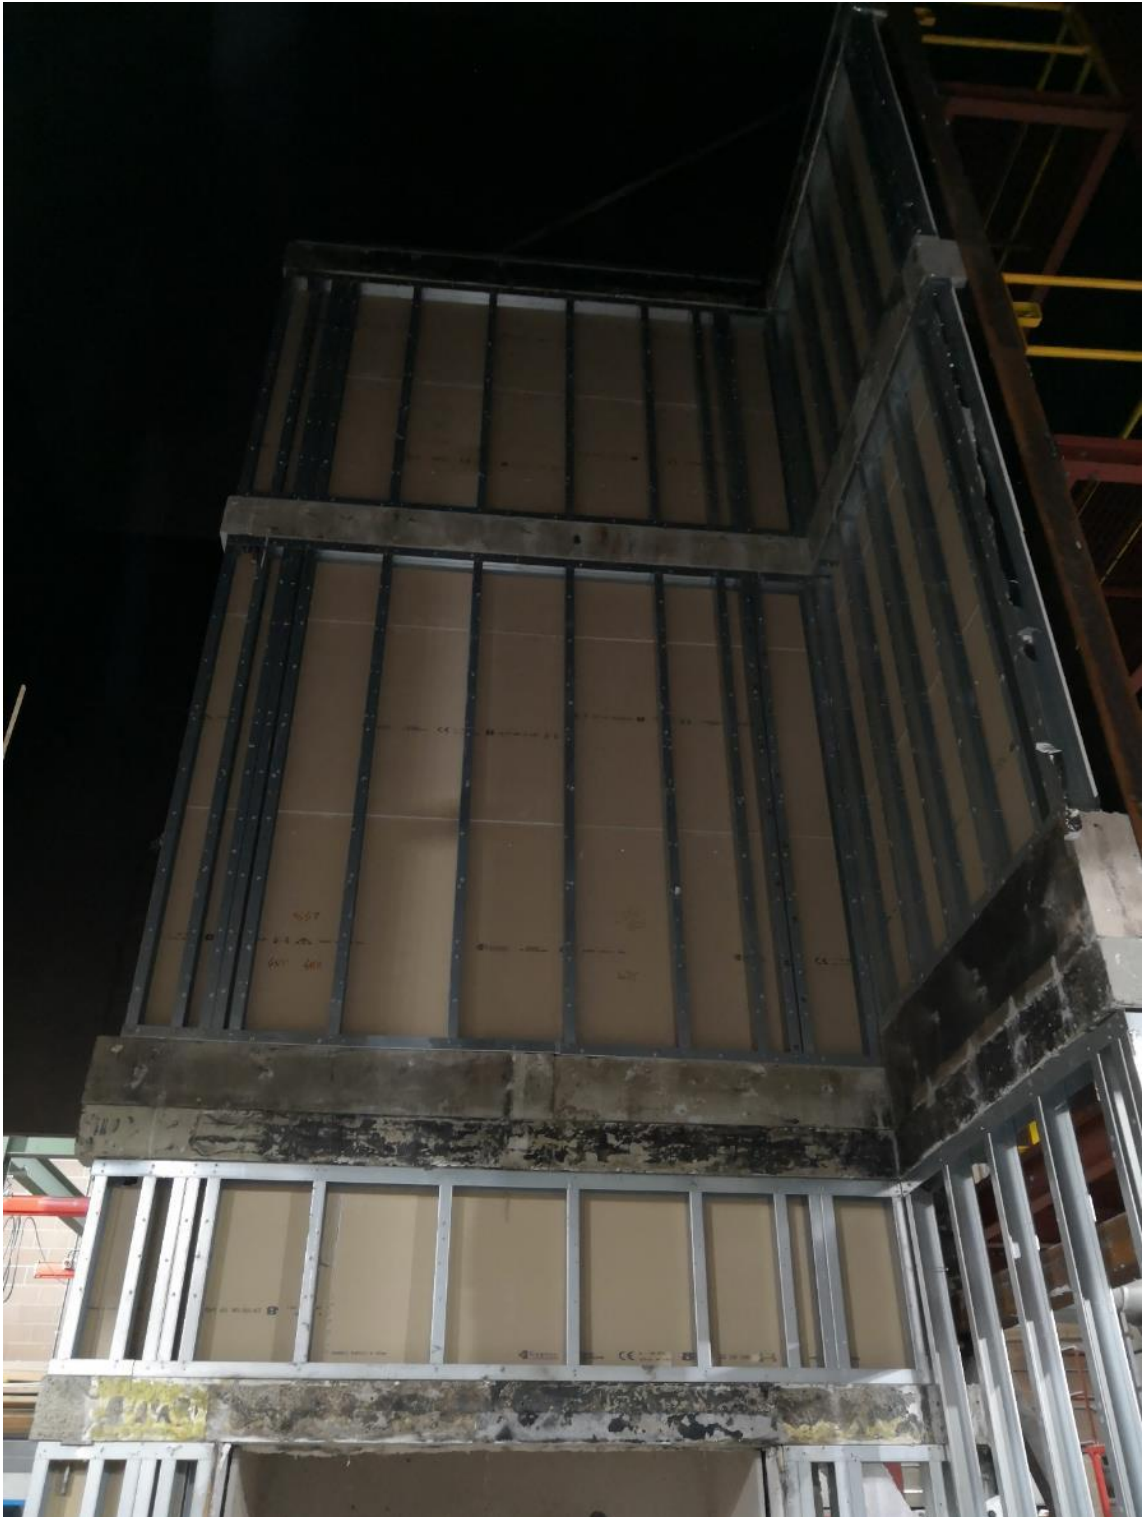
No damage was observed to plasterboard layer installed on the unexposed side of the system. No discoloration was observed.

No damage was observed to SFS Kingframe; all studwork was in place and intact after testing. No discoloration was observed.

Figure 4.25. Post-examination damage. Photo of the system showing the plasterboard layer and SFS Kingframe after the test.
