Fire Performance Testing of an External Cladding System
BS 8414-2:2015 + A1:2017

Test Report

Prepared for : Kingspan Insulation Ltd.
Project : System Development
Report No. : DLR1547 Rev.0
Sample : 100mm Kingspan Kooltherm K15 with Dri-Design Aluminium Cassette

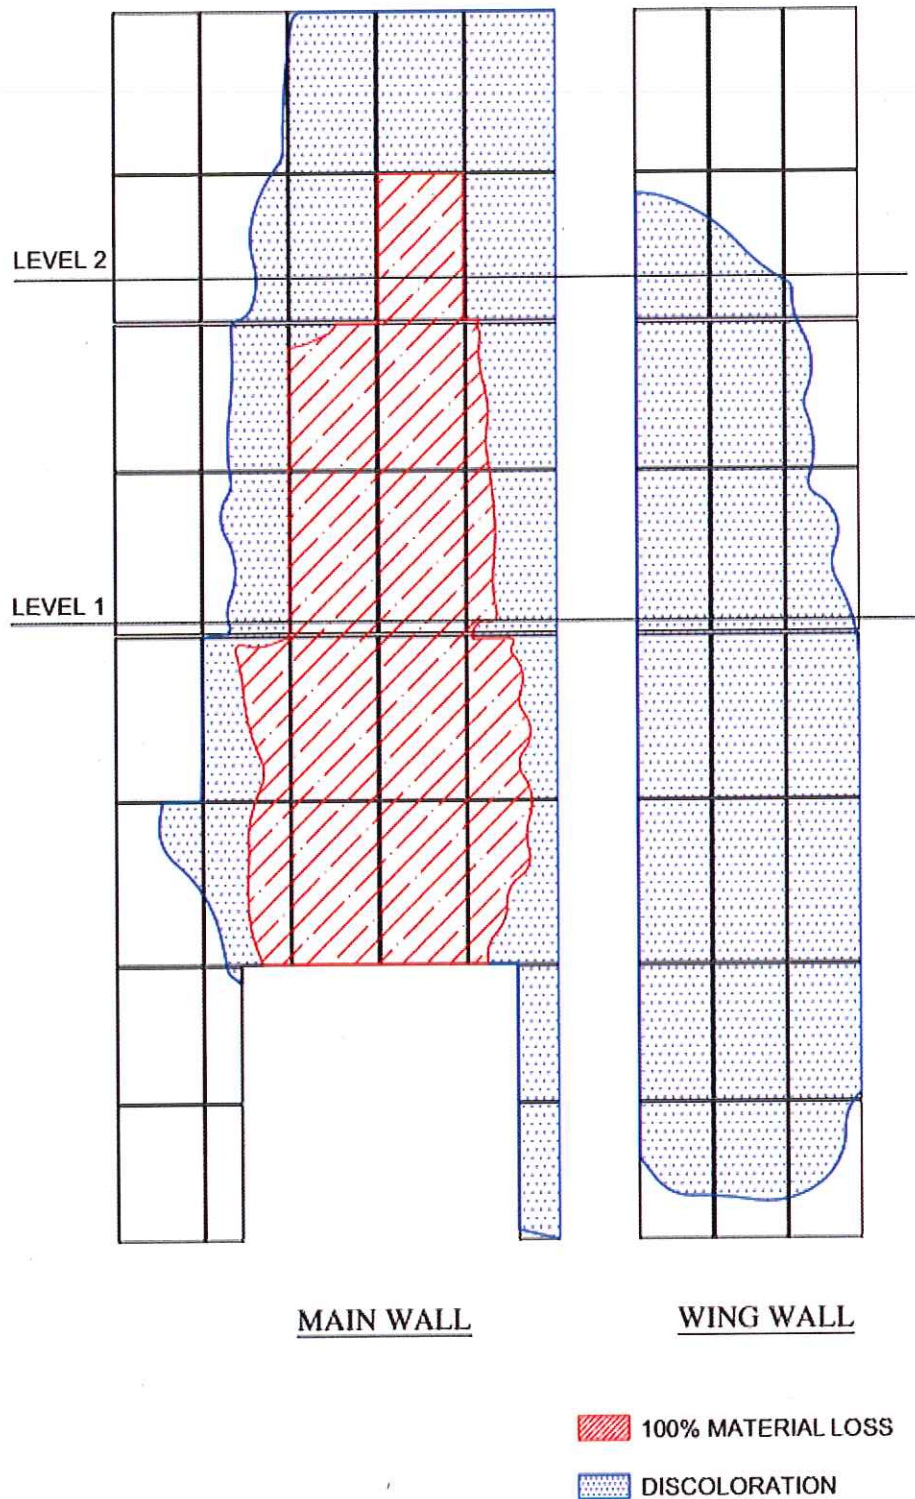
Figure 12 Area Map Showing the Condition of the Sample After the Test

- Approximately 9m² of the total external visible area was completely consumed.
- Approximately 19m² of the total external visible area was discoloured.

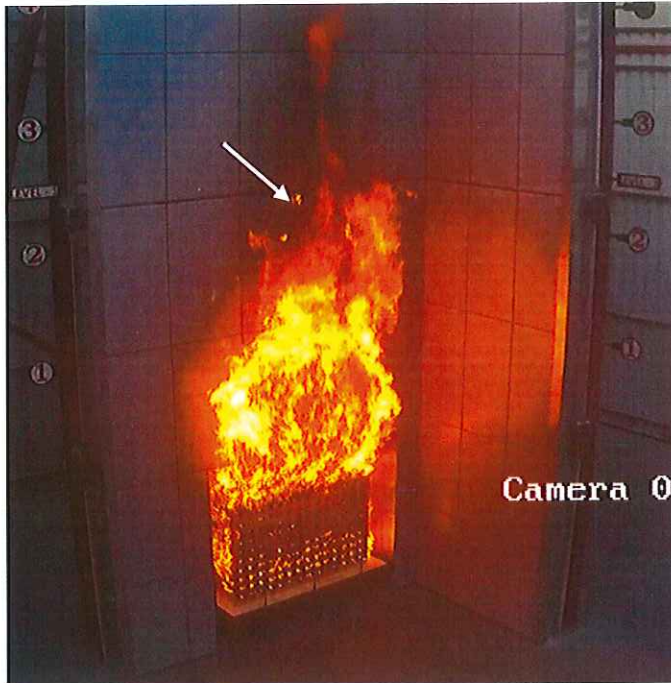
06:17:45	66	Flame tip at 3m above the combustion chamber.	-
06:18:25	106	Coating of panels M9, M10, M14 & M15 started to burn off.	-
06:19:23	164	Coating of panels M19 & M20 started to burn off.	DLP C2753J/0001

DLP C2753J/0001 Coating of panels M19 & M20 started to burn off.

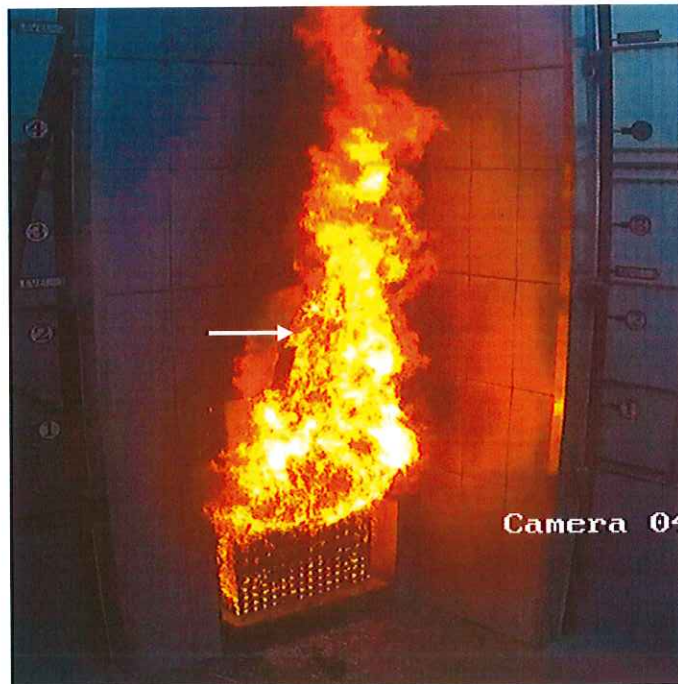
06:22:35	356	Self-sustained flames on the surface of panel M8.	-
06:23:17	398	Continuous falling of aluminium debris from the main wall.	-
06:23:22	403	Panels M9, M10, M14 & M15 partially melted and insulation behind the panels burning.	DLP C2753J/0002

DLP C2753J/0002 Panels M9, M10, M14 & M15 partially melted and insulation behind the panels burning.

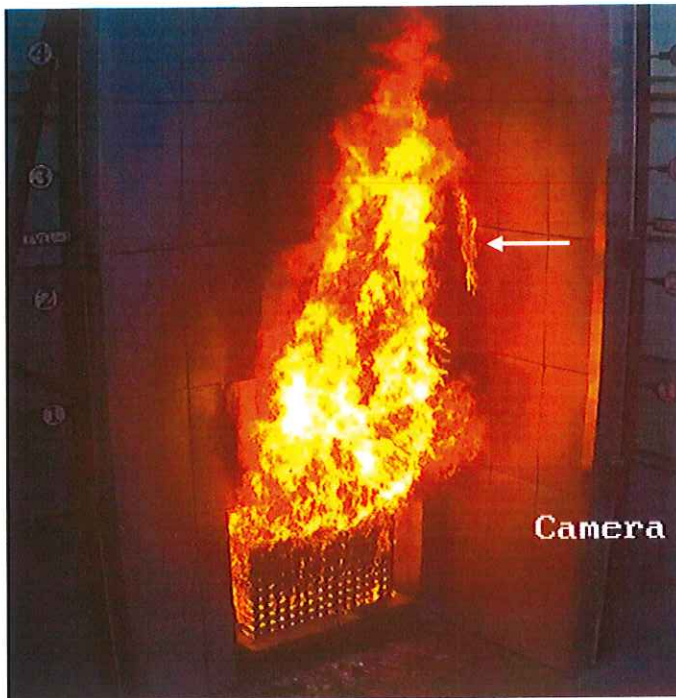
06:23:34	415	Debris of insulation behind panel M14 fell off.	-
06:23:49	430	Self-sustained flames on the surface of panel W7.	DLP C2753J/0003
06:23:59	440	Self-sustained flames on the surface of panel W10.	-

DLP C2753J/0003 Self-sustained flames on the surface of panel W7.

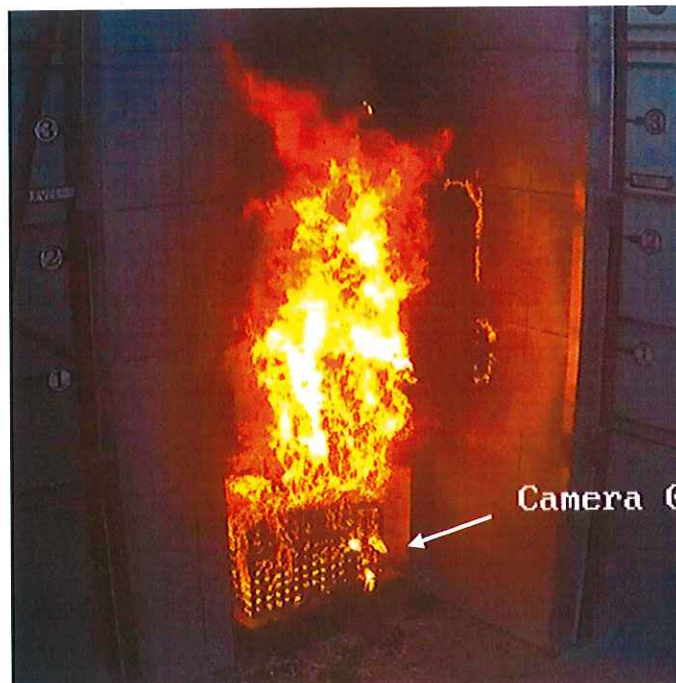
06:24:38	479	Flaming debris fell off the main wall.	DLP C2753J/0004
06:25:22	523	Coating of panel M30 started to burn off.	-
06:25:43	544	Self-sustained flames on the surface of panel M24.	-

DLP C2753J/0004 Flaming debris fell off the main wall.

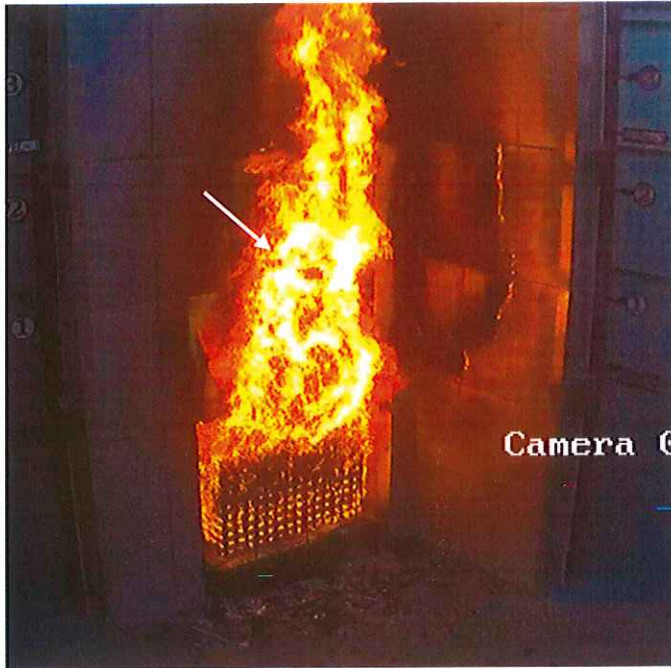
Time	Seconds	Observation	Photo Reference
06:26:05	566	Approximately 90% of panels M9, M10, M14 & M15 melted.	DLP C2753J/0005
06:27:12	633	Self-sustained flames at panels M7 & M8 vertical joint.	-

DLP C2753J/0005 Approximately 90% of panels M9, M10, M14 & M15 melted.

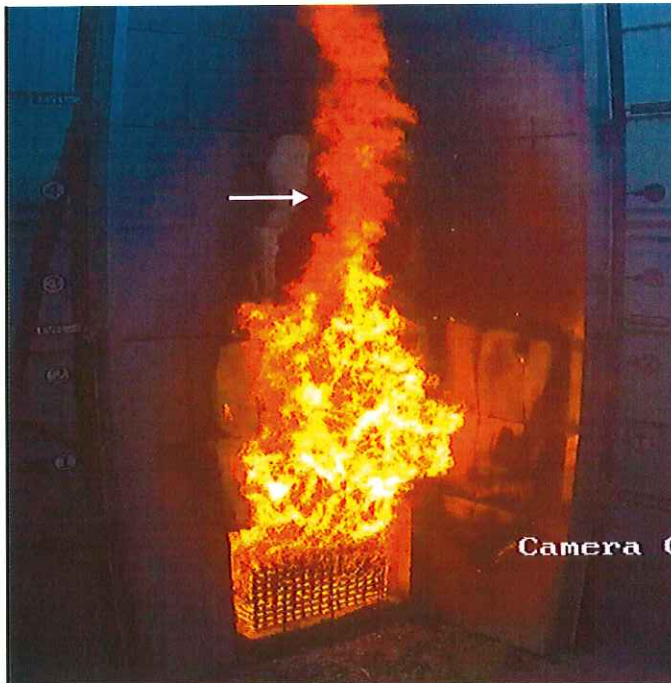
06:27:43	664	Self-sustained flames on the surface of panels W8 & W11.	-
06:28:39	710	Panels M24 & M25 partially melted and insulation behind the panels burning.	DLP C2753J/0006

DLP C2753J/0006 Panels M24 & M25 partially melted and insulation behind the panels burning.

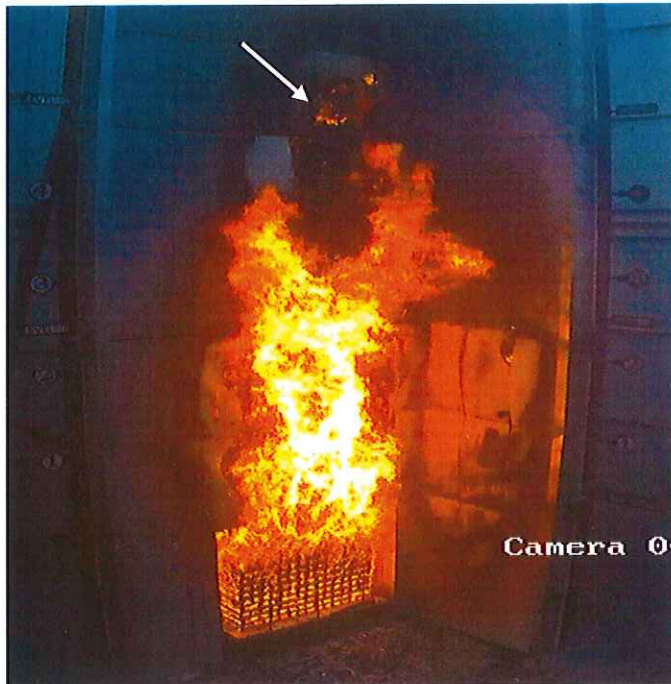
06:29:14	755	Self-sustained flames on the surface of panels W13 & W14.	-
06:31:48	909	Self-sustained flames on the surface of panel W16.	-
06:32:42	963	High intensity flames on the insulation behind the panel M30.	DLP C2753J/0007

DLP C2753J/0007 High intensity flames on the insulation behind panel M30.

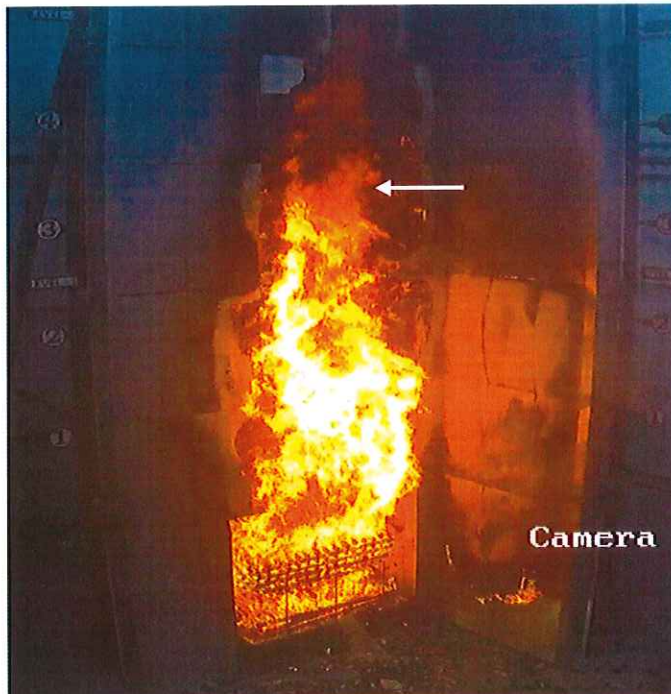
06:33:59	1040	Coating of panel M35 started to burn off.	-
06:34:58	1099	100% of the panels M19, M20, M25 & M30 consumed.	DLP C2753J/0008
06:35:17	1118	Self-sustained flames on the surface of panels W2 & W6.	-

DLP C2753J/0008 100% of the panels M19, M20, M25 & M30 consumed fell off.

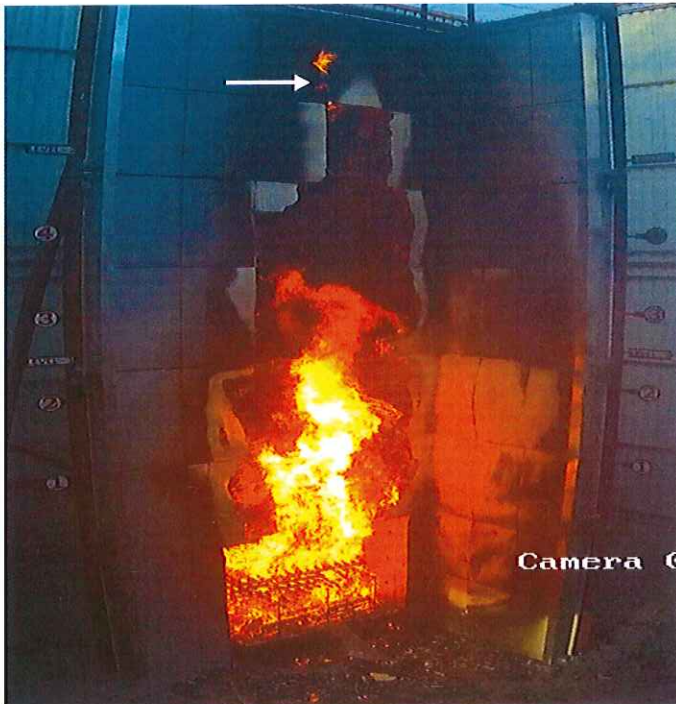
06:36:27	1188	Self-sustained flames at panels M34 & M35 vertical joint.	-
06:38:07	1288	Flames behind panel M35.	DLP C2753J/0009
06:40:35	1436	Continuous falling of debris of insulation.	-

DLP C2753J/0009 Flames behind panel M35.

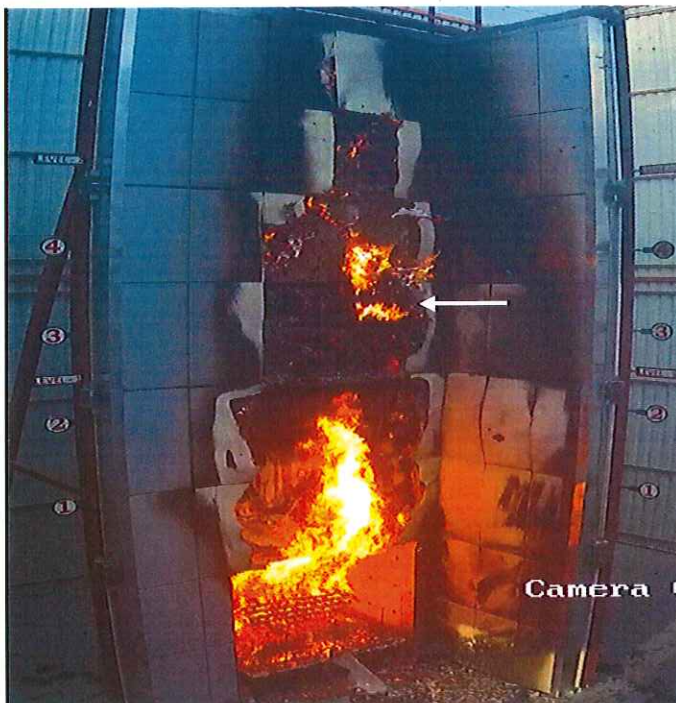
06:41:56	1517	Panel M35 discoloured.	-
06:42:00	1521	Flaming debris of the insulation behind panel M24 fell off.	DLP C2753J/0010
06:45:33	1734	Heat source was extinguished. Observations continued for another 30 minutes.	-

DLP C2753J/0010 Flaming debris of the insulation behind panel M24.

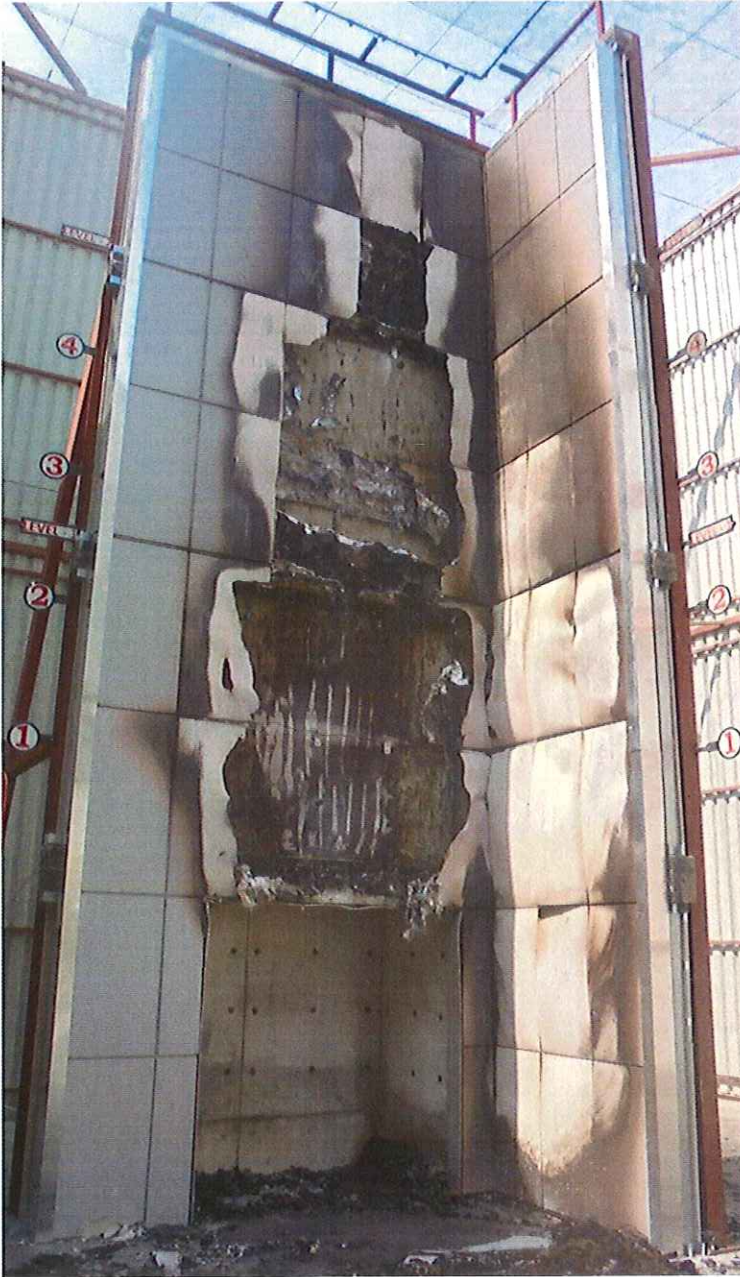
DLP C2753J/0011

Sl. No.	Components	Observation	Photo Reference
1	2mm Aluminium Cassette panels	<p>Panels M1, M2, M4, M4, M12, M17, M22, M27 & M32 - No changes on the panels.</p> <p>Panels M3, M6, M11, M21, M29, M31, M34, M35 & M36 - 100% discoloration on the panels.</p> <p>Panels M5, M7, M28 & M33 - Minor discoloration on the panels.</p> <p>Panels M8, M11, M13, M16, M21 & M26 - Approximately 50% material loss observed. Remaining area was buckled and discoloured.</p> <p>Panels M9, M10, M14, M15, M19, M20, M25 & M30 - 100% material loss observed.</p> <p>Panels M18 & M23 - Approximately 50% of the panel was discoloured.</p> <p>Panels W1, W2, W3, W4, W5, W6, W7, W8, W9, W10, W11, W12, W13 & W14 - Panels were discoloured.</p> <p>Panels W15, W16, W17, W18, W19, W20, W21, W22, W23 & W24 - Minor discoloration on the panels.</p>	<p>DLP C2753J/0011.</p> <p>Please see Figure 13 in this section for damaged areas</p>

View of the sample after the test

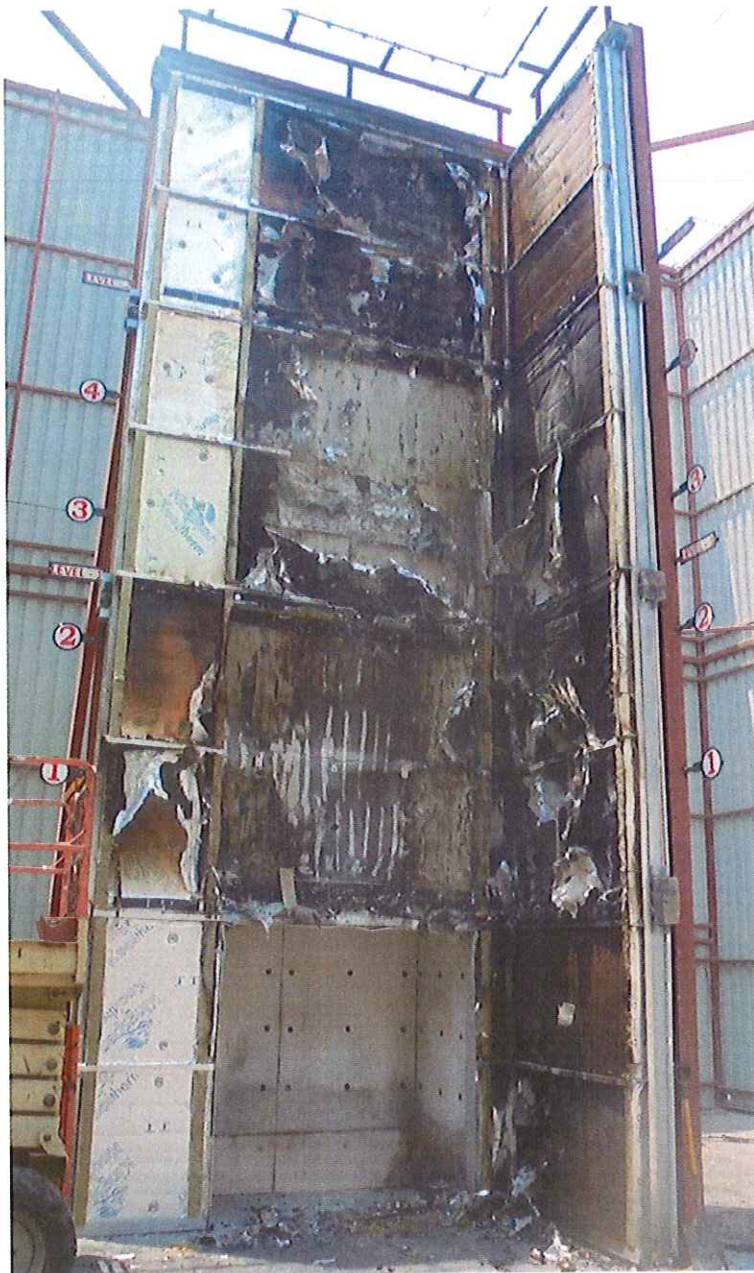
DLP C2753J/0012

2.	Kingspan Kooltherm K15 insulation	<p>Main wall:</p> <p>Insulation behind panels M8, M9, M10, M13, M14, M15, M19, M20, M24 & M25 was completely burned and fell off.</p> <p>Insulation behind panels M11, M16, M18, M21, M23, M26, M28, M29, M30, M31, M33, M34, M35 & M36 was burned and left as char.</p> <p>Insulation behind panels M3, M6, M7 & M12 was discoloured.</p> <p>All other insulation on the main wall was in place and no changes observed.</p> <p>Wing wall:</p> <p>Insulation behind panels W7, W8, W9, W10, W11 & W12 was burned and left as char.</p> <p>All other insulation on the main wall was discoloured.</p> <p>Material loss observed.</p>	<p>DLP C2753J/0012, DLP C2753J/0016, & DLP C2753J/0017.</p>

Sl. No.	Components	Observation	Photo Reference
3.	Cavity barrier	<p>Horizontal intumescent cavity barrier:</p> <p>Main wall:</p> <p>The 1st horizontal cavity barrier at 150mm above the combustion chamber was activated except the cavity barrier behind panel M7. Intumescent layer was not present during dismantling. Material loss observed.</p> <p>The 2nd horizontal cavity barrier at 2375mm above the combustion chamber was activated. Intumescent layer was partially present during dismantling. Cavity barrier was in place and material loss observed.</p> <p>The 3rd horizontal cavity barrier at 4875mm above the combustion chamber was activated except the cavity barrier behind panel M27. Intumescent layer was partially present during dismantling. Cavity barrier was in place and minor material loss observed.</p> <p>The 4th horizontal cavity barrier at 6890mm above the combustion chamber was activated except the cavity barrier behind panel M32. Intumescent layer was present during dismantling. Cavity barrier was in place and minor material loss observed.</p> <p>Wing wall:</p> <p>All the cavity barriers on the wing wall were activated. Intumescent layer was present during dismantling. Minor material loss observed.</p> <p>Vertical cavity barrier:</p> <p>Buckling and discoloration on the vertical cavity barrier on the main wall and wing wall.</p>	DLP C2753J/0012, DLP C2753J/0015, DLP C2753J/0016 & DLP C2753J/0017.

4.	Railings	<p>Railings:</p> <p>Railings behind panels M8, M9, M10, M11, M13, M14, M15 M16, M18, M19, M20, M21, M23, M24, M25 & M26 were melted completely.</p> <p>Railings behind panels M28, M29, M30, M31, M33, M34, M35 & M36 were discoloured and buckled.</p> <p>All other railings on the main wall were in place and no damage was observed.</p> <p>All the railings on the wing wall were discoloured.</p>	DLP C2753J/0012, DLP C2753J/0016 & DLP C2753J/0017.

Kingspan Kooltherm K15 insulation, cavity barrier and railings

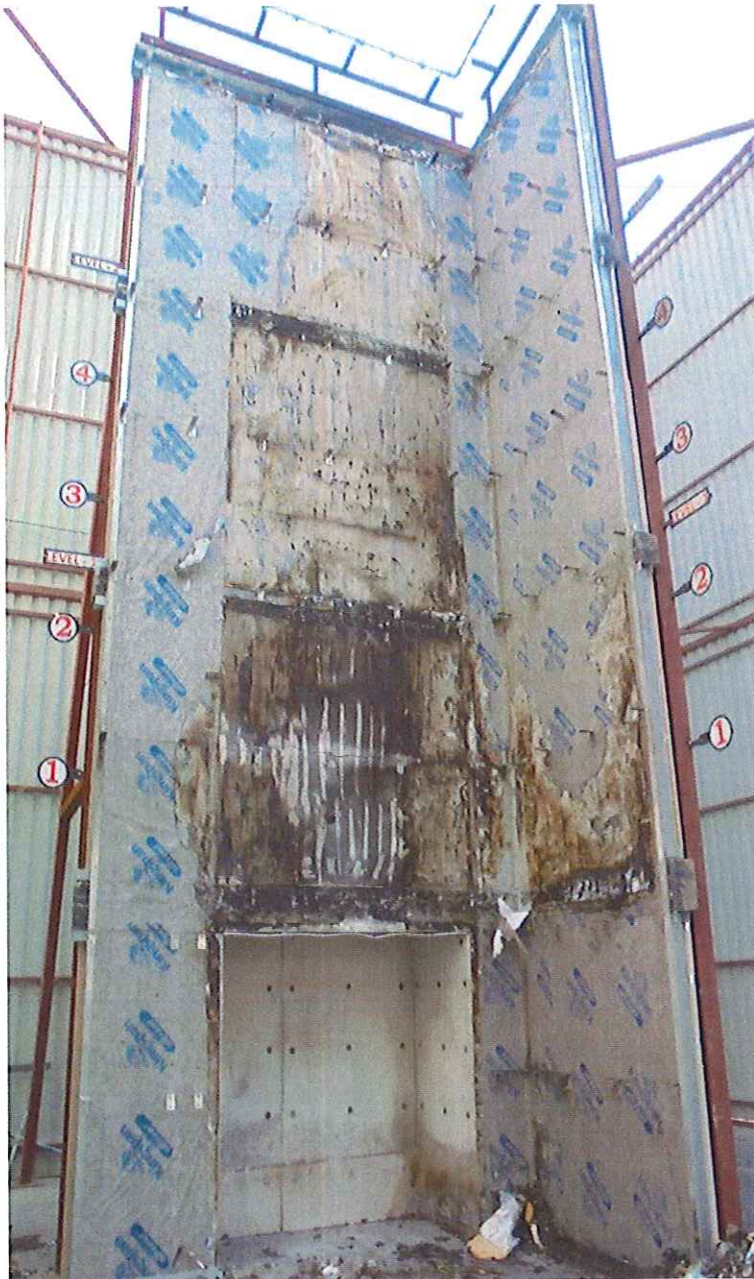
DLP C2753J/0013

Sl. No.	Components	Observation	Photo Reference
5.	Brackets and Breather membrane	<p>Brackets:</p> <p>Approximately 10% of the Helping Hand brackets on the main wall were partially melted.</p> <p>All other brackets on the main wall and wing wall were in place and no damage was observed.</p> <p>Breather membrane:</p> <p>Material loss and discolouration to the Nilvent breathable membrane on the main wall and wing wall.</p>	DLP C2753J/0013, & DLP C2753J/0018.
6.	12mm Versapanel cement particle board	Minor damages and discolouration to the Versapanel cement particle board on the main wall and no significant changes to the Versapanel cement particle board on wing wall.	DLP C2753J/0013, & DLP C2753E/0018.
7.	Kingframe SFS and plaster boards	No significant changes.	DLP C2753J/0014.

Breather membrane and brackets

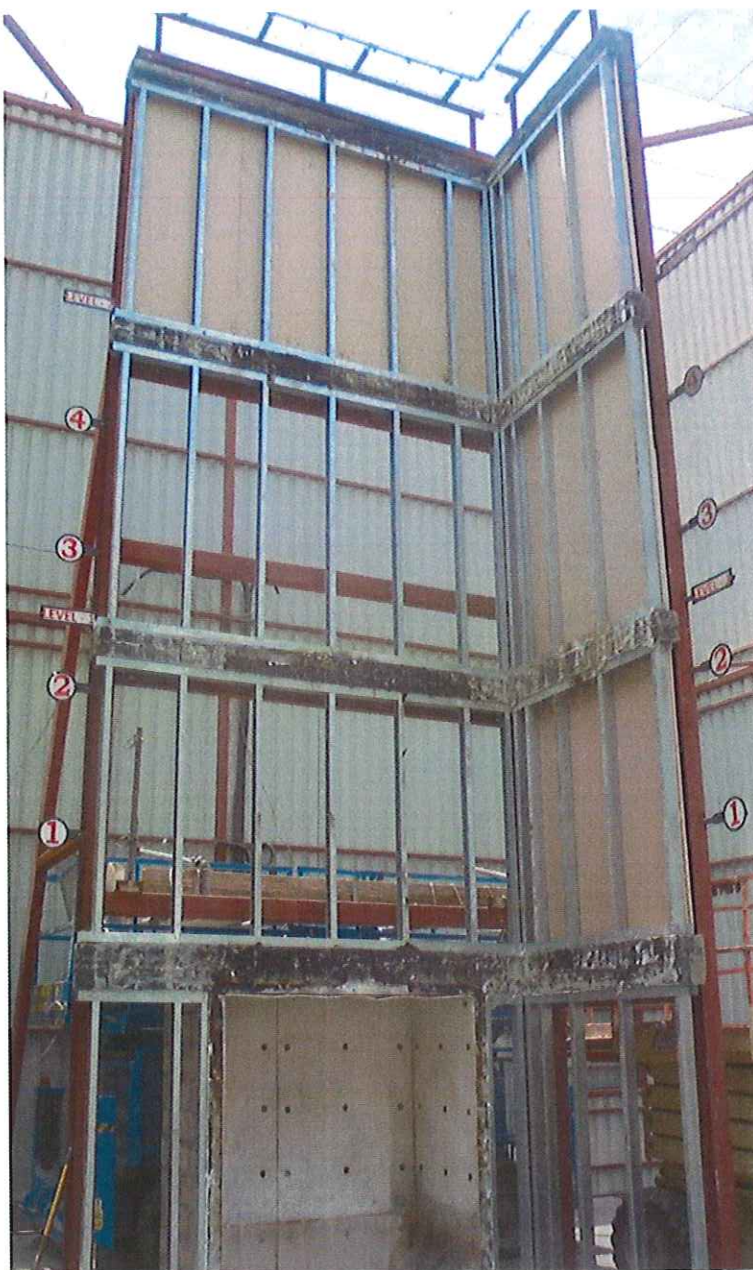
DLP C2753J/0014

Kingframe SFS and plaster board

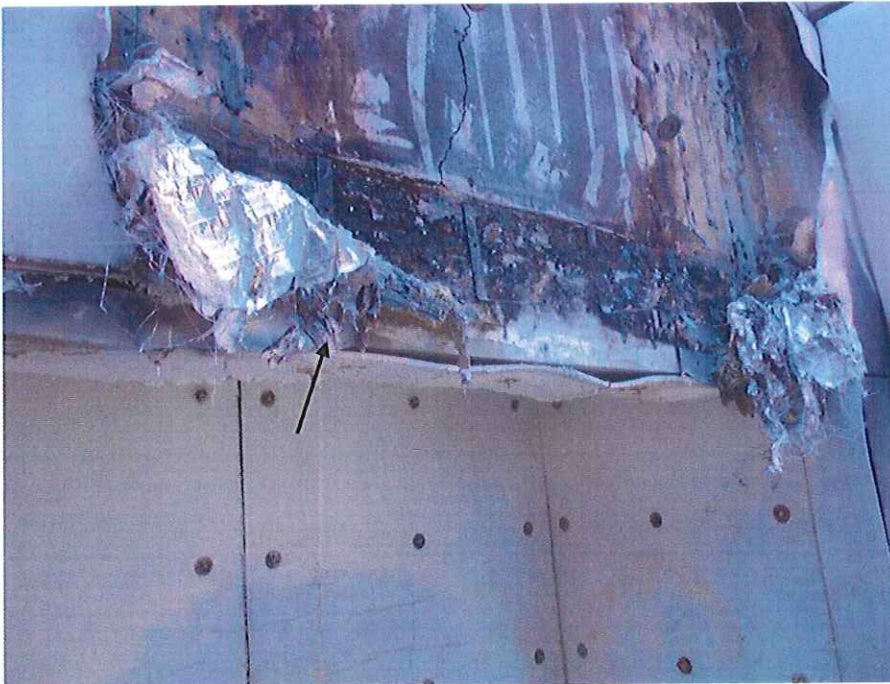
DLP C2753J/0015 Cavity barrier above the combustion chamber

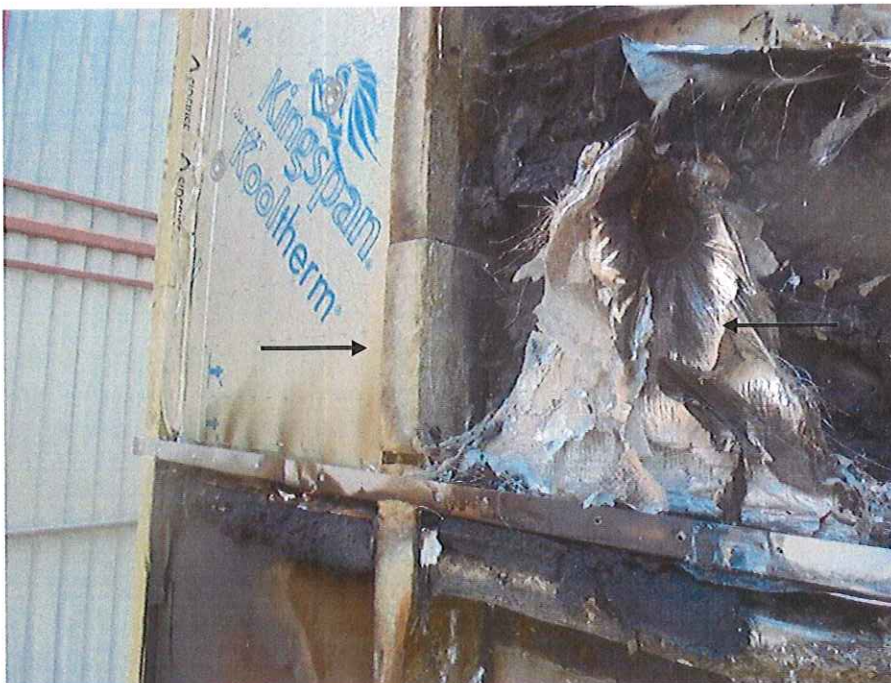
DLP C2753J/0016 Vertical cavity barrier, insulation and railings on main wall

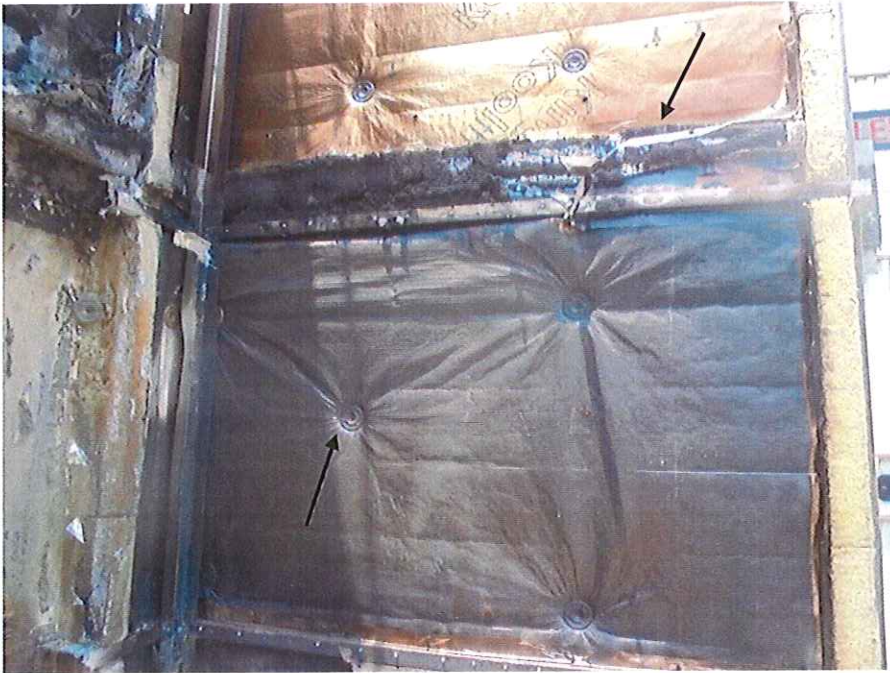
DLP C2753J/0017 Cavity barrier, insulation and railings on wing wall
