BRE Global Test Report

BS8414-2 : 2005 Test on a Kingspan Ltd BENCHMARK Engineered Façade system- Metallic Hook on Cassette

Prepared for: Kingspan Ltd
Date: 3 October 2014
Report Number: 297804 **Issue:** 1

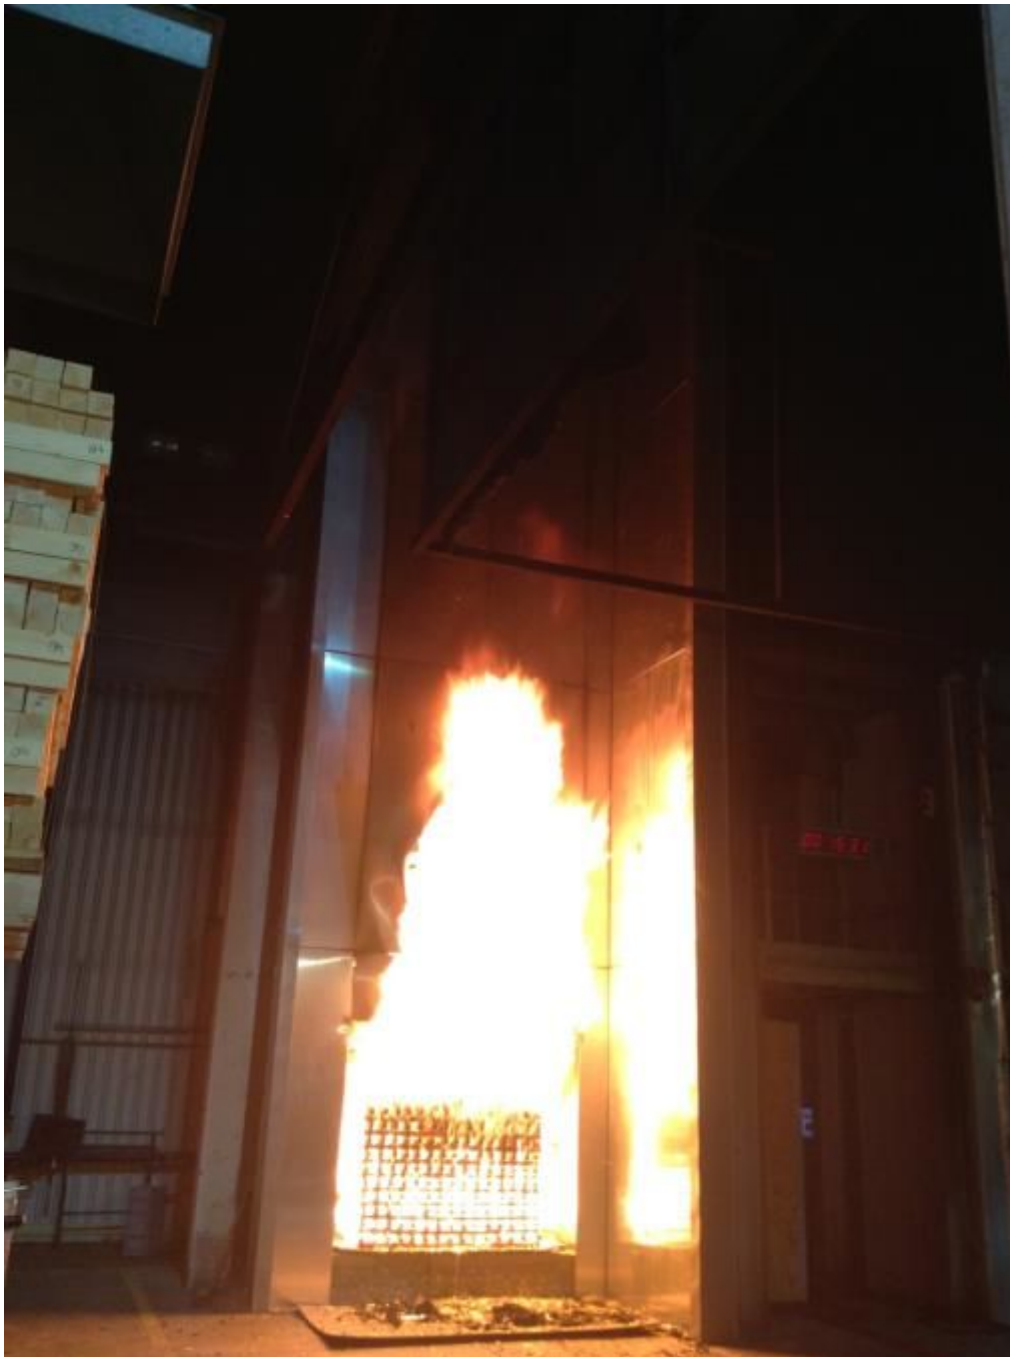
Figure 17. Cladding system during the test.

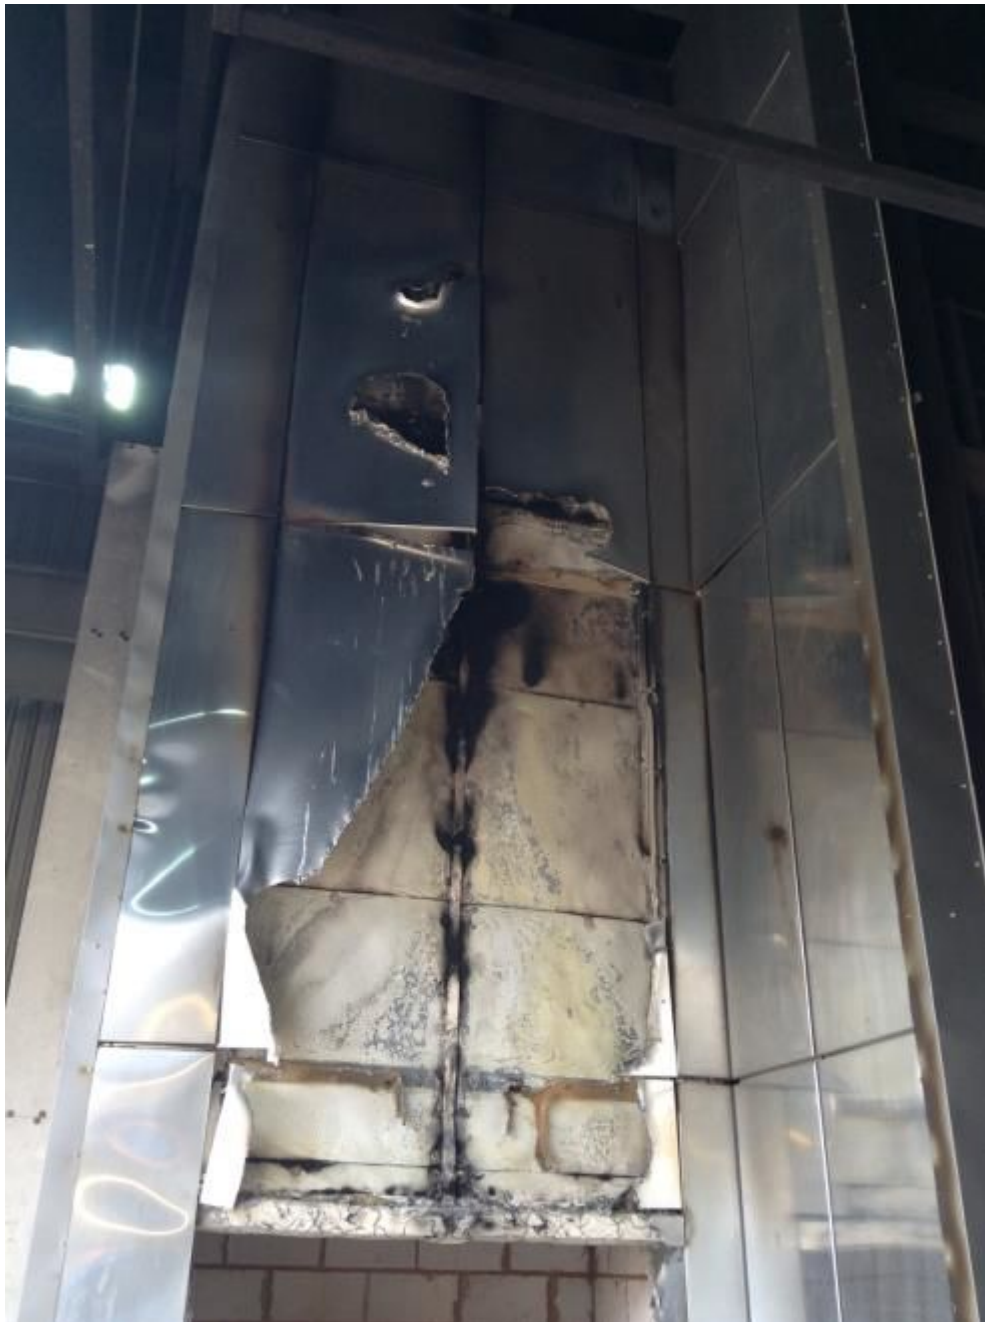
A schematic illustration of the damage to the system is shown in Figure 19 and the condition of the cladding system after the test is shown in Figure 18. It was noted that there was no observed burning on the external face of the system.

Figure 18. Photograph showing the condition of the cladding system post-test (Decorative Layer Full height).

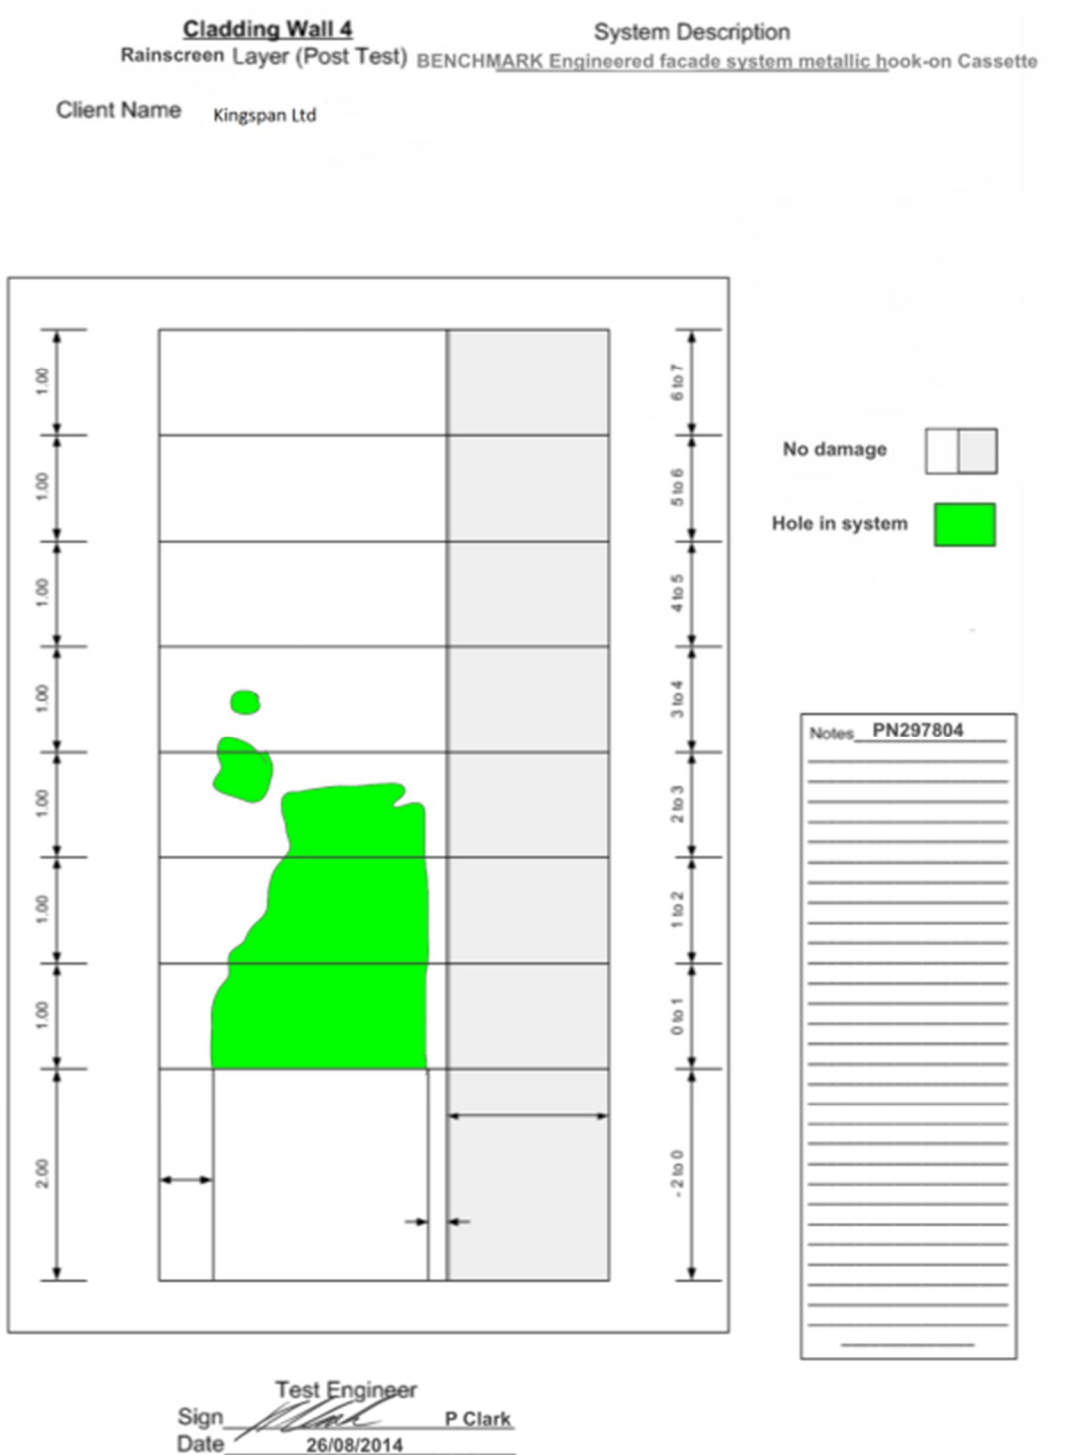
There was only partial collapse of rain screen metallic sheets up to 4 m on the cladding wall main face.

Figure 19. Schematic of the condition of the cladding system post-test (Surface coat layer).

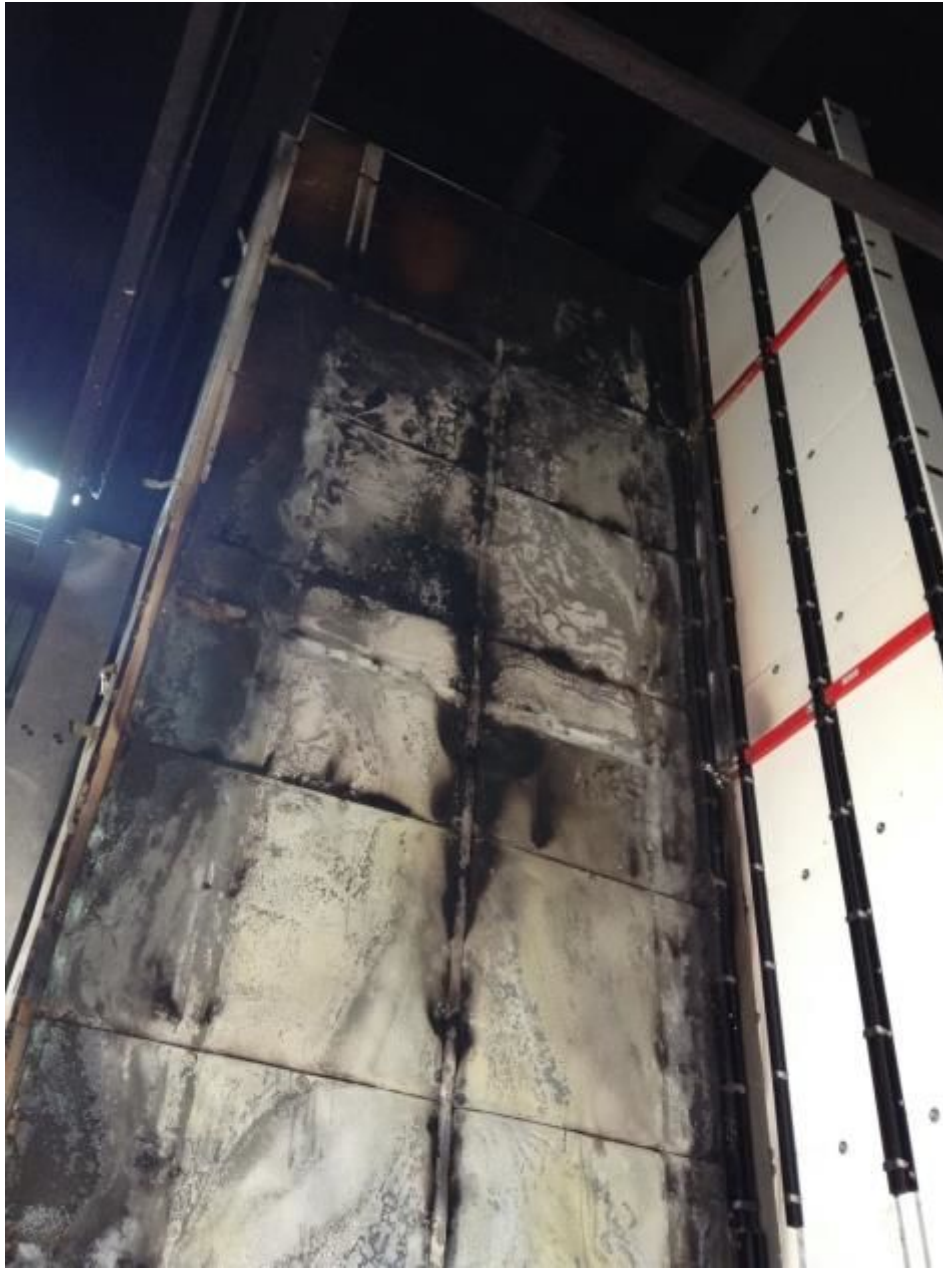
Figure 20. Photograph showing the condition of the cladding system post-test (Insulation Layer Full height).

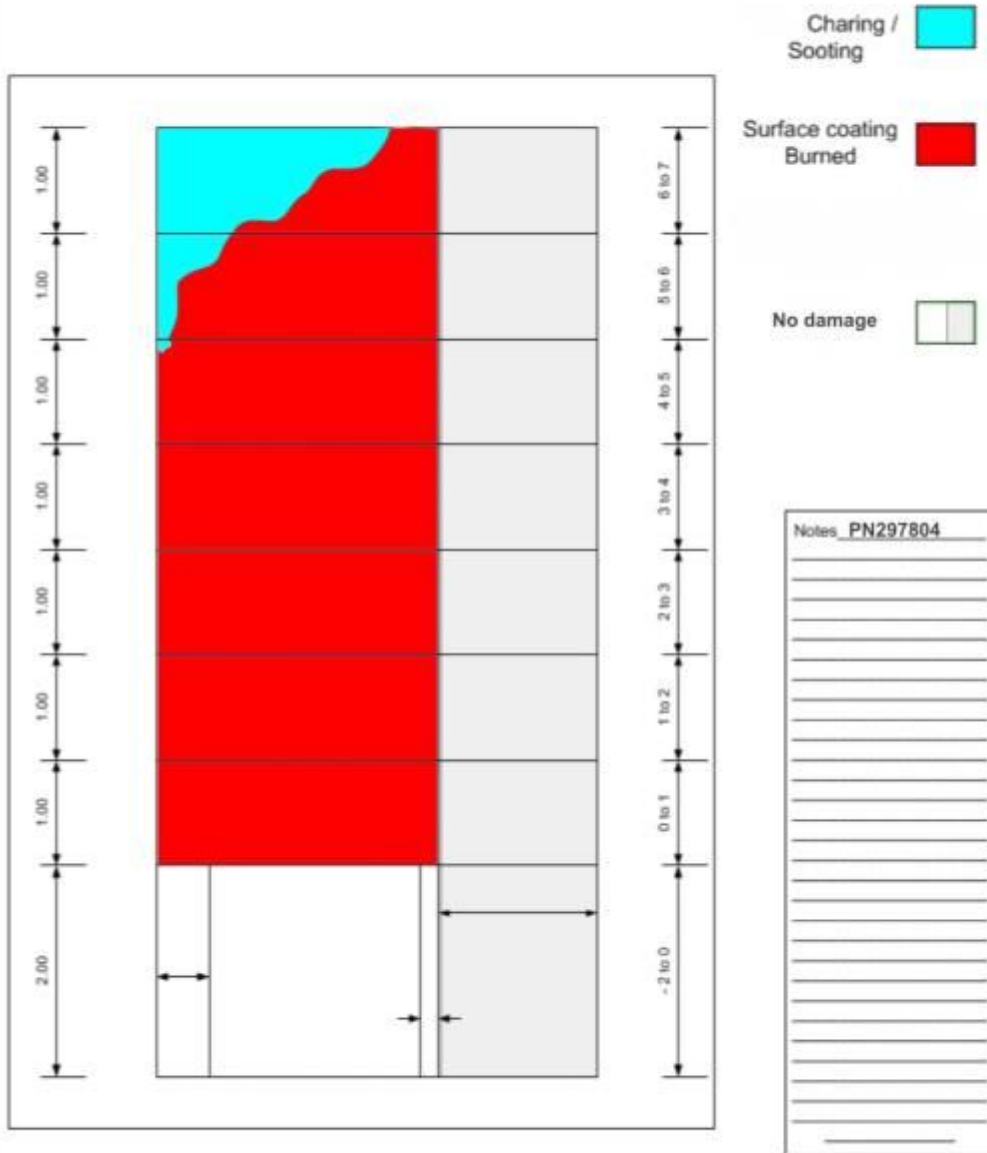
The condition of the panels after the test is shown in Figure 21. It was noted that the insulation layer continued to burn past the 30 minute mark with flaming combustion visible in the insulation at 4m mark until approximately 44 minutes.

Figure 21. Schematic of the condition of the cladding system post-test (Insulation layer).
