BRE Global Test Report

BS 8414-1:2015 + A1:2017 test on a ventilated façade system with Kingspan Kooltherm K15 insulation and Alpolic/fr panels.

Prepared for: Kingspan Insulation Limited

Report Number: P107017-1000 Issue: 1

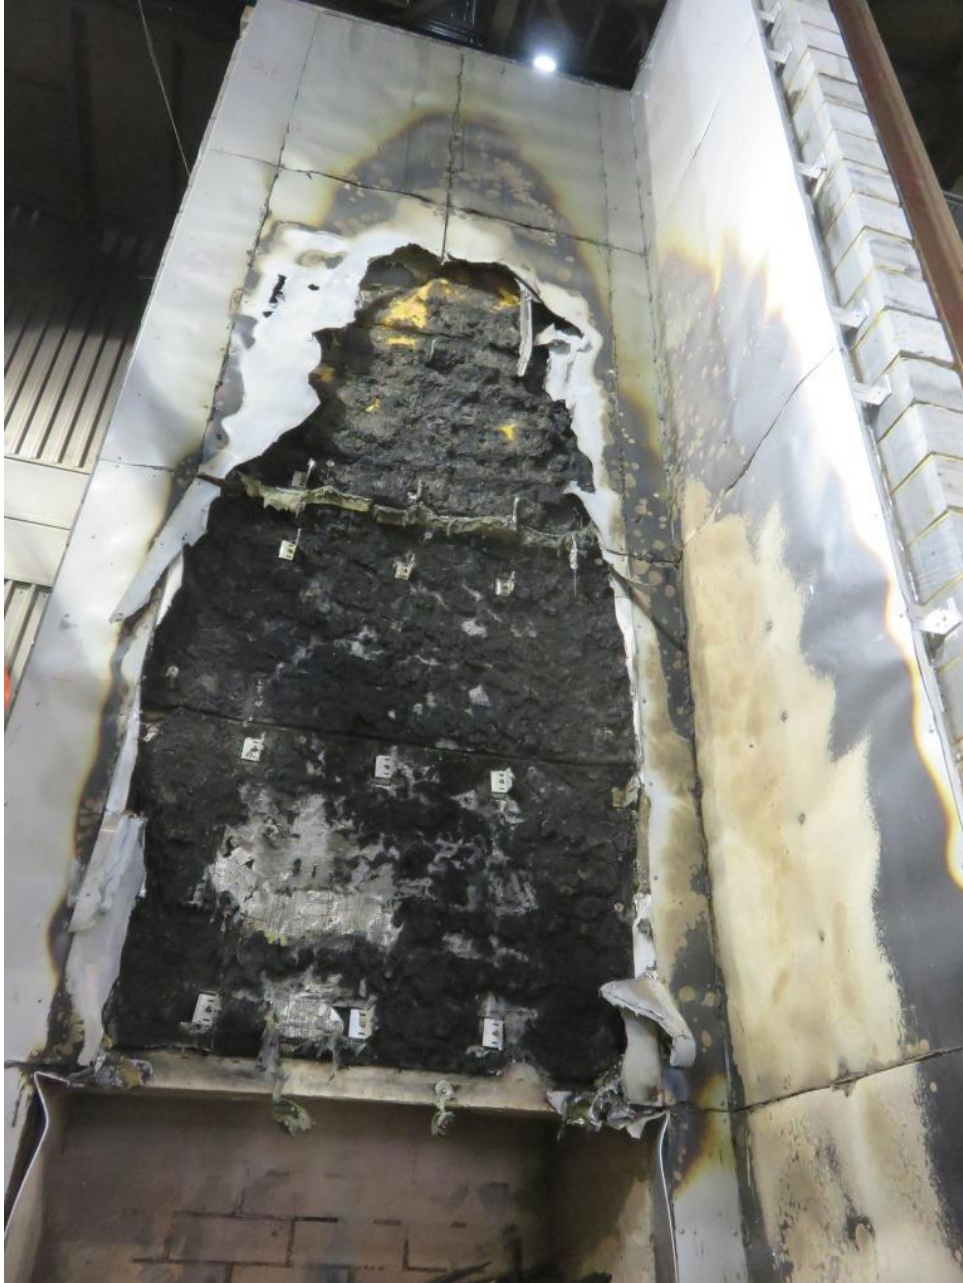
Figure 14. Full-height photograph immediately after test.

6.1 ACM panels

Row 0 – Panel 0A was significantly distorted and discoloured (approximately 70% panel coating removed, 25% dark discolouration). On panel 0B there was a small area (approximately 300mmx150mm) of dark discolouration in the top left hand corner of the panel (adjacent to the combustion chamber). Panel 0E was not visibly damaged.

Row 1 – Panel 1A was significantly distorted and discoloured (approximately 50% panel coating removed, 25% dark discolouration). Panel 1B was significantly distorted and discoloured (approximately 50% panel coating removed, 50% dark discolouration). Panels 1C and 1D were both almost fully consumed. Panel 1E was distorted and darkly discoloured in a 50mm-wide full-height vertical strip in line with the combustion chamber opening.

Row 2 – Panel 2A was distorted and discoloured (<10% panel coating removed, 50% dark discolouration). Panel 2B was distorted and discoloured at the base of the panel (small areas of panel coating removed, 40% dark discolouration). Panels 2C and 2D were damaged across the full panel surface: panel consumed (55% and 40% respectively), distorted and discoloured across the remaining panel. An area approximately 1500mm x 400mm of panel 2D remained loosely attached with consumption of the panel core. Small holes approximately 50mm x 300mm and 50mm x 50mm were observed in panel 2D approximately 3750mm above combustion chamber. Panel 2E was distorted and slightly discoloured.

Row 3 – Panels 3A&3B had minor distortion. Panel 3C was distorted and discoloured (small areas of panel coating removed, approximately 30% dark discolouration). Panel 3D was distorted and discoloured (small areas of panel coating removed, approximately 25% dark discolouration). Panel 3E had minimal visible damage.

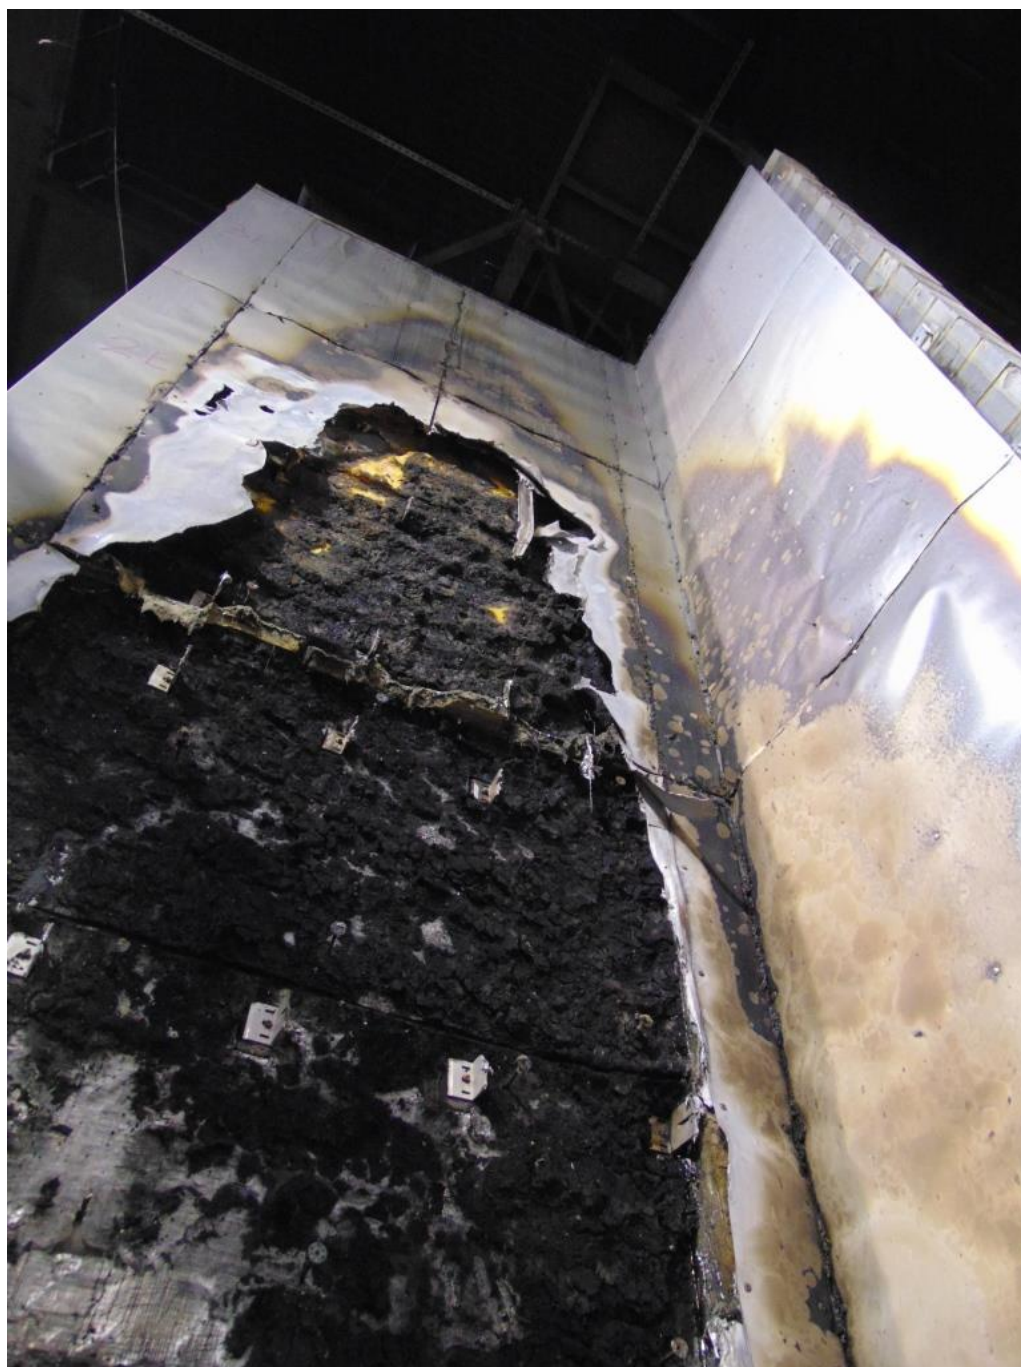
Figure 15. Post-test photo of exposed insulation on the main wall.

6.1 Phenolic Insulation

- 0E. The foil facing on the insulation remained intact
- 1B. Dark discolouration towards the second horizontal cavity barrier and small areas of detachment/consumption of foil facing.
- 1C&1D. Small amount of charred insulation remains. Rear foil facing visible across approximately 10%, mostly intact.
- 1E. Foil facing of insulation intact Slight discolouration in places.
- 2B. Minor discolouration of the foil facing.
- 2C. Charring of the insulation occurred in decreasing severity between the second and third cavity barrier. External foil facing and some uncharred insulation remained adjacent to the third horizontal cavity barrier. The internal foil facing was not visible.

- 2D. Damage to the insulation was similar to that observed beneath panel 2C, however; a band of significant insulation consumption and detachment extended from approximately mid-height to approximately 300mm below the third cavity barrier. The blockwork was exposed in an approximately 300mm-width which would have been directly below the damaged edge of the remains of panel 2D.
- 2E. Insulation appeared to be undamaged.
- 3B. Insulation appeared to be undamaged.
- 3C&3D. Discolouration of the foil facing most pronounced along centre line of combustion chamber opening.
- 3E. Insulation appeared to be undamaged.

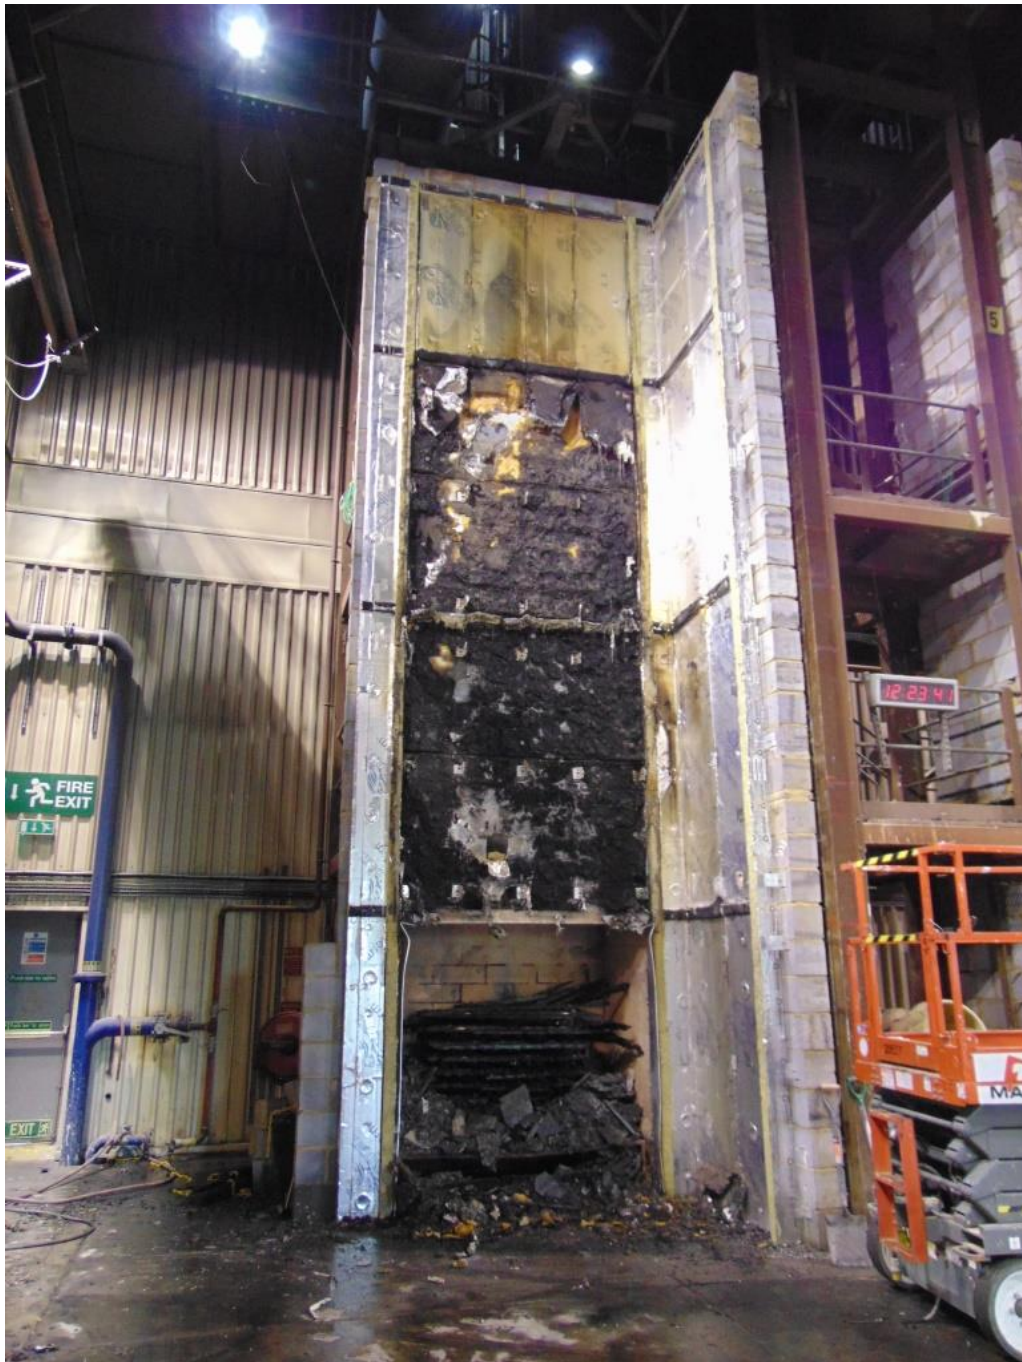
Figure 16. Full-height photograph of system following removal of ACM panels and aluminium rail substructure.

The central aluminium 'T'-shaped rail on the main wall was fully consumed up to a height of approximately 4m. Partial consumption and distortion continued to the top of 2C-2D panel junction.

The 'L'-shaped rails to the left and right of centre on the main wall were fully consumed up to a height of approximately 3.5m. Partial consumption and distortion continued for approximately 500mm.

The Siderise RSV 90/30 vertical cavity barriers on the main and wing wall remained intact throughout the height of the system. On the main, there was minor surface discolouration up to the height of the third horizontal cavity barrier. The wing wall vertical cavity barrier sustained no visible damage.

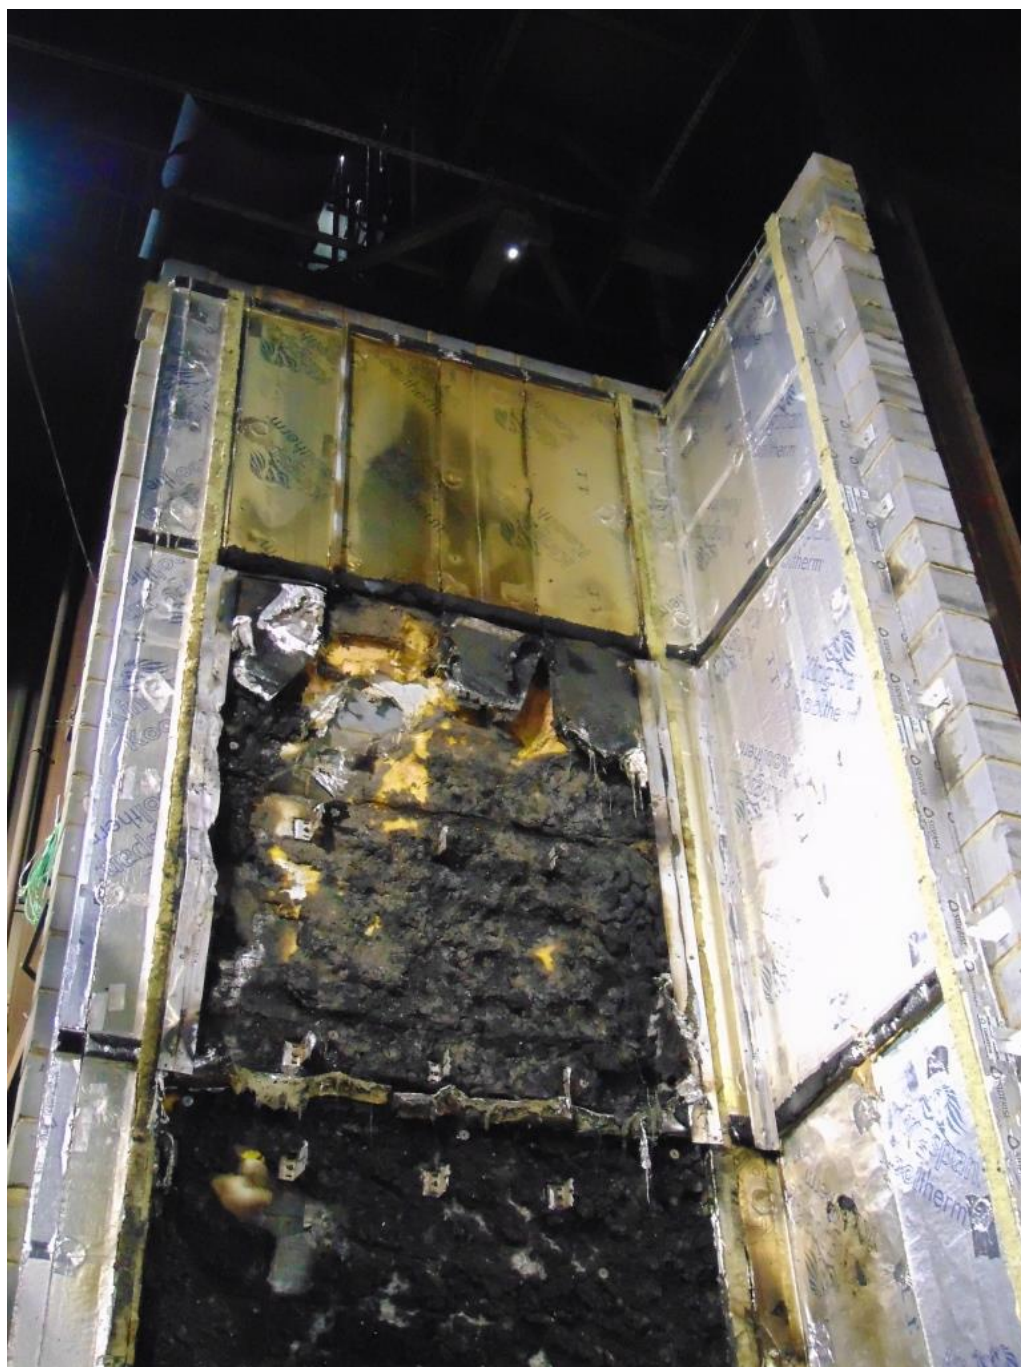
Figure 17. Post-test photo of system following removal of cladding panels.

Note: majority of aluminium rail substructure has been removed.

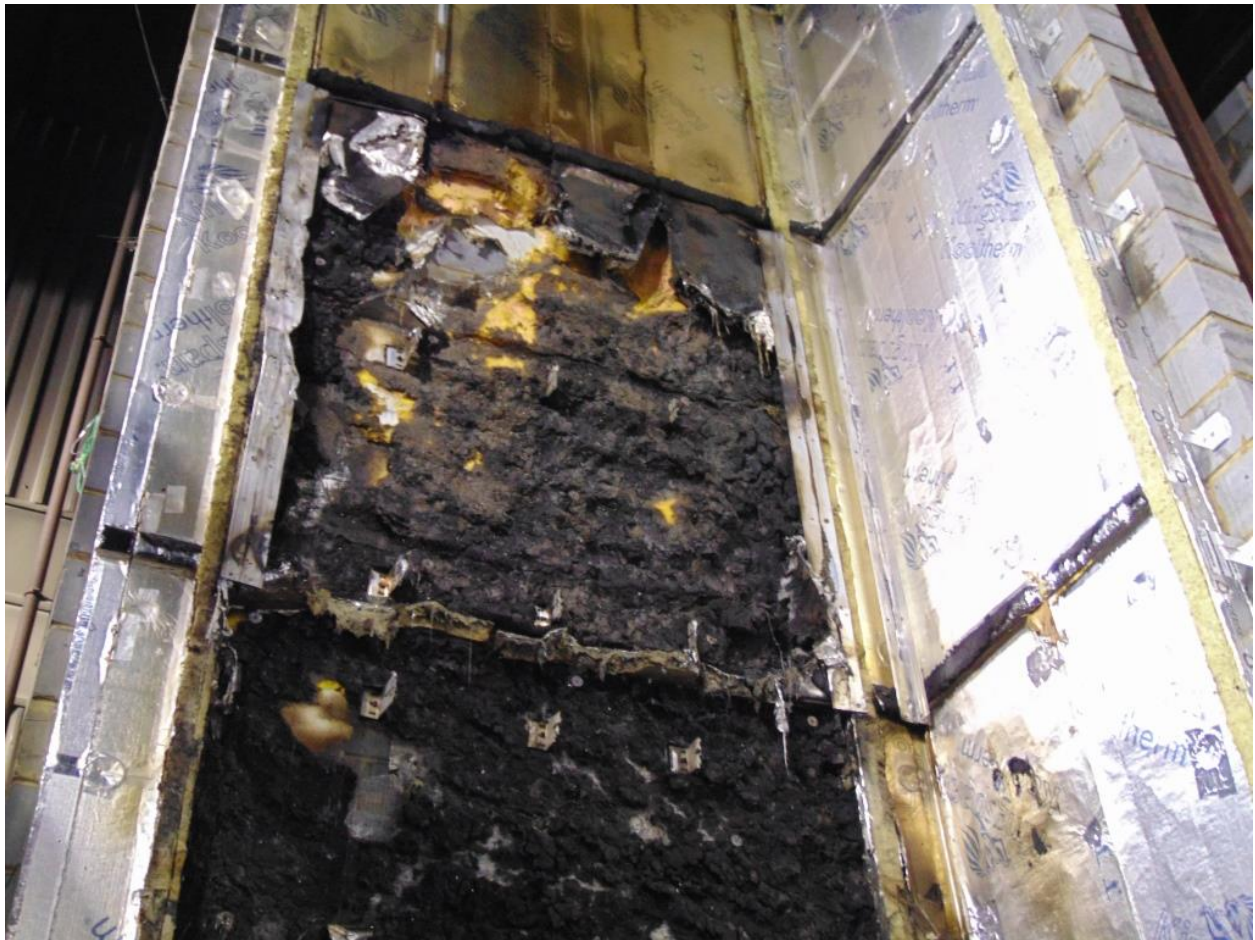
Figure 18. Post-test photo between second and third row Siderise RH25G 90/30 horizontal open state cavity barriers.

The second row horizontal cavity barrier had activated but was significantly damaged (directly in line with the combustion chamber opening) up the vertical cavity barriers, beyond these there was evidence of activation across the full width of main and wing walls.

Note: majority of aluminium rail substructure has been removed.

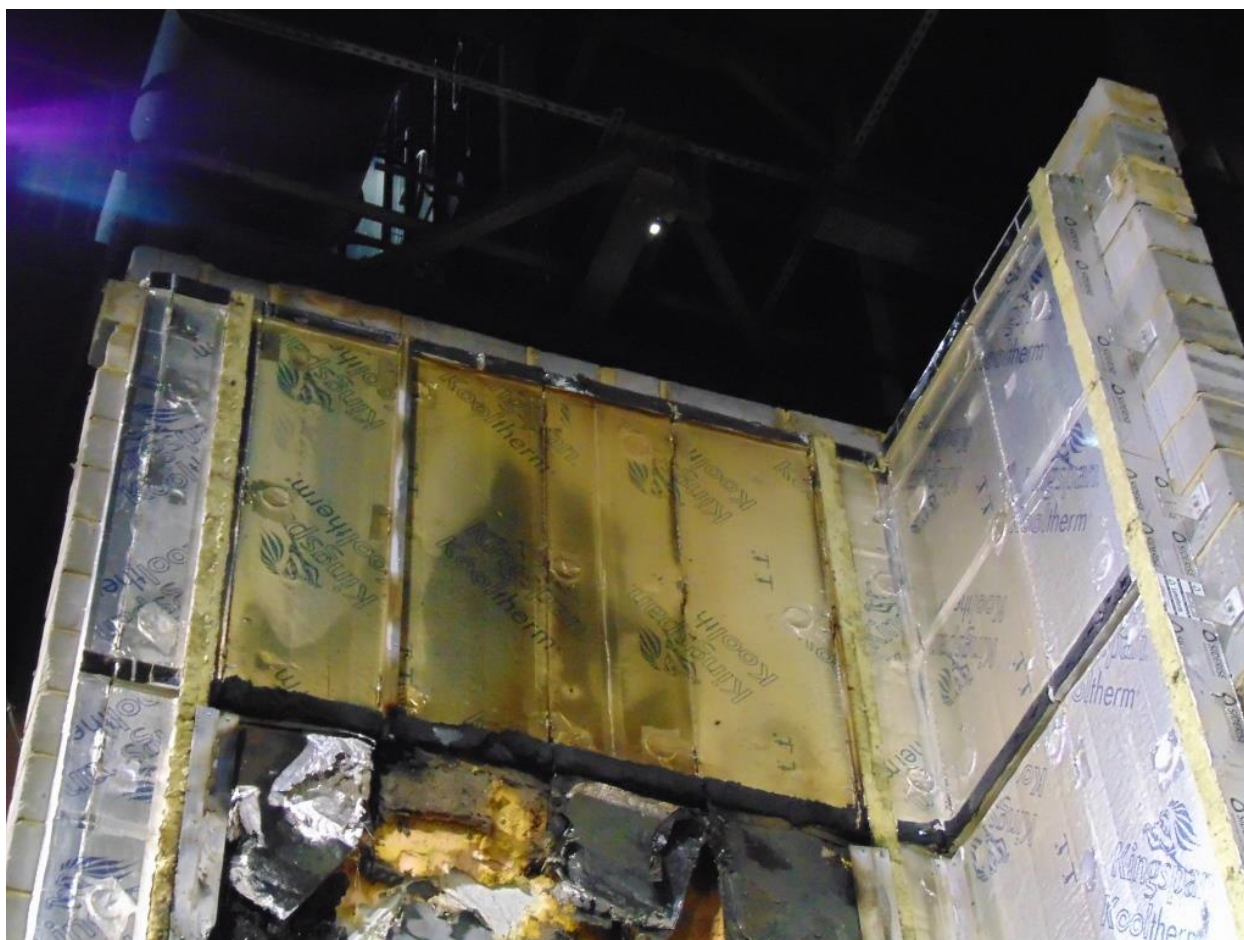
Figure 19. Post-test photo between third and fourth row Siderise RH25G 90/30 horizontal open state cavity barriers.

The third row horizontal cavity barrier had fully activated across the central 2000mm-width (directly in line with the combustion chamber opening). Partial activation of the intumescent strip occurred across the wing wall. Evidence of slight heat damage was visible at the outside edge of the main wall.

Note: majority of aluminium rail substructure has been removed.
