BRE Global Test Report

BS 8414-2:2015 + A1:2017 Test on Terracotta tile with Kingspan K15 insulation (80mm-thick)

Prepared for: Kingspan Insulation Limited

Report Number: P119586-1000 Issue: 1

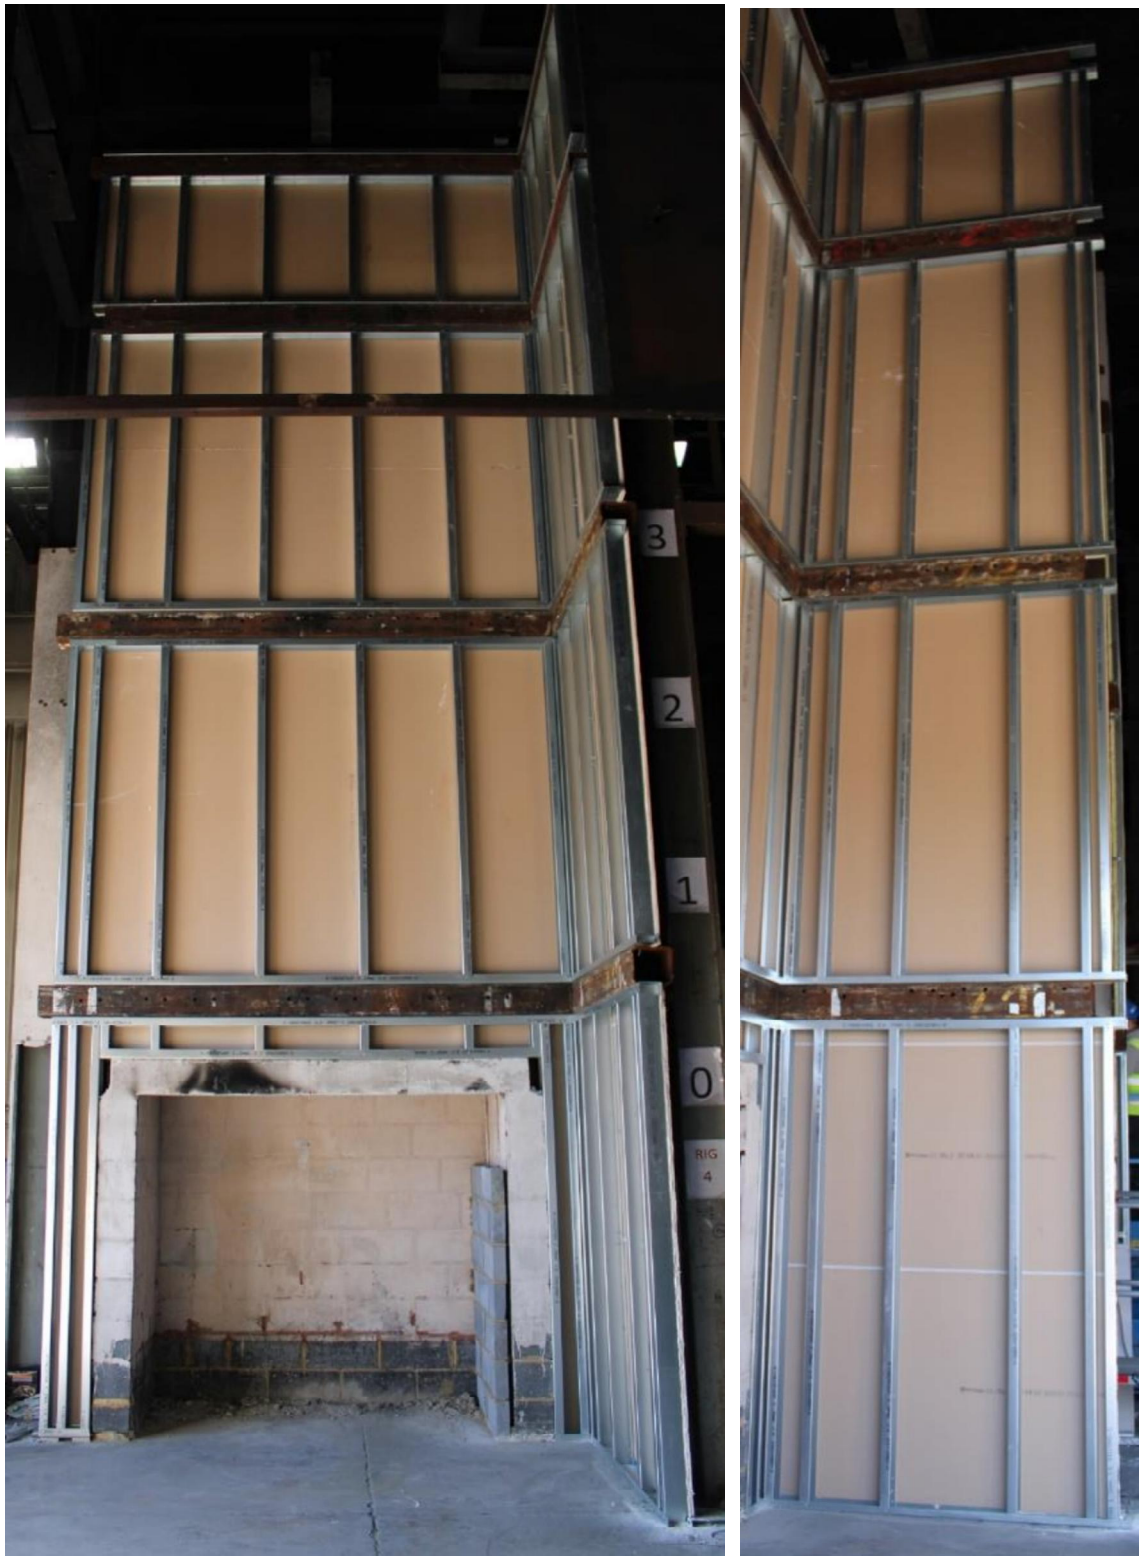
Figure 3. Full-height installation of the steel framing system and plasterboard.

Note: 100mm-thick blockwork skin to right side of combustion chamber opening was fully removed prior to test.

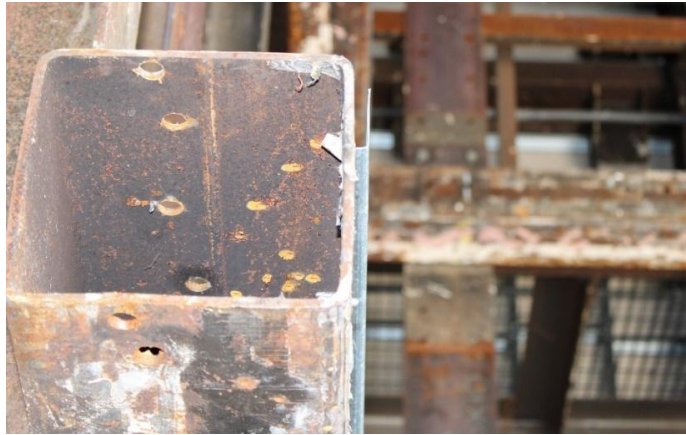
Figure 4. Base track oversailing SHS.

Head tracks (Item 1) were fixed to the underside of the SHS beams, with Evolution SuperTek 7 TSBW5.5-50-7 (5.5mm×50mm) self-drilling screws with EDPM washers at nominal 600mm horizontal centres.

A mixture of base tracks (Item 2A & 2B) were fixed to the ground and top side of the SHS beams, with FixFast HTF-6.3mm×70mm screws to ground and Evolution SuperTek 7 TSBW5.5-50-7 (5.5mm×50mm) self-drilling screws with EDPM washers to the SHS at nominal 600mm horizontal centres.

Vertical studs (Item 3) were fixed between the base and head tracks with FixFast DFS-CF-5.5mm×22mm screws, one screw at top and base of stud to front face only. Nominal stud centres were at 600mm horizontally with reduced centres at edge of walls. The Steel Framing System (SFS) oversailed the SHS beams by nominal 10mm.

The profiled brackets (Item 19A) were fixed to the SFS head track at the top of system (See Figure 4), with two FixFast DF3-SS-CF4.8mm×25mm screws per bracket. The centre of brackets were installed at nominal 1000mm horizontal centres.

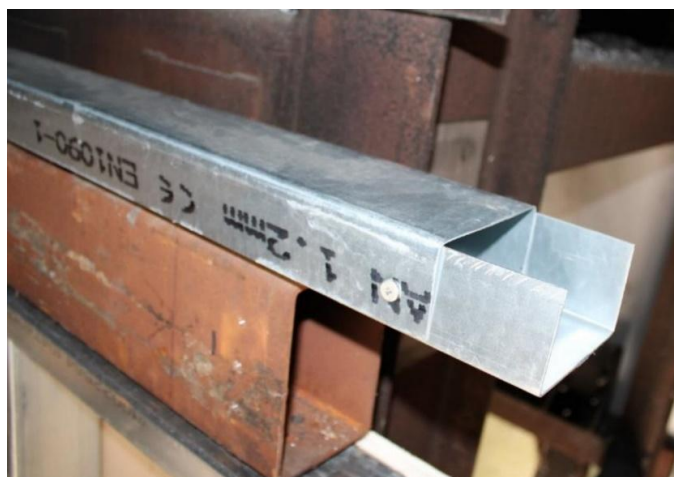
Figure 5. Installation of top of system detail.

Head track (Item 1) was fixed at the top of the system to the top face of the SHS (9180mm from ground), with Evolution SuperTek 7 TSBW5.5-50-7 (5.5mm×50mm) screws with EDPM washers. A second head track was fixed on top with FixFast DFS-CF 5.5mm×22mm screws. All fixing centres at nominal 600mm horizontally.

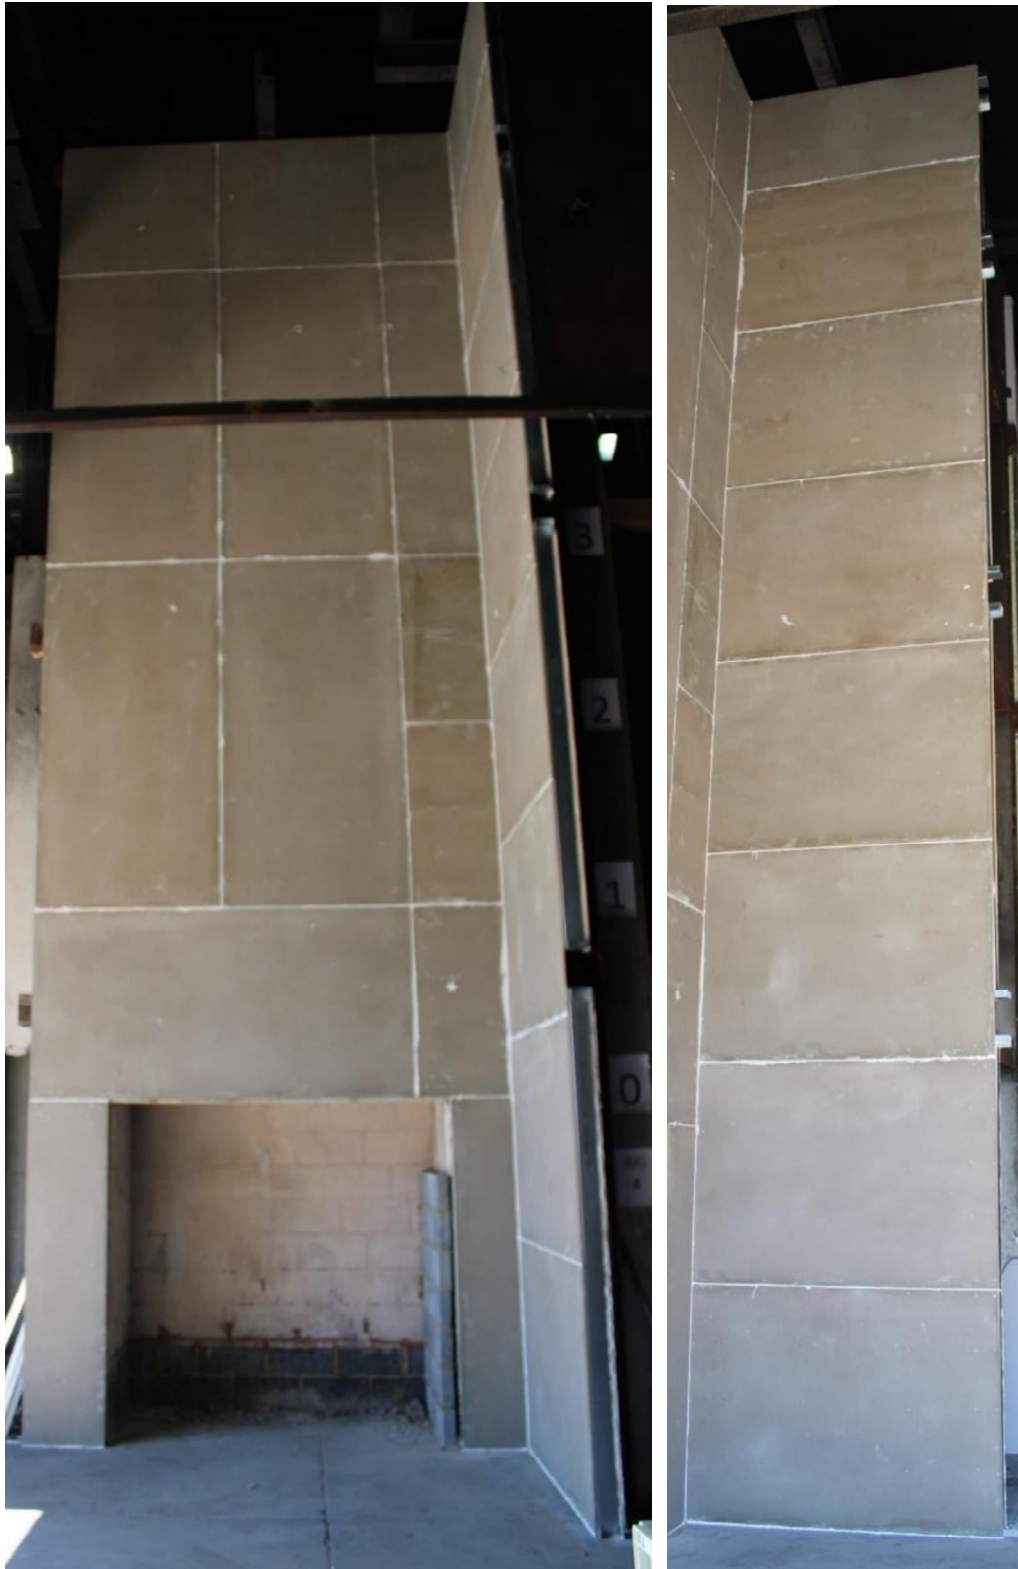
Figure 6. Full-height installation of the sheathing board.

Note: 100mm-thick blockwork skin to right side of combustion chamber opening was fully removed prior to test.

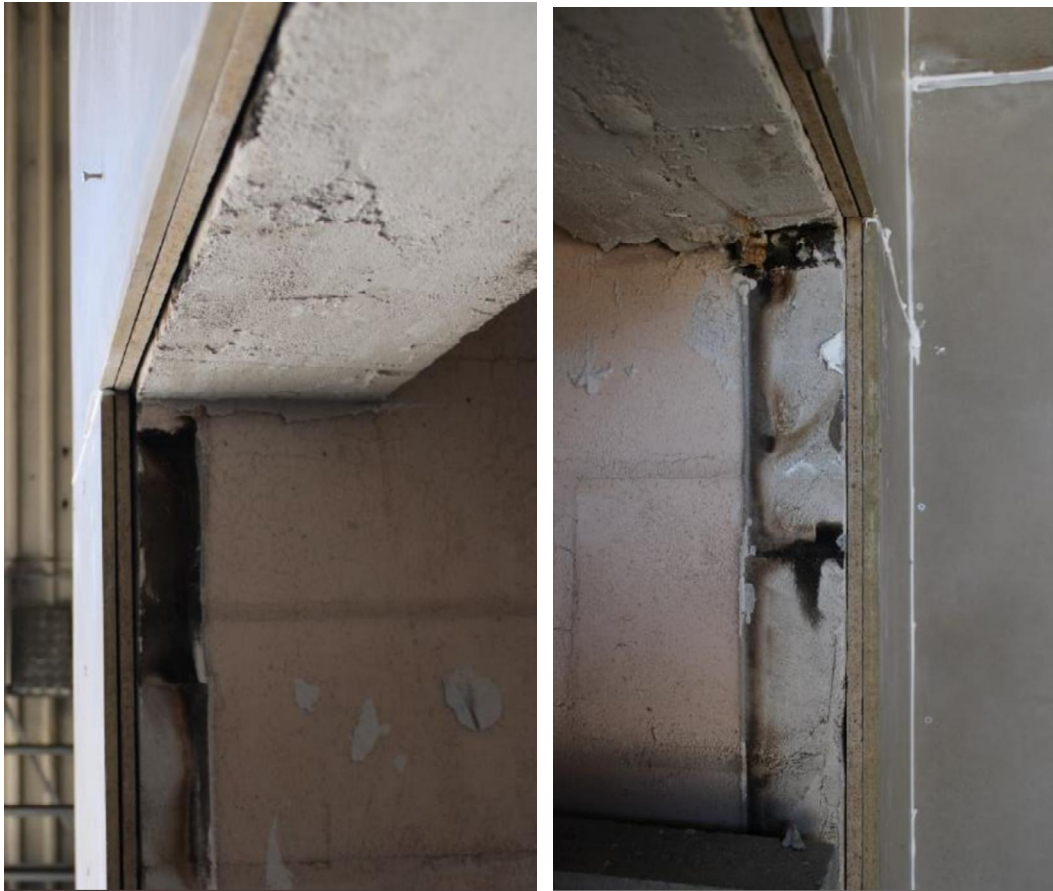
Figure 7. Double layer of sheathing board at combustion chamber surround.

A single layer of cement particle board (Item 5) was fixed to the front face of the SFS. An additional layer of board (Item 5) was packed into the approx. 10mm cavity that formed where the first layer overlapped the blockwork at the front face of the combustion chamber. The boards were fixed to the SFS. On the main wall, the boards were cut to size where required (combustion chamber and at wing wall junction) and installed with long edge vertical (except directly above the combustion chamber). Board joints were not staggered. Fixed with FixFast DF3-SSA4-W-4.8mm×40mm screws at nominal 300mm vertical centres. Board joints were 5mm nominal width and were sealed with Everbuild Everflex Fire Mate intumescent sealant.

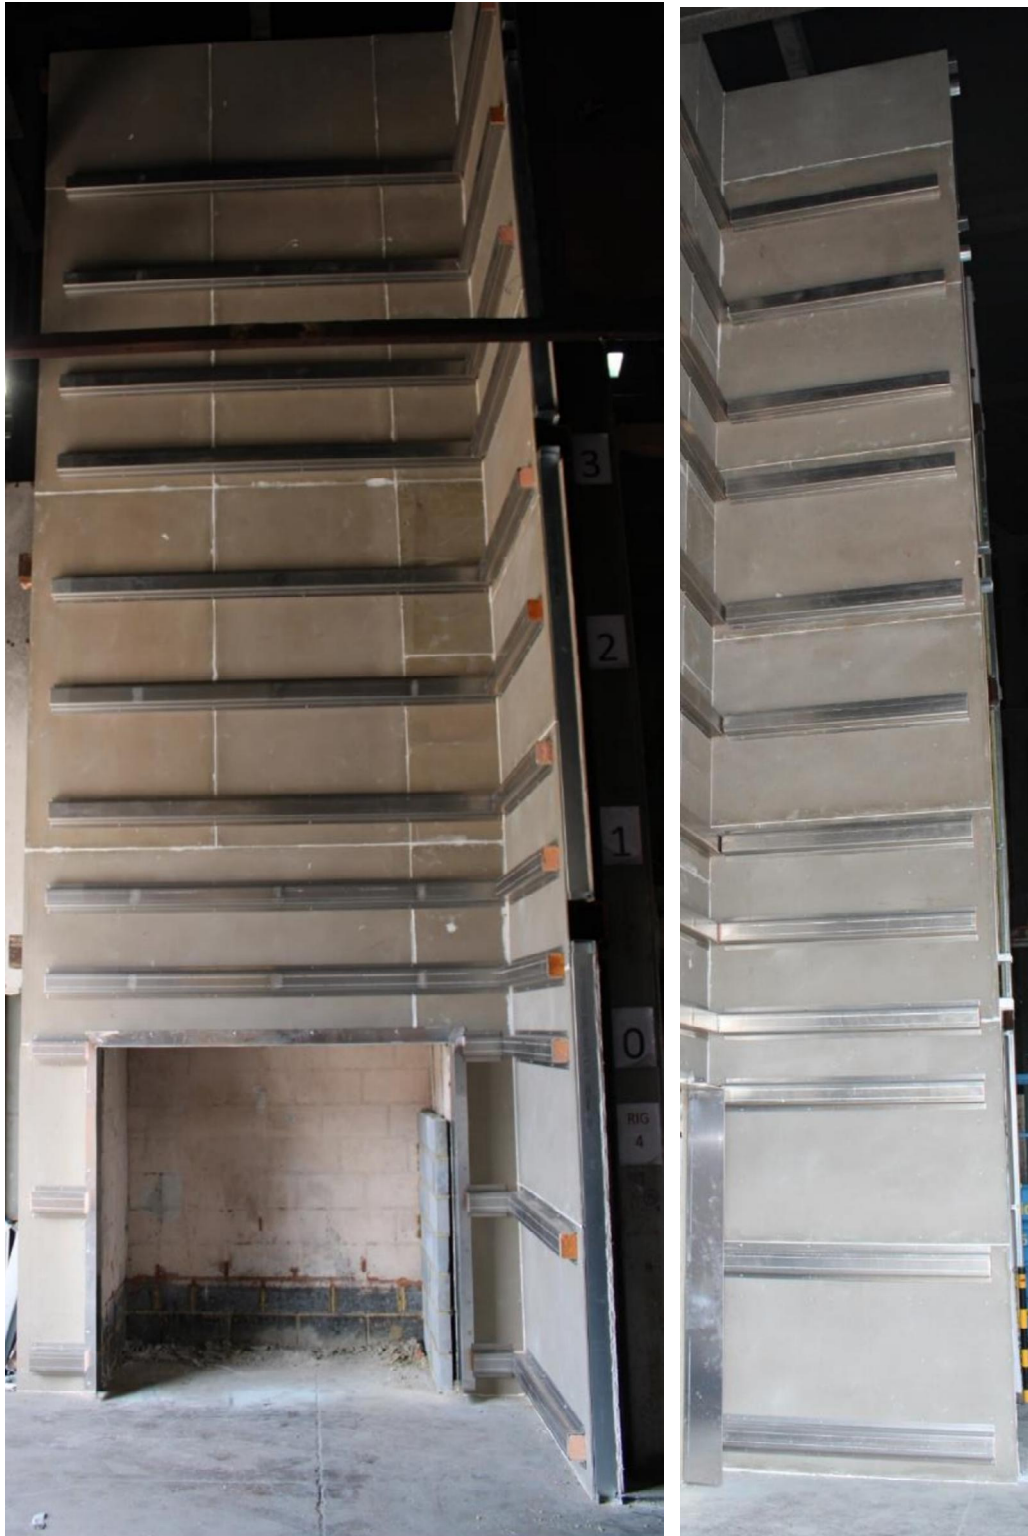
Figure 8. Installation of the top-hat channel and combustion chamber flashing.

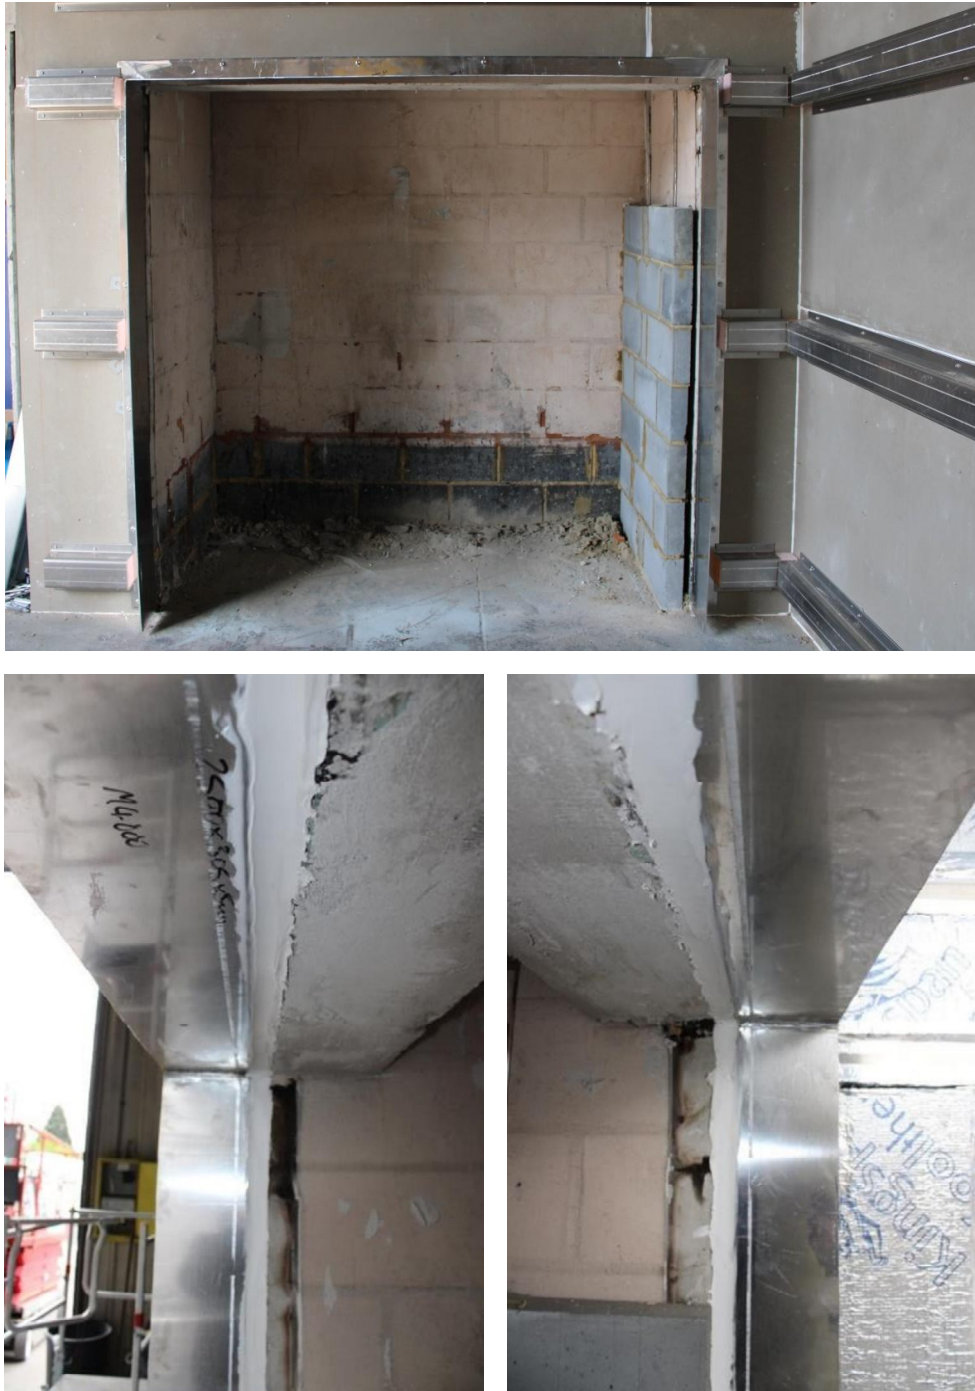
Figure 10. Installation of combustion chamber flashing.

Aluminium flashing (Item 8) was fixed flush to the combustion chamber opening face, with Fischer SXR 10mm×60mm FUS A4 screws with plastics anchors, at approximately 480mm centres. Everbuild Everflex Fire Mate intumescent sealant was applied to flashing and combustion chamber joint.

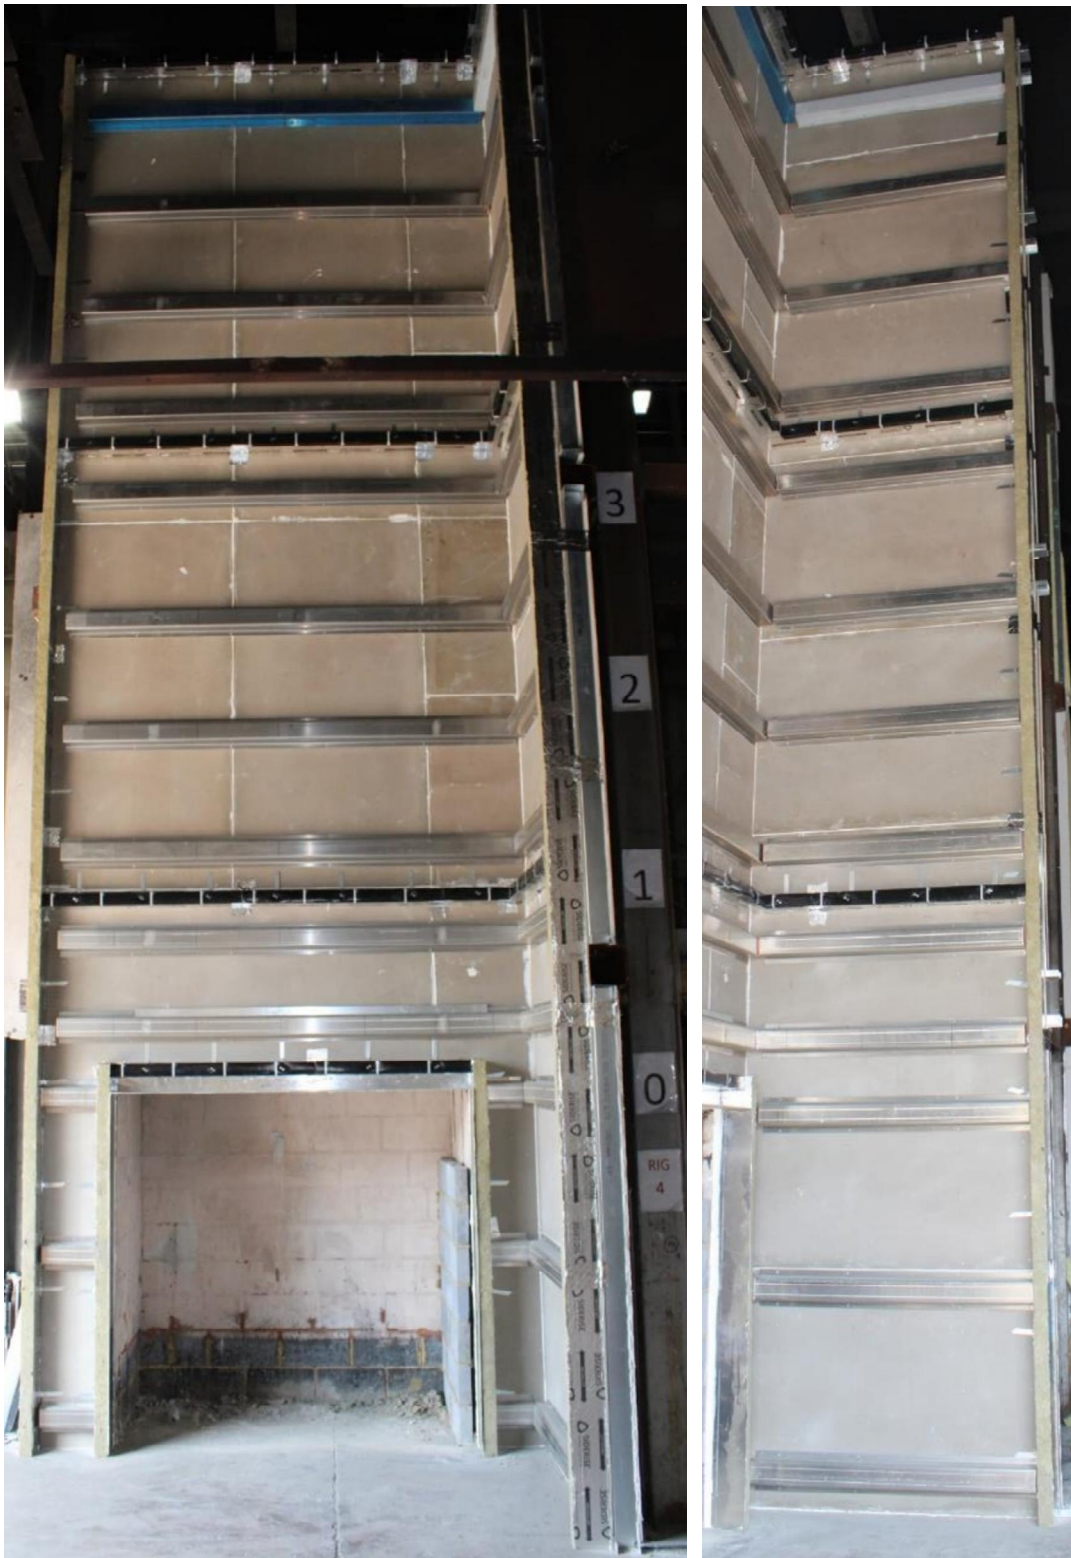
Figure 11. Installation of horizontal and vertical cavity barriers.

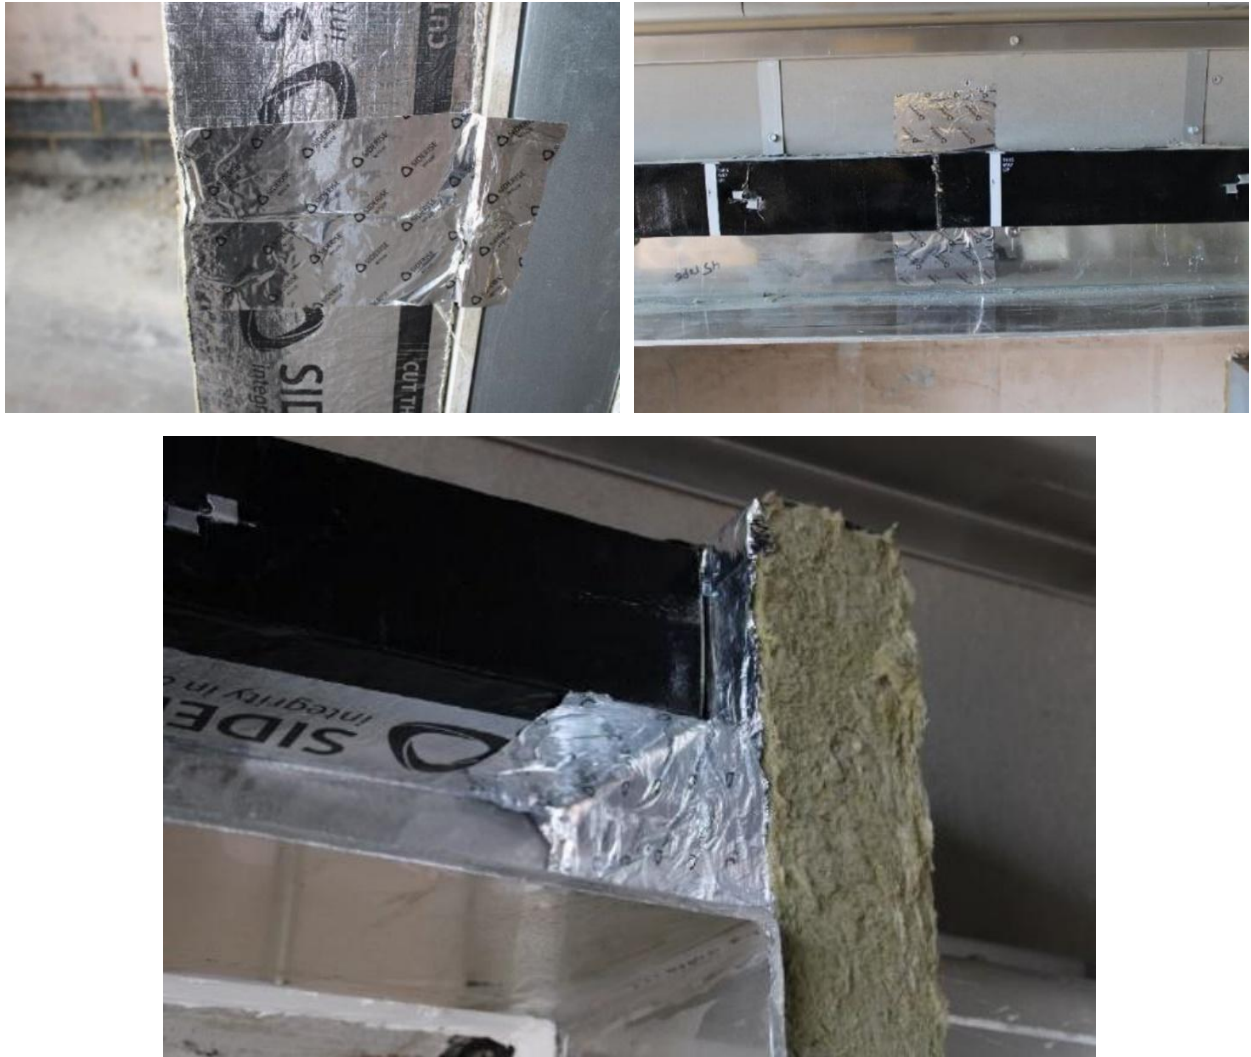
Figure 12. Horizontal and vertical cavity barrier joints.

Steel split-end brackets (Item 9) were cut to 310mm, folded to 140mm-deep and fixed in three full-width rows located at: 3200mm, 6190mm and 9260mm from ground to centre of barrier. Another row was located at: 2180mm from ground in line with the combustion chamber opening width (2100mm). The brackets were fixed above the barrier location (except at the top of the system) at 400mm horizontal centres with one FixFast DF3-SS-5.5mm×50mm screws.

Horizontal cavity barriers (Item 10) were pressed onto the split-end brackets so that the brackets protruded. The tip of the bracket was trimmed and the split-ends folded back to secure the barrier in place. Aluminium tape was applied to the barrier joints at top and bottom faces in line with the foil face.

Steel brackets (Item 11) were folded to 140mm-deep and fixed in two continuous columns located at: 2950mm (main wall) and 1630mm (wing wall) from the sheathing board face at the main-wing wall junction to centre of barrier. An additional two columns were installed either side of the combustion chamber at: 335mm and 2520mm from the wing wall sheathing board to a height of 2230mm. The brackets were fixed at 600mm vertical centres with one FixFast DF3-SS-5.5mm×50mm screws.

Vertical cavity barriers (Item 12) were pressed onto the brackets in columns. Aluminium tape was applied: at vertical barrier-horizontal barrier joints (top and bottom face of horizontal barrier) and vertical barrier-barrier joints (side faces).

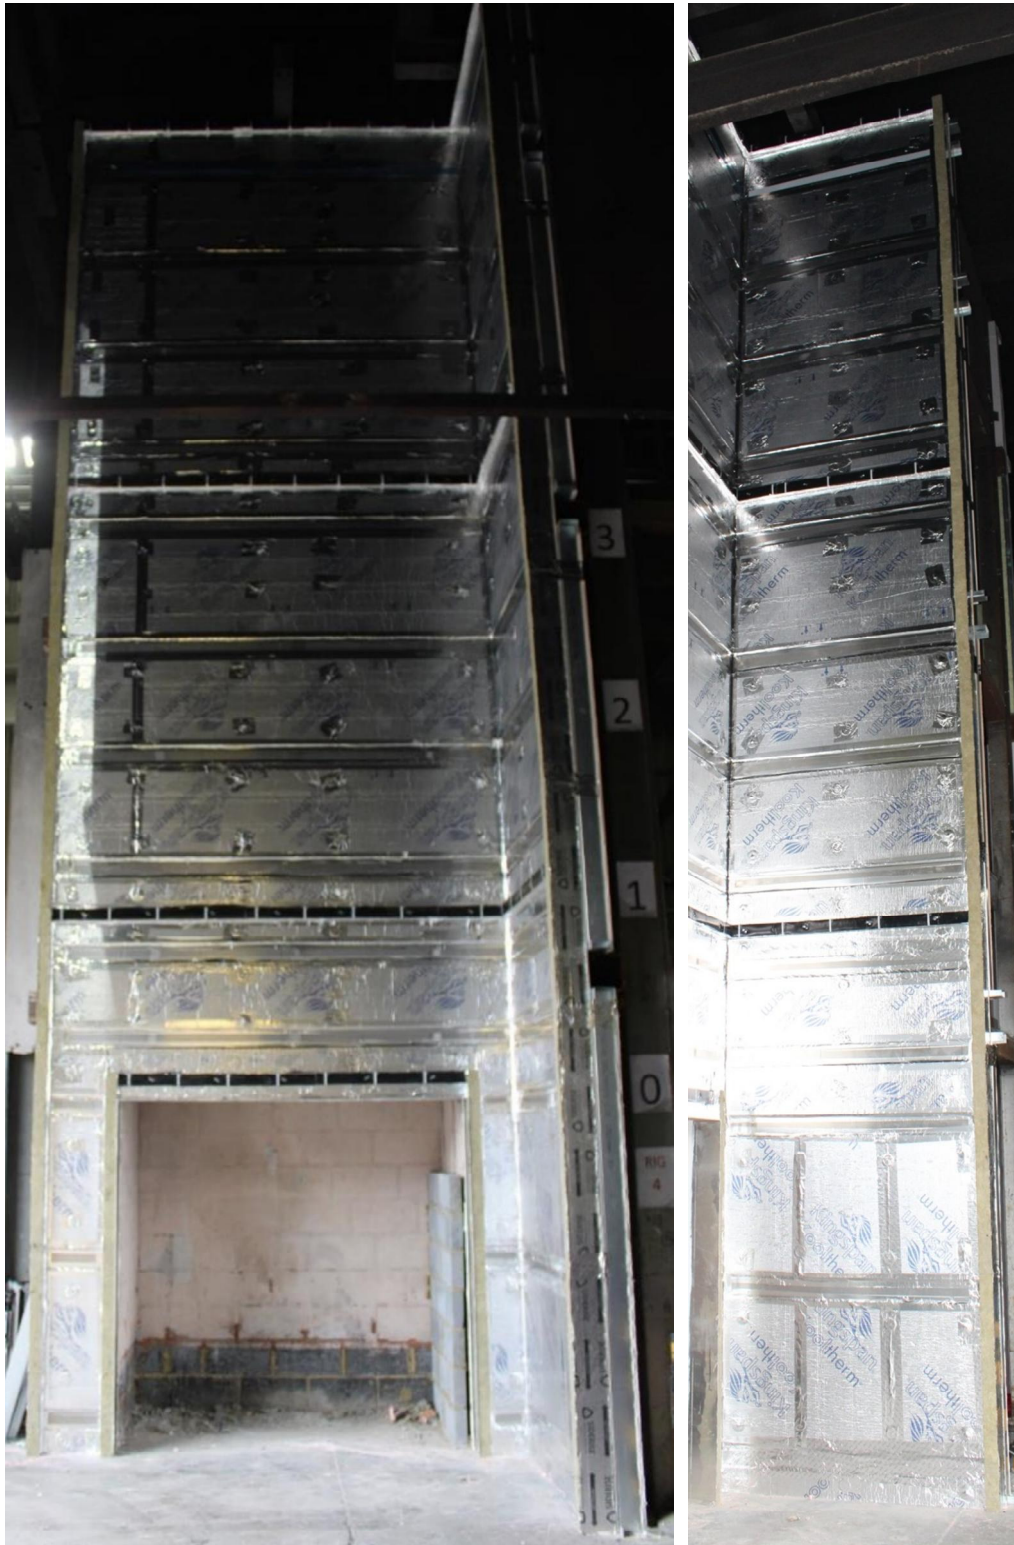
Figure 13. Installation of insulation.

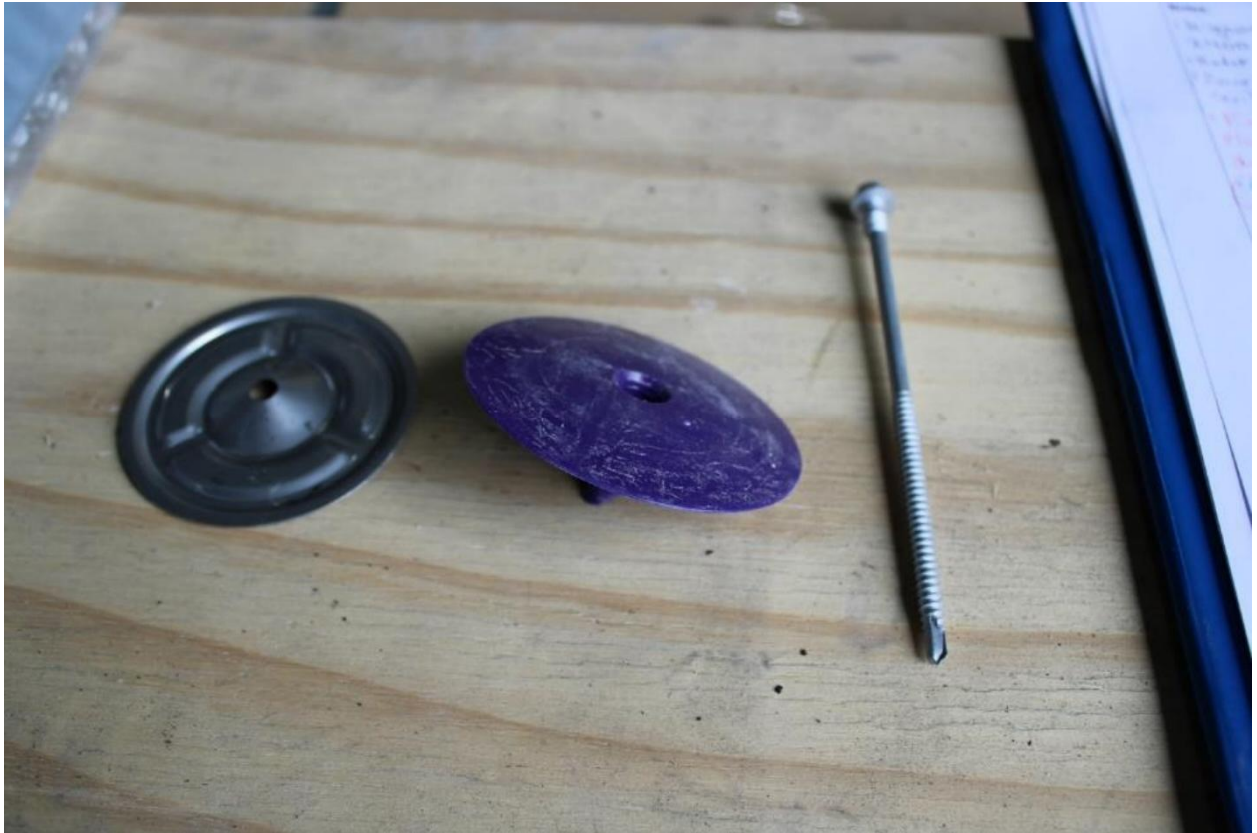
Figure 14. Insulation fixing washers and screw.

Insulation boards (Item 7) were cut to size and installed between the top-hat channels. Insulation boards were fixed with FixFast SF-T-75×25mm plastic tube washers and FixFast SF-P-SS-70-D pressure plates with FixFast DF3-SS-HT-A15-5.5mm×130mm screws. The vertical centres of fixings were nominally at 500mm and the horizontal centres varied depending on the board sizes but were measured to be between 400mm-1000mm. Aluminum tape was applied: over the fixings, at insulation to top-hat channel joints and at insulation to cavity barrier joints.

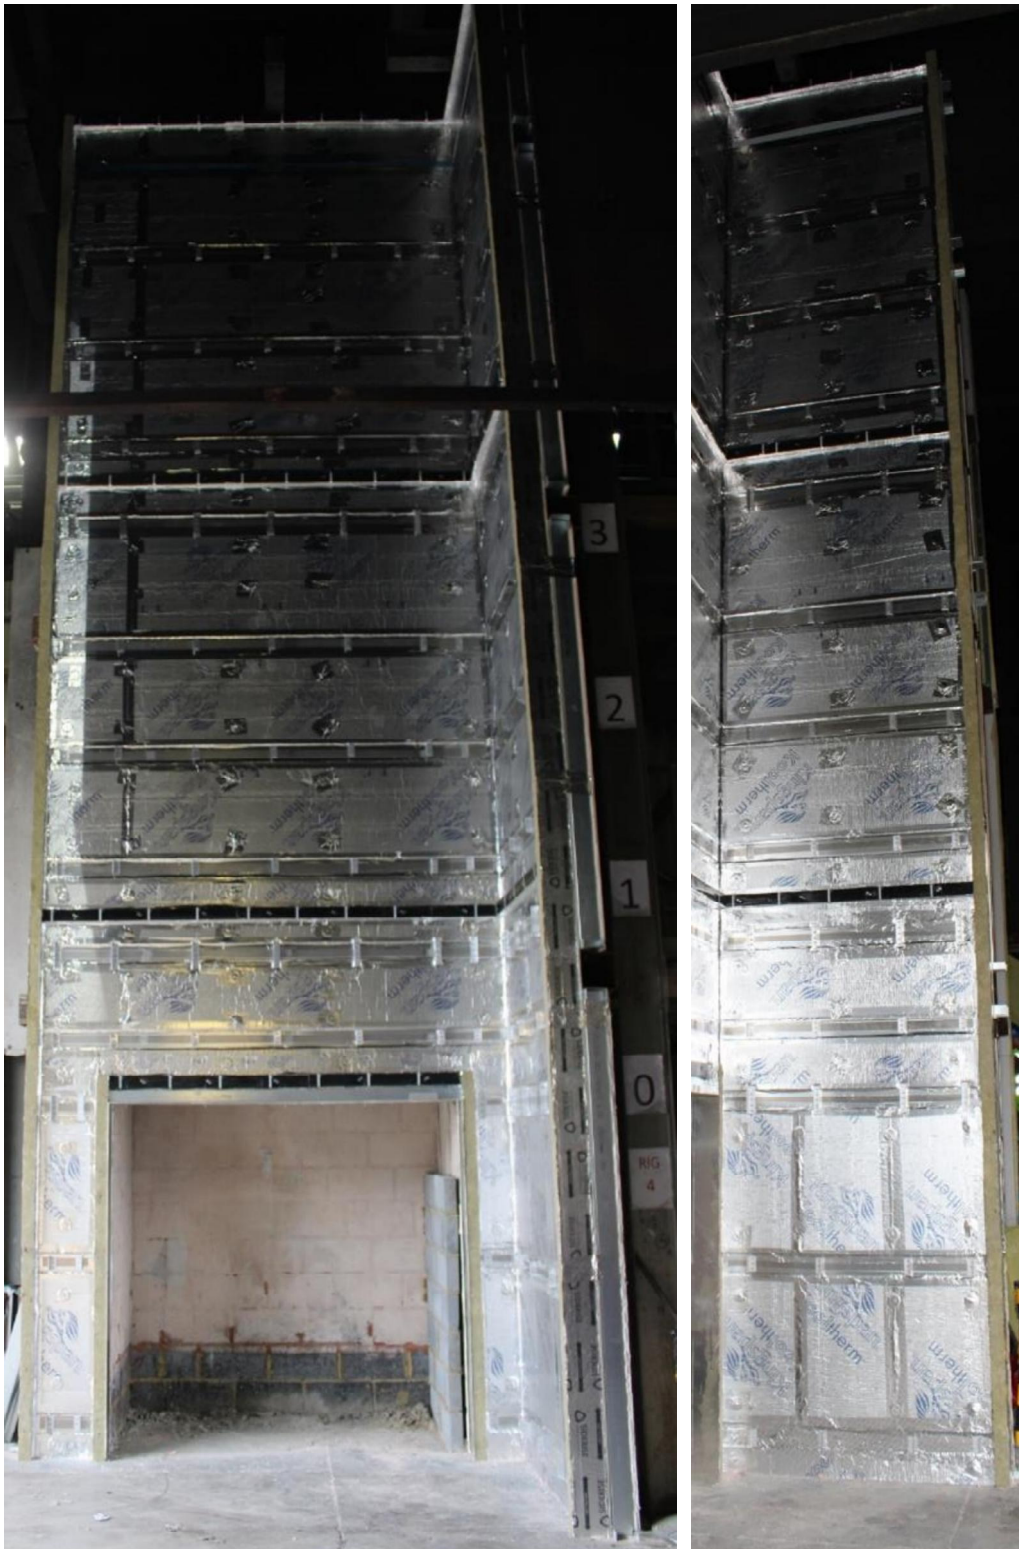
Figure 15. Installation of brackets.

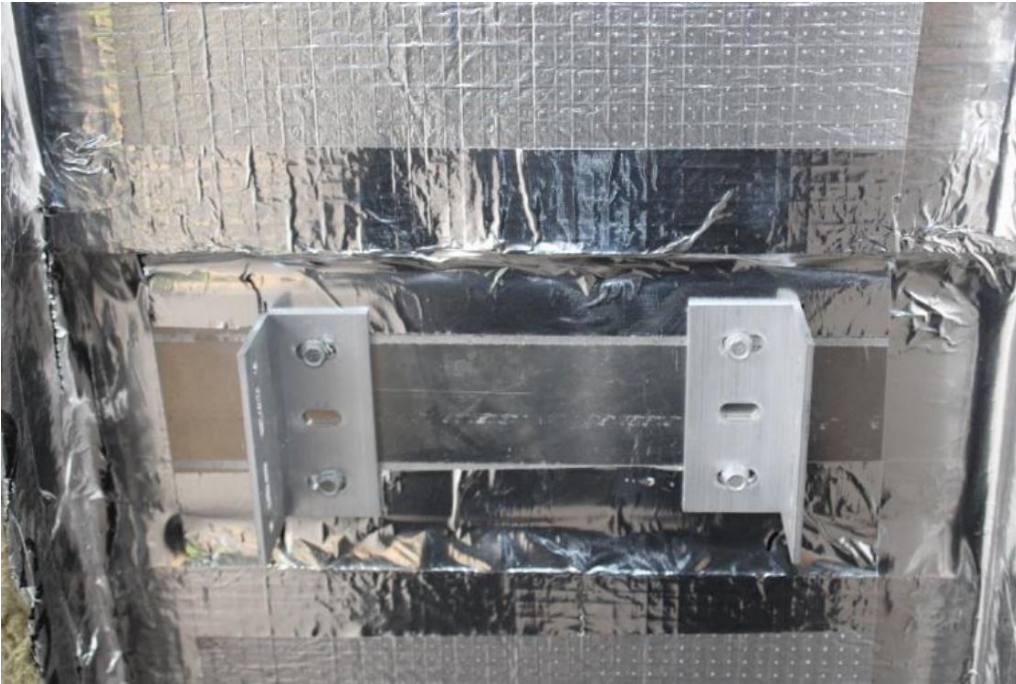
Figure 16. Single bracket.

Aluminium brackets (Item 13A & 13B) were fixed to the top-hat channels with FixFast DF3-SS-5.5×35mm screws, two per single bracket and three per double bracket. Horizontal bracket centres were measured at 492mm and reduced to 195mm at the combustion chamber sides.

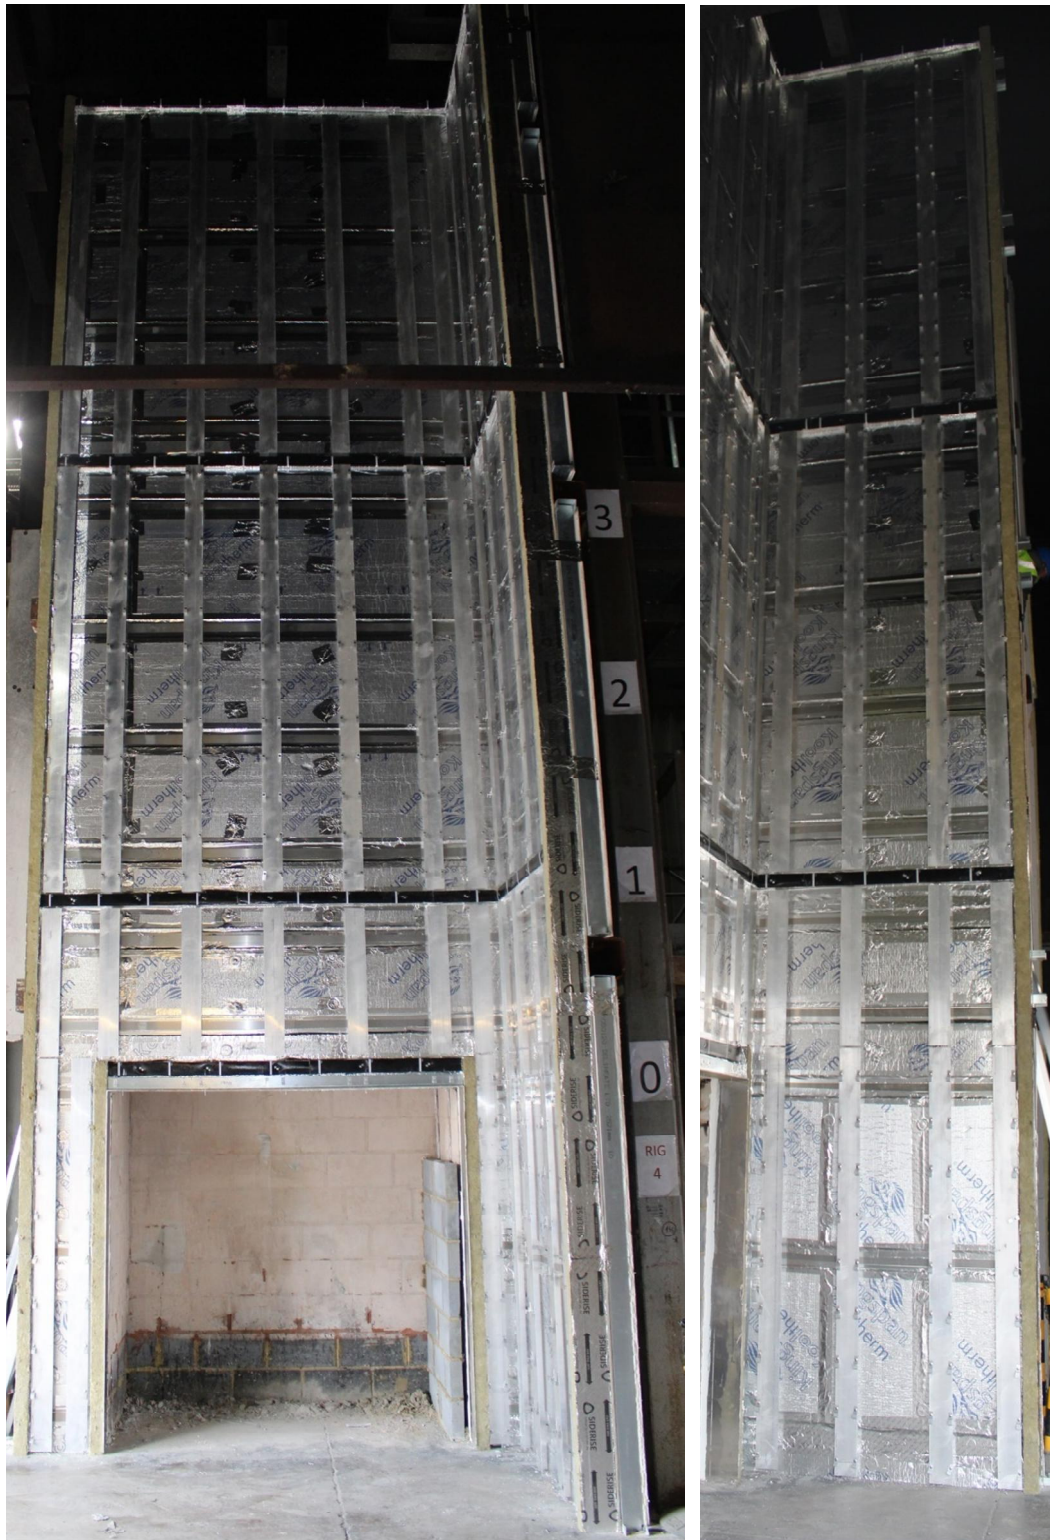
Figure 18. Installation of 'T'-shaped rails.

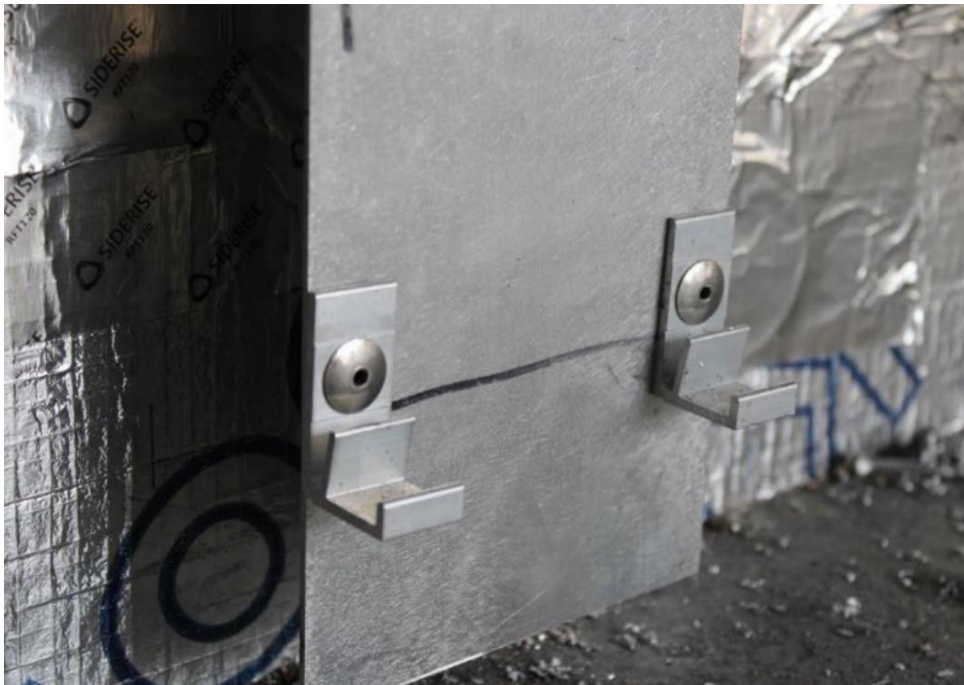
Figure 23. Base tile clip fixed to rails

Base clips (Item 16A) were fixed to 'T'-shaped rails at ground level only, approx. 45mm from ground. Clips were fixed with FixFast R-SS-LF-4.8×16mm rivets, two per location 100mm horizontal centres (pre-existing fixing location).

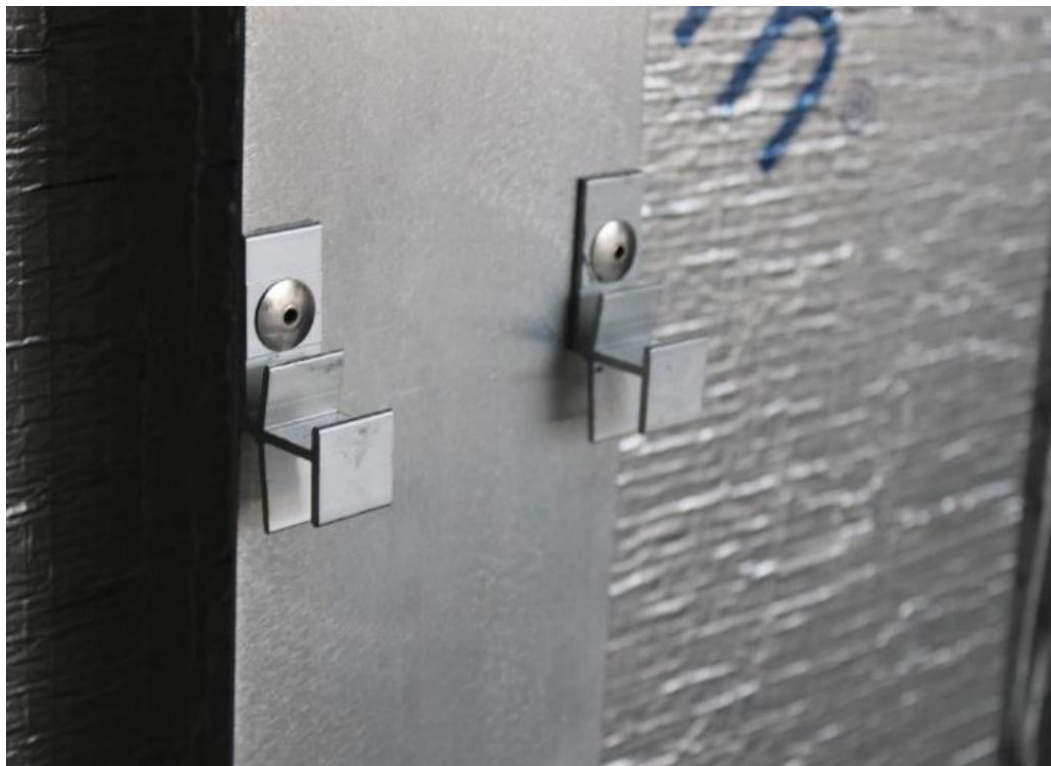
Figure 25. Centre double clip fixed to rail.

Double faced centre clips (Item 16B) were fixed to the 'T'-shaped rails at 250mm vertical centres from the base clips, two per location, 100mm horizontal centres (pre-existing fixing location).

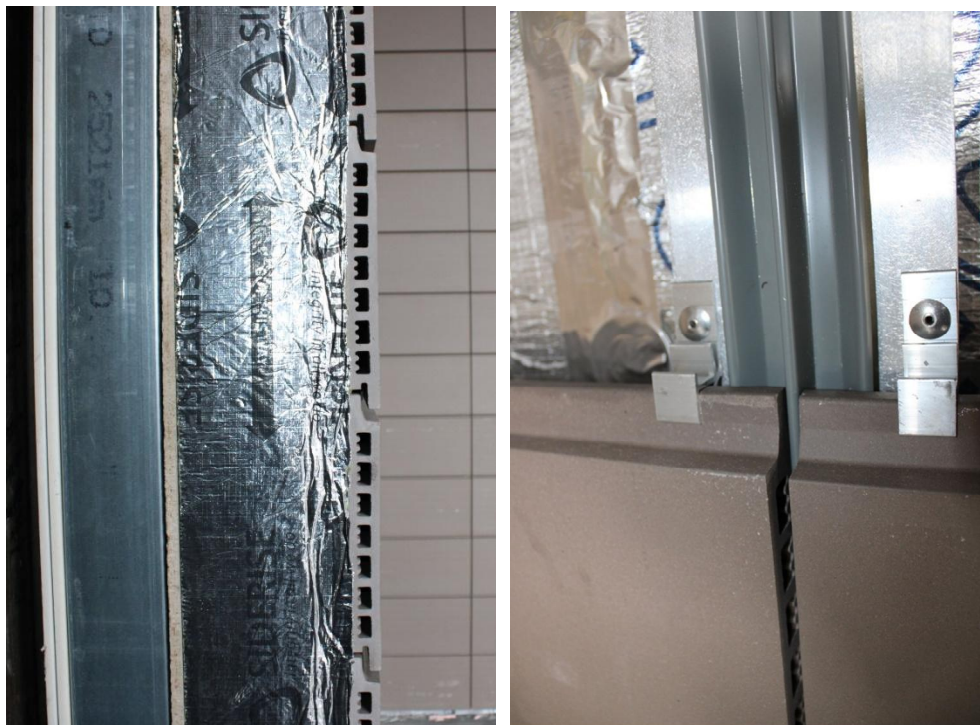
Figure 29. Installation of tiles.

The first row of tiles (Item 18) were hooked onto the base clips at the base of system, with the top of tiles secured with the centre clips. The next row of tiles were placed onto the centres clips and secured with centre clips at top of tiles, this process was continued to the penultimate row at top of system. The final row of tiles were secured at the top edge using a continuous top clip rail (see Figures 27-29). Panel gaps were measured to be 4mm at vertical joints and 13mm at horizontal joints.

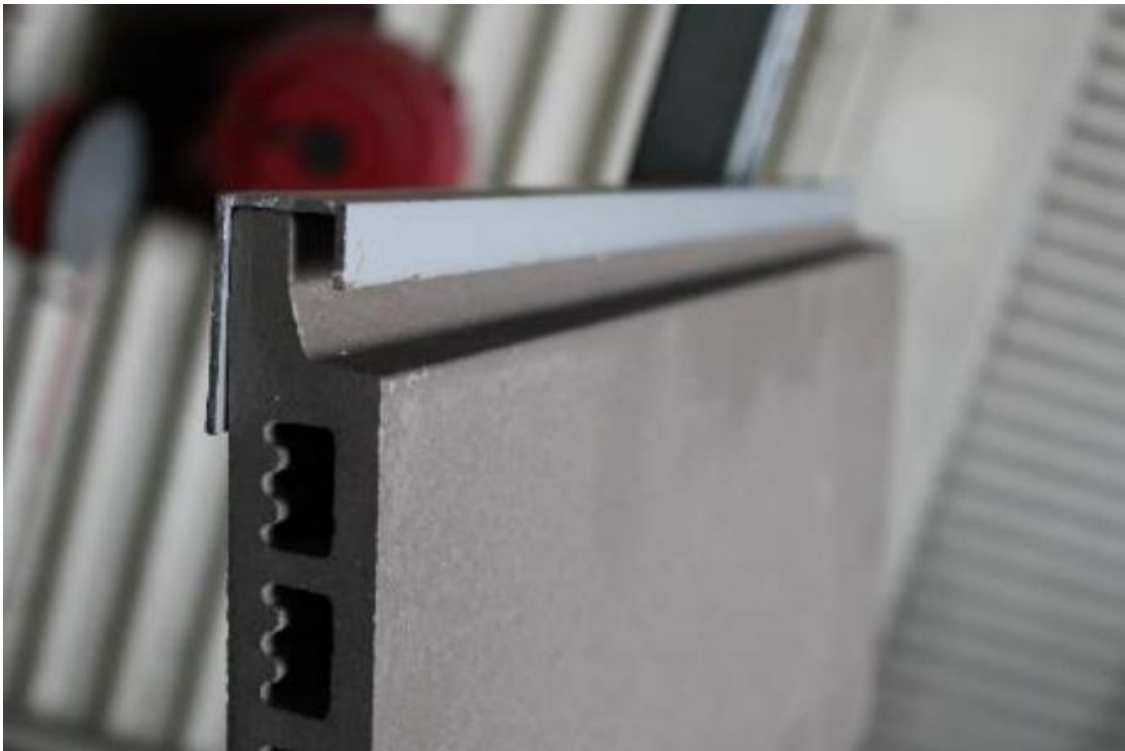
Figure 31. Example of top clip placed at the top of tile.

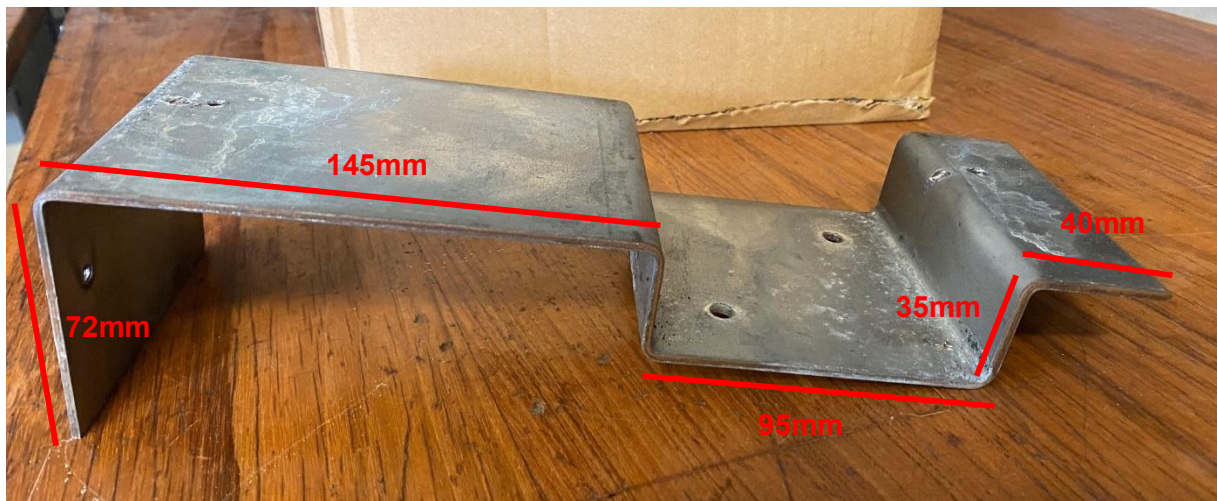
Figure 32. Top of system detail – profiled bracket (Item 19A)
