BRE Global Test Report

BS 8414-2:2015 + A1:2017 Test on Terracotta tile with Kingspan K15 insulation (80mm-thick)

Prepared for: Kingspan Insulation Limited

Report Number: P119586-1000 Issue: 1

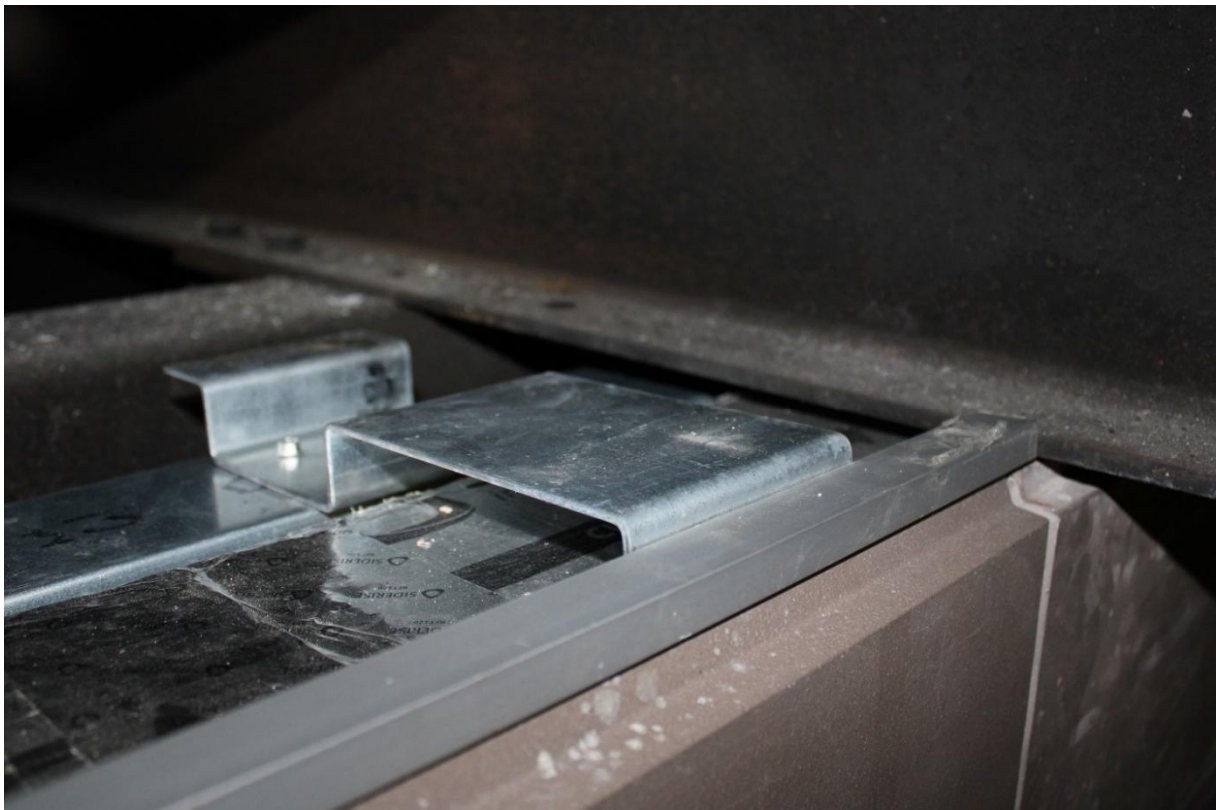
Figure 33. Top of system detail - profiled bracket and continuous top clip.

The top clip (Item 16C) was fixed to the front face of profiled bracket (Item 19A) with one FixFast DF3-SS-CF4.8mm×25mm screws per bracket. The top clip was positioned to line up with the top edge of the tiles.

The profiled brackets (Item 19A) were fixed to the SFS head track at the top of system (See Figure 4), with two FixFast DF3-SS-CF4.8mm×25mm screws per bracket. The centre of brackets were installed at nominal 1000mm horizontal centres.

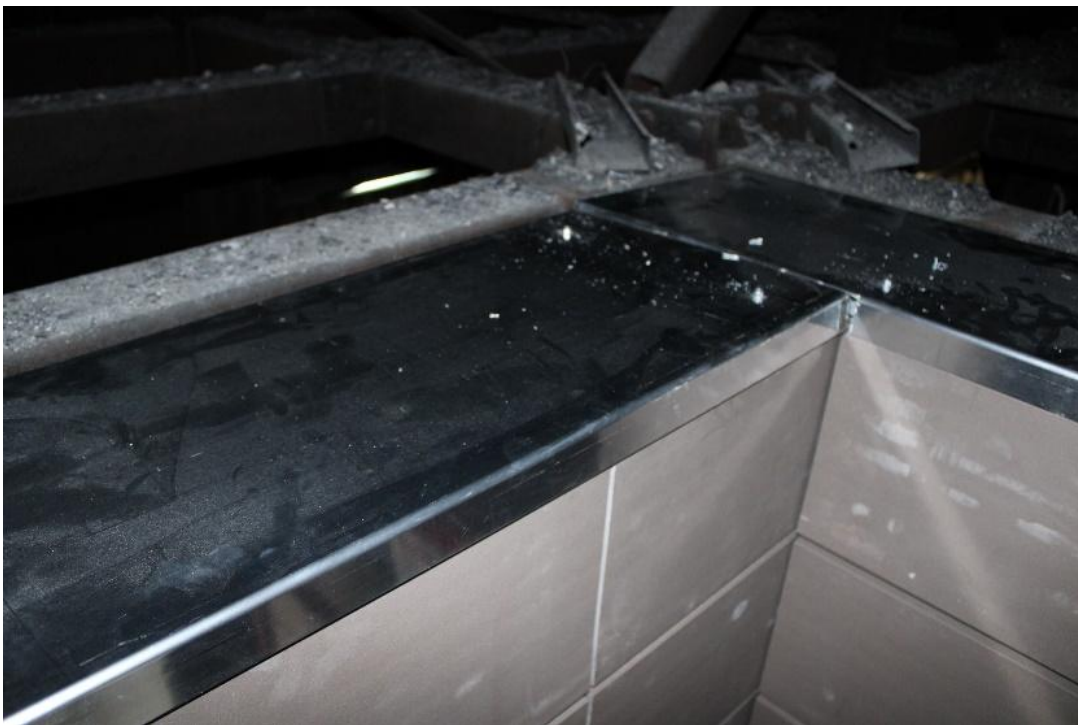
Figure 34. Top of system capping

Aluminium capping (Item 19B) was fixed to the profiled brackets (Item 19A) with the 40mm-high edge facing the exposed system face. The item was fixed with FixFast DF3-SS-CF4.8mm×25mm screws, two screws per location, 200mm apart.

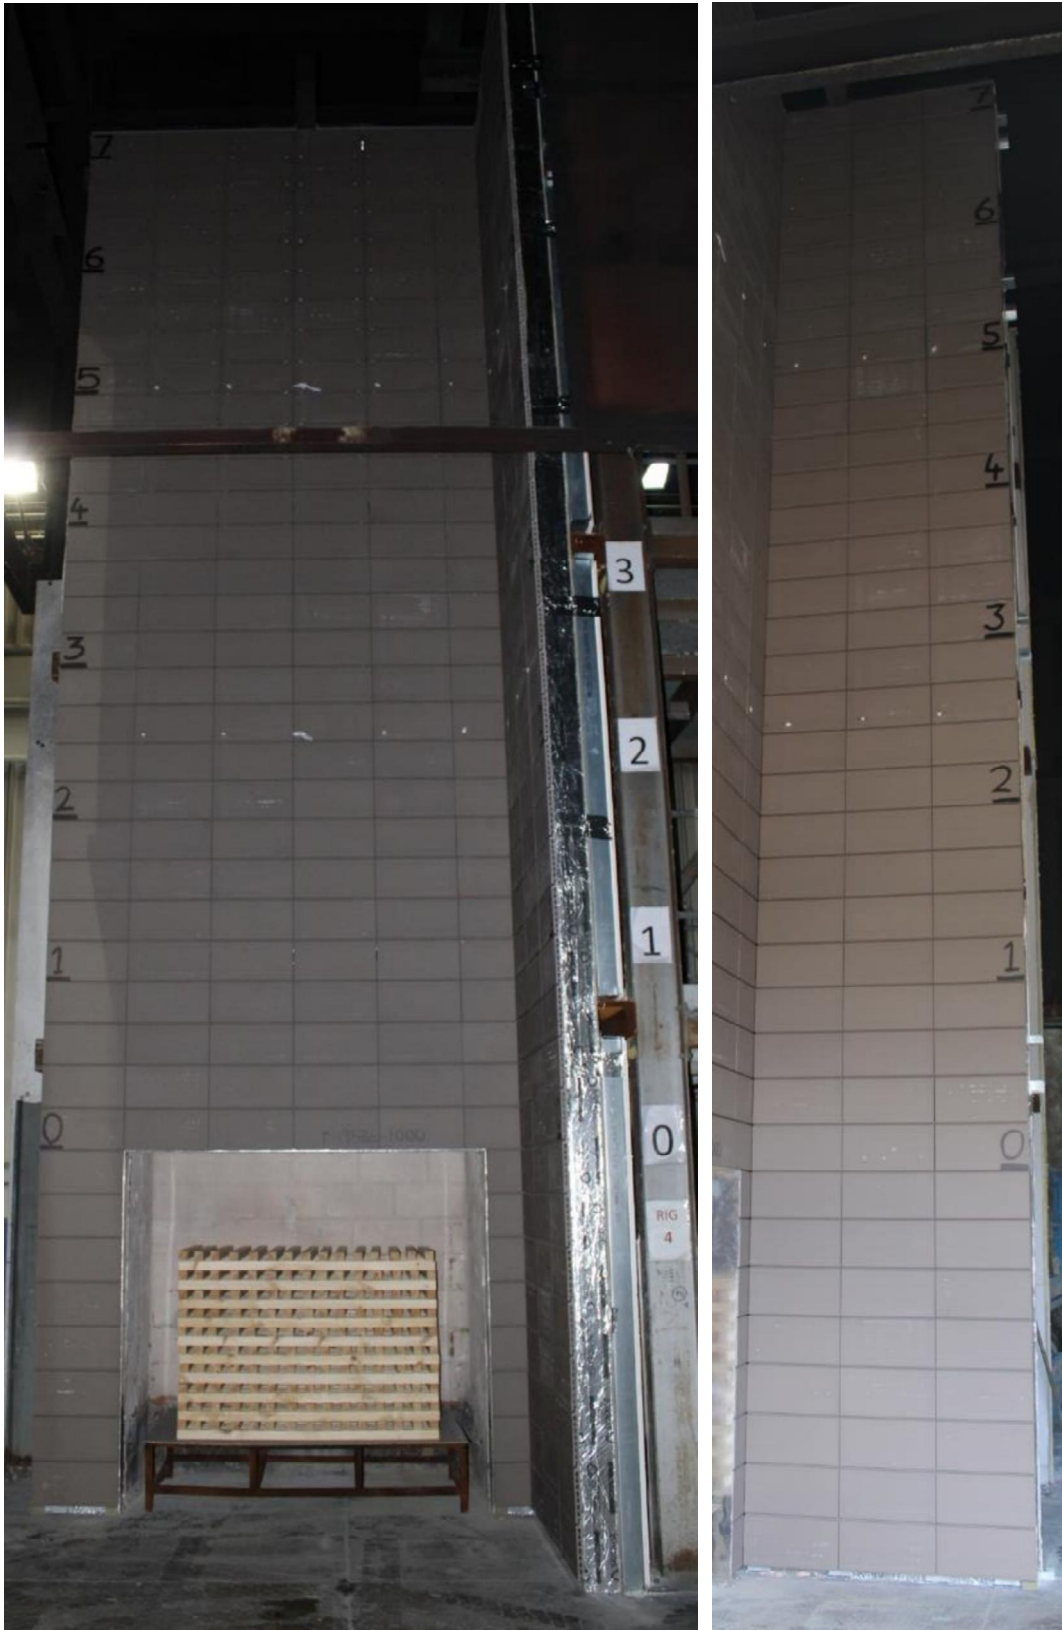
Figure 35. Full-height photograph of completed installation prior to testing.

Figures 43-50 provide the temperature profiles recorded during the test. Figure 35 shows the system before the test.

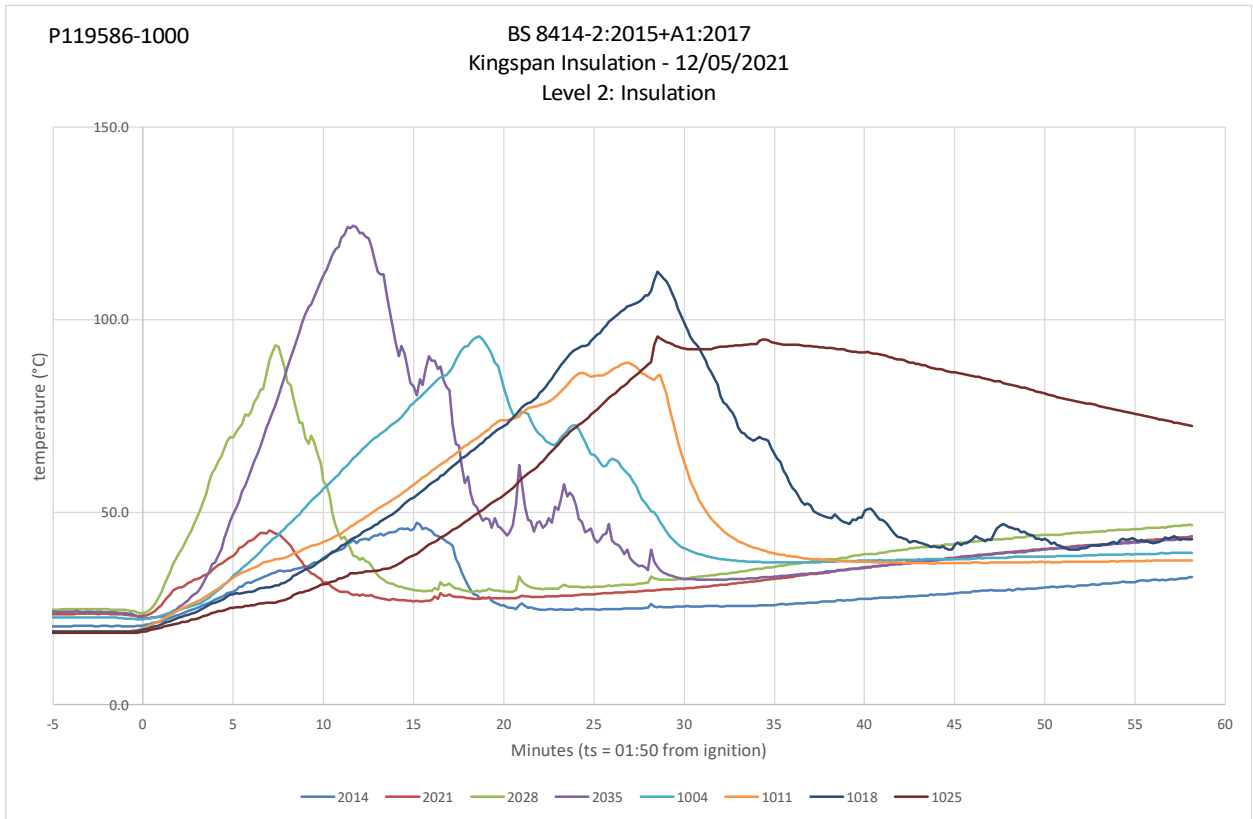
Figure 47. Level 2 insulation thermocouples.

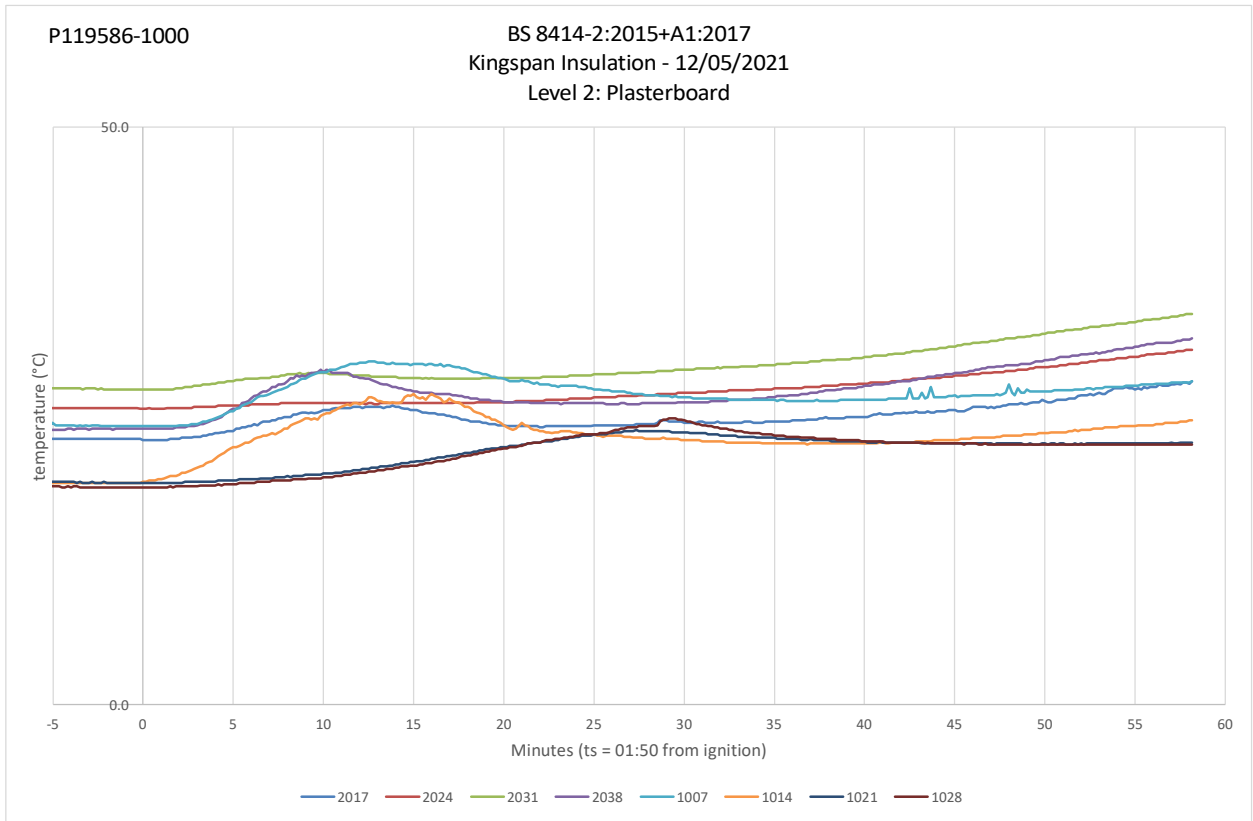
Figure 50. Level 2 plasterboard thermocouples.

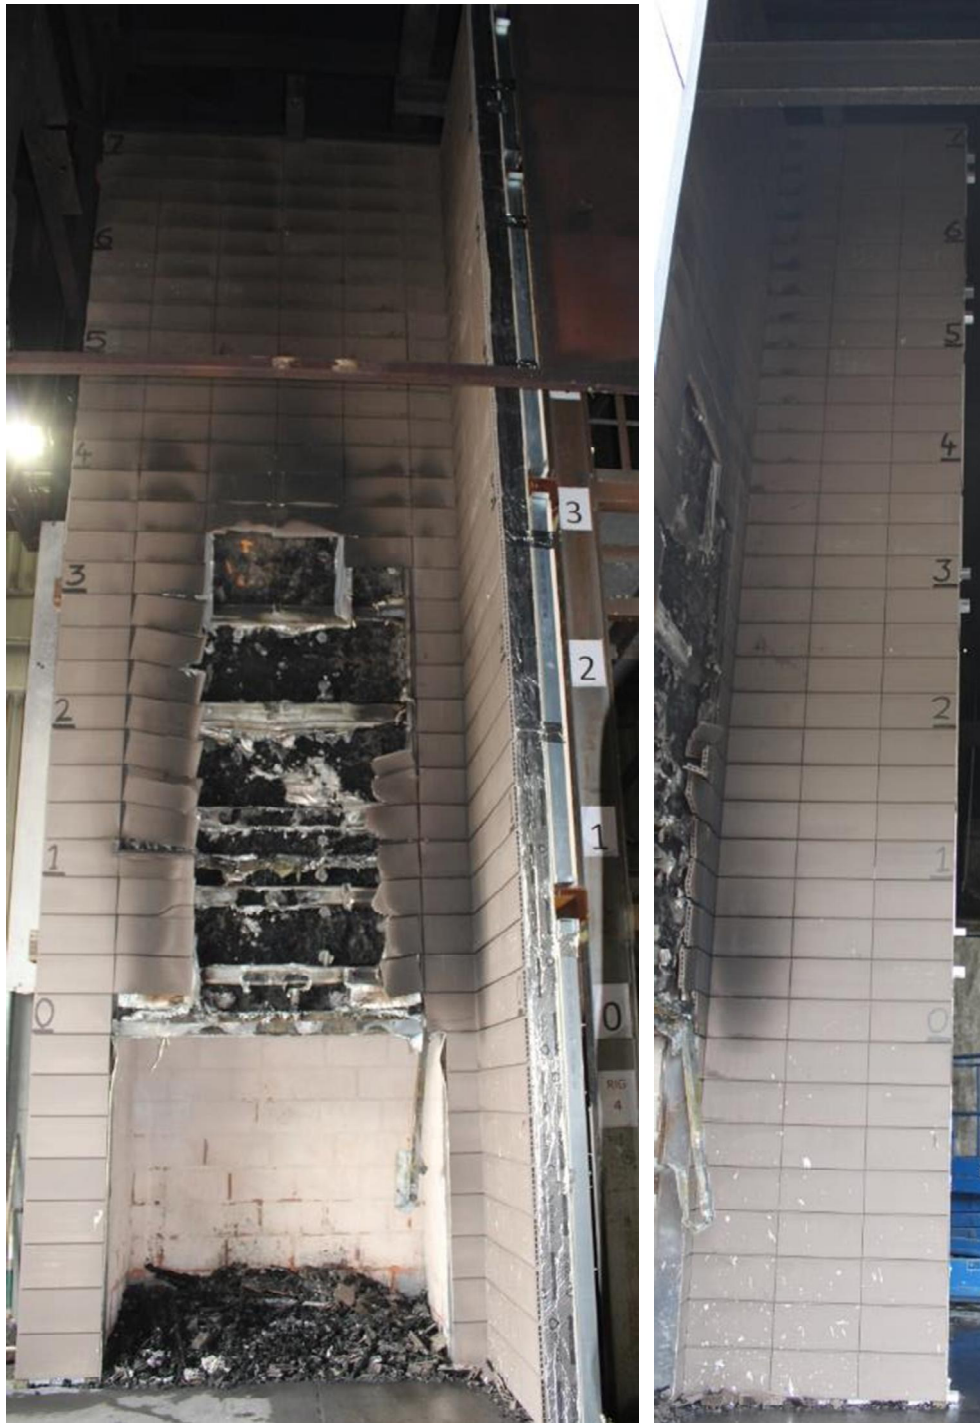
Figure 51. Full-height photograph of cladding system immediately after test.

On the main wall, the tiles had detached in an area approx. 1 to 2m-wide (min/max) \times 3.6m-high (approx. 4.8m²) above the combustion chamber opening. Tiles were discoloured from the combustion chamber opening to top of system.

On the wing wall, tiles were discoloured along the main-wing junction approx. 500mm-wide, 2m from ground to top of system.

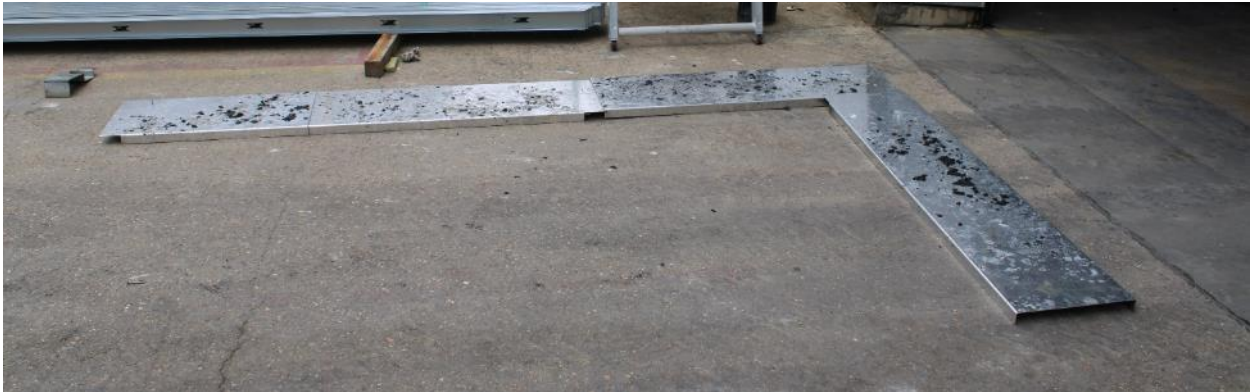
Figure 52. Top of system capping.

Capping at the top of the system remained in place with no visible damage.

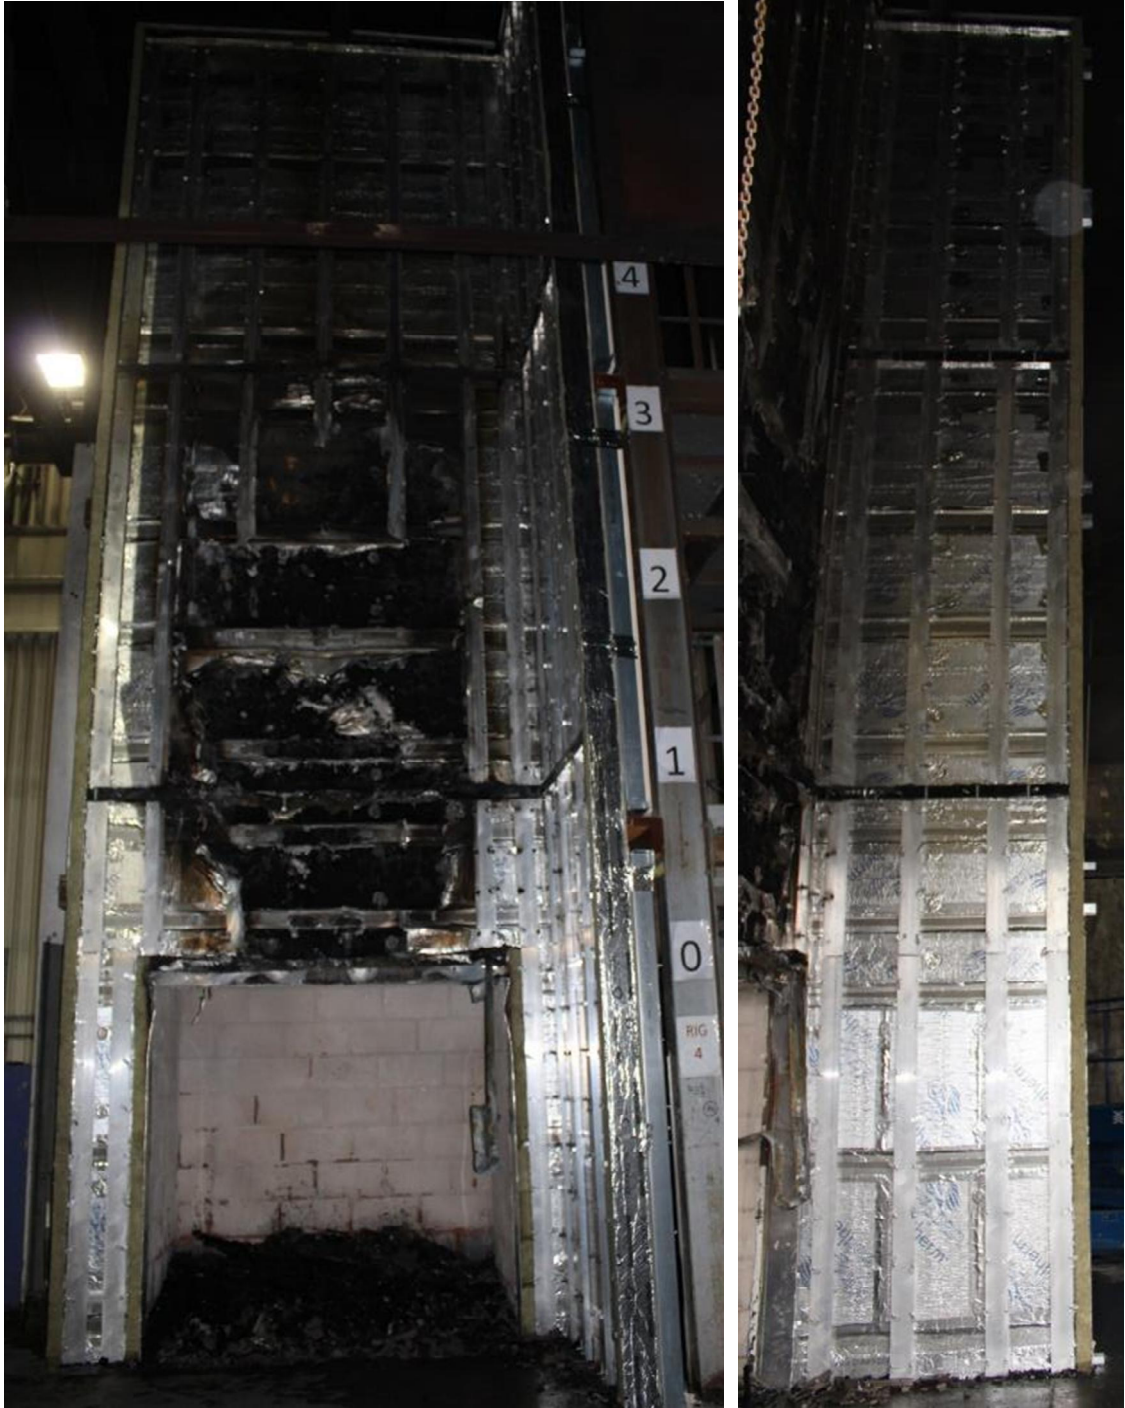
Figure 53. Full-height photograph following removal of tiles.

On the main wall, the centre rail in line with the combustion chamber centre line had melted up to 4m, the rails immediately either side of it had melted to 3.2m above the combustion chamber opening. All rails had signs of distortion up to 4m above the combustion chamber opening with discolouration to top of system.

On the wing wall, the rails remained in place with no visible damage.

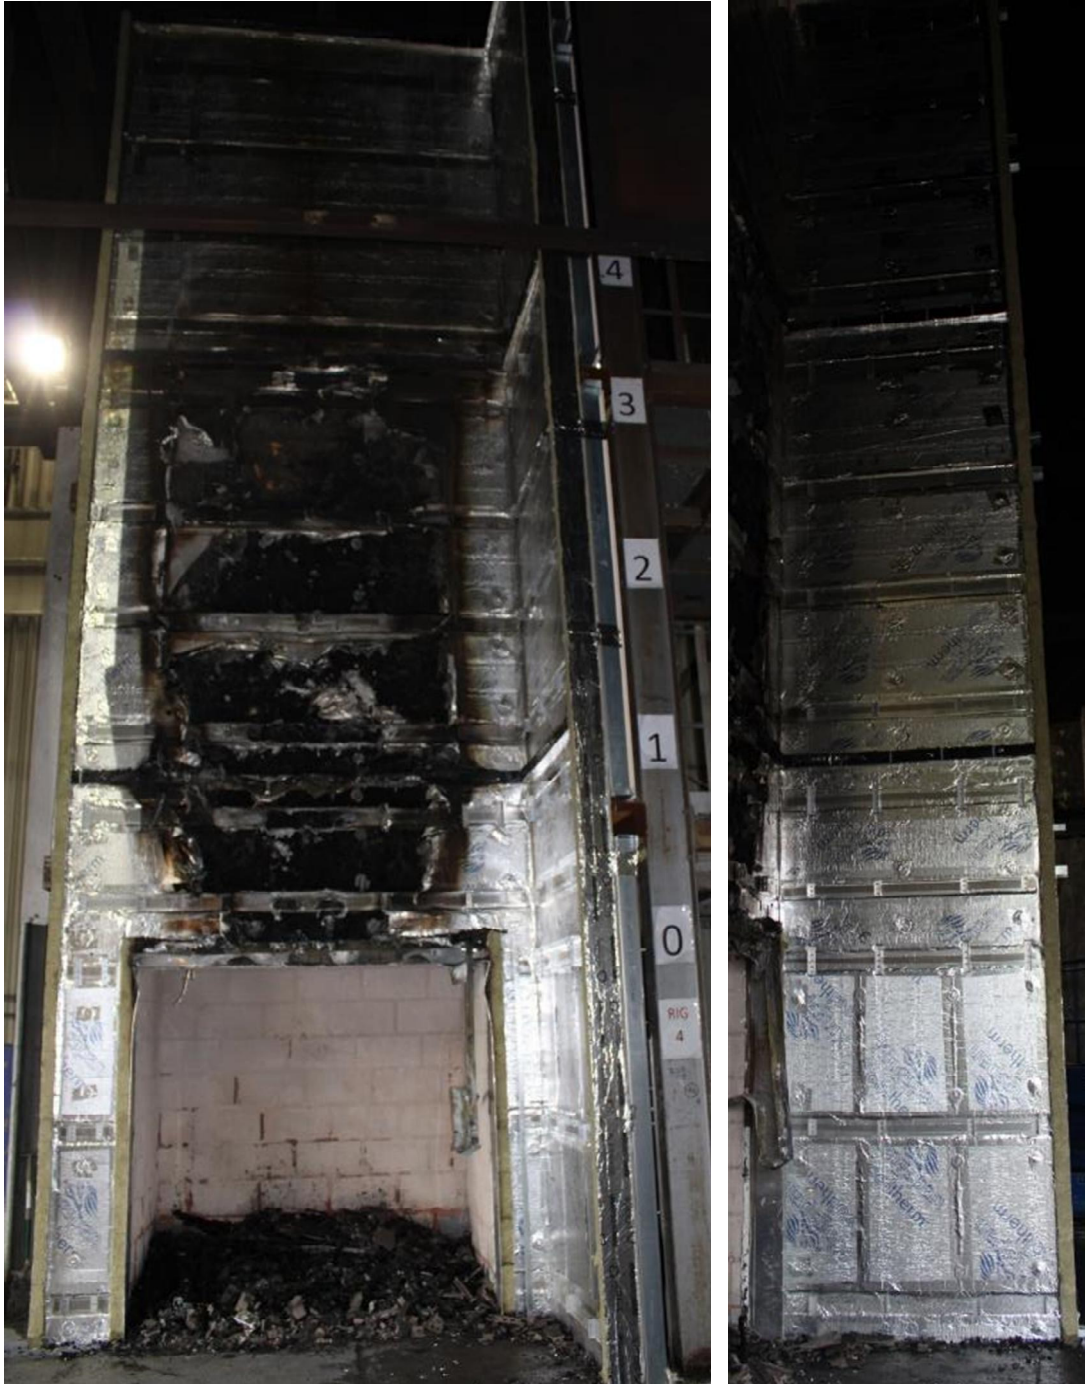
Figure 54. Full-height photograph following removal of rails

On the main wall, the insulation was charred or had detached/been consumed up to 4.2m-high \times 2m-wide above the combustion chamber opening, and was discoloured to top of system. On the wing wall, the insulation remained in place with no visible damage.

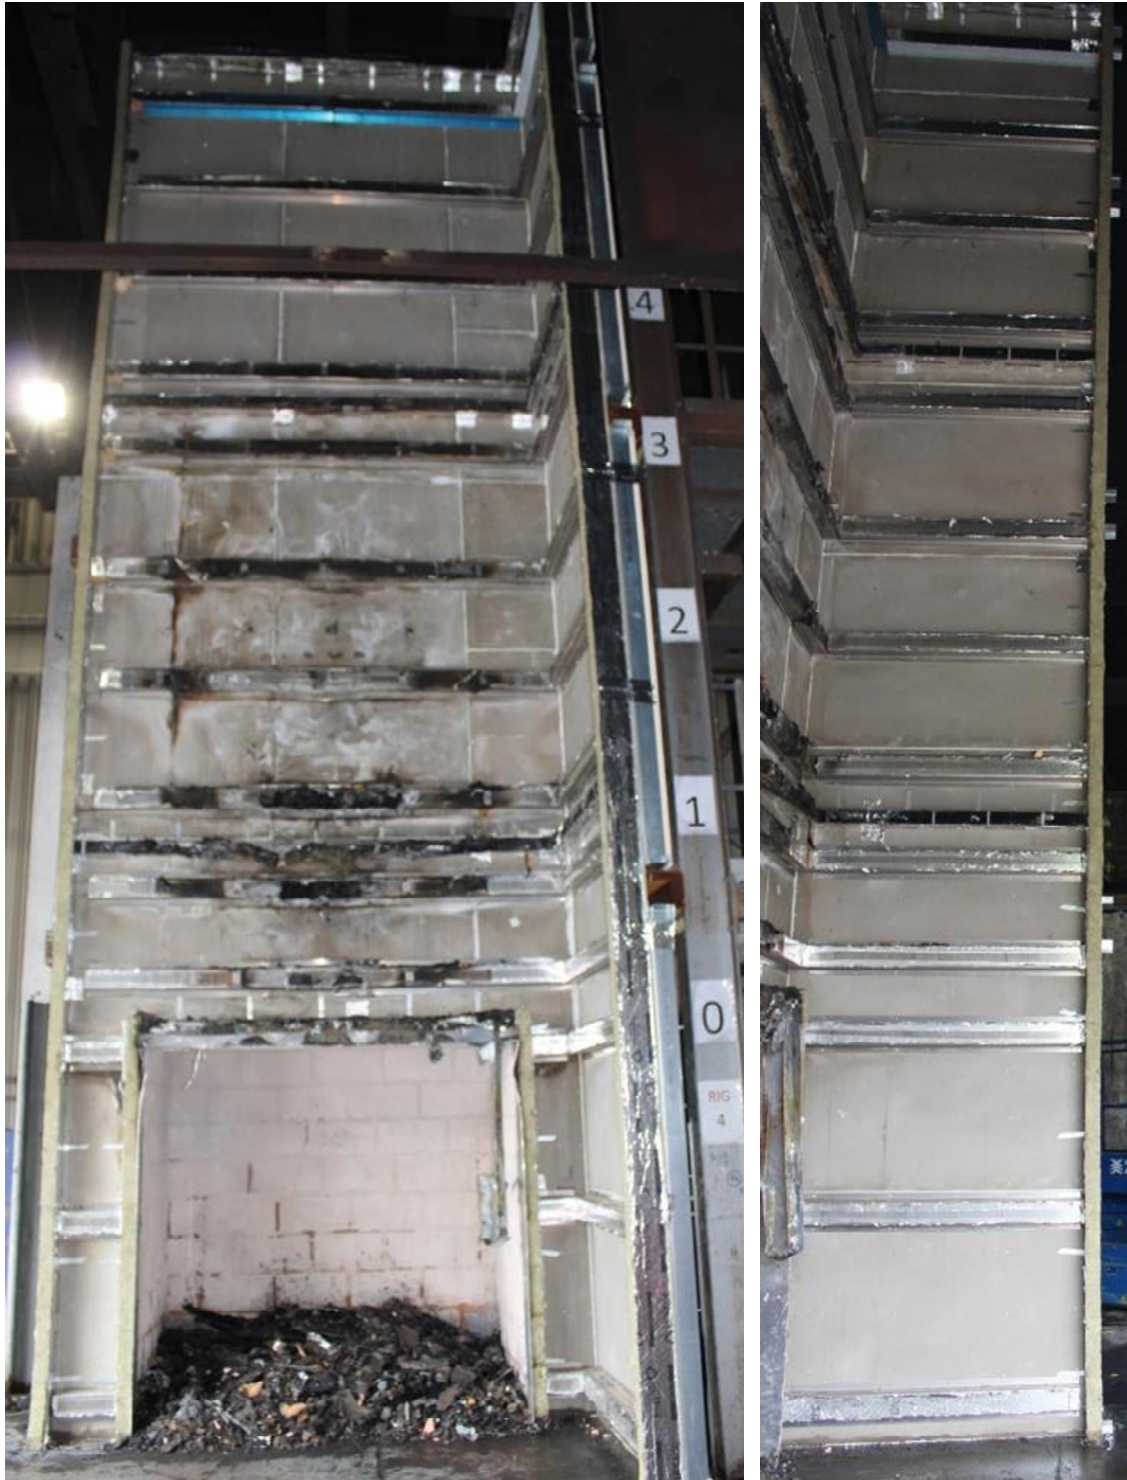
Figure 55. Full-height photograph following removal of insulation and brackets.

The vertical cavity barriers either side of the combustion chamber opening were discoloured at the top edge approx. 400mm-high. The vertical cavity barriers located at the outer edges of both walls remained in place with no visible damage.

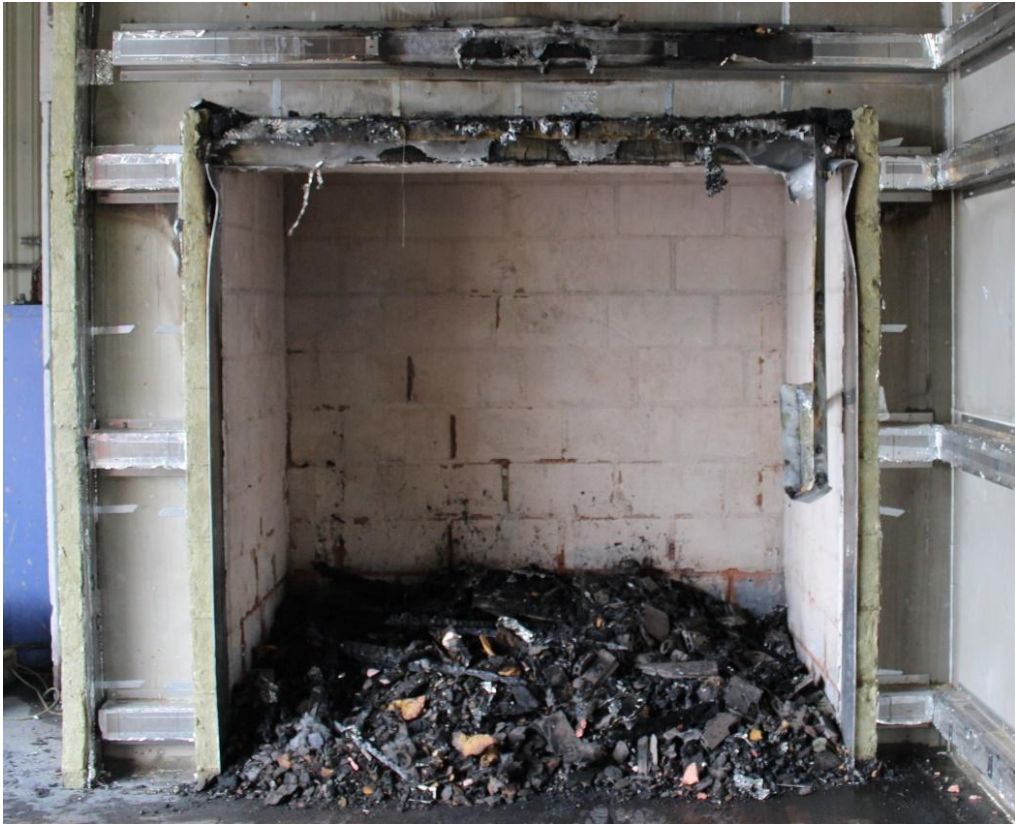
Figure 56. Photograph of the horizontal cavity above combustion chamber.

The horizontal cavity barrier located directly above the combustion chamber had fully activated across the full width. Sections of the intumescent strip had detached.

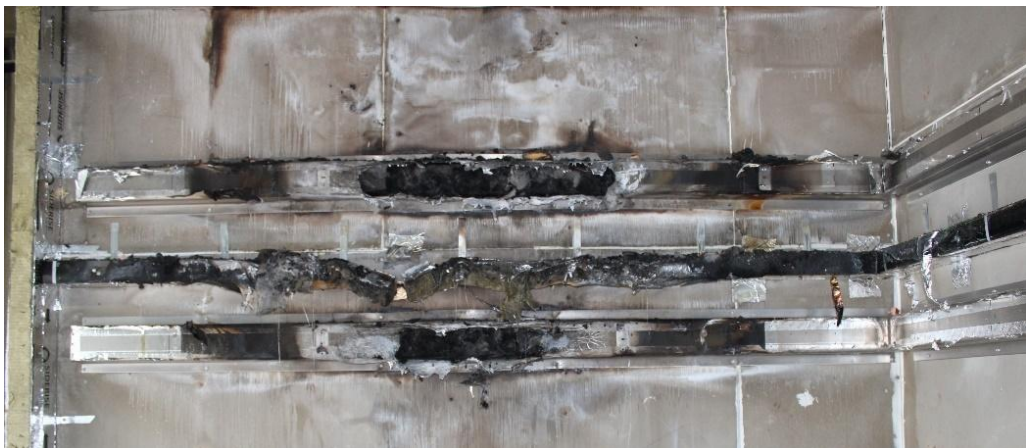
Figure 57. Photograph of the 1st full width horizontal cavity barrier.

On the main wall, the 1st full width horizontal cavity barrier had fully activated across the full width.

On the wing wall, the horizontal cavity barrier had signs of expansion at the junction approx. 300mm-wide.

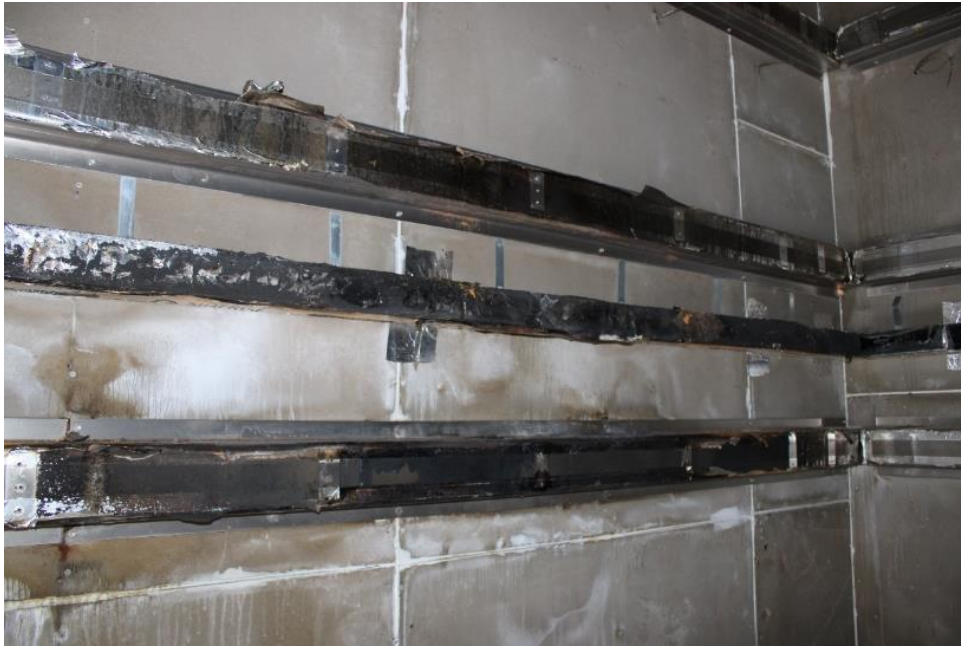
Figure 58. Photograph of the 2nd full width horizontal cavity barrier.

On the main wall, the 2nd full width horizontal cavity barrier had fully activated across the full width.

On the wing wall, the horizontal cavity barrier had signs of expansion at the junction approx. 300mm-wide.

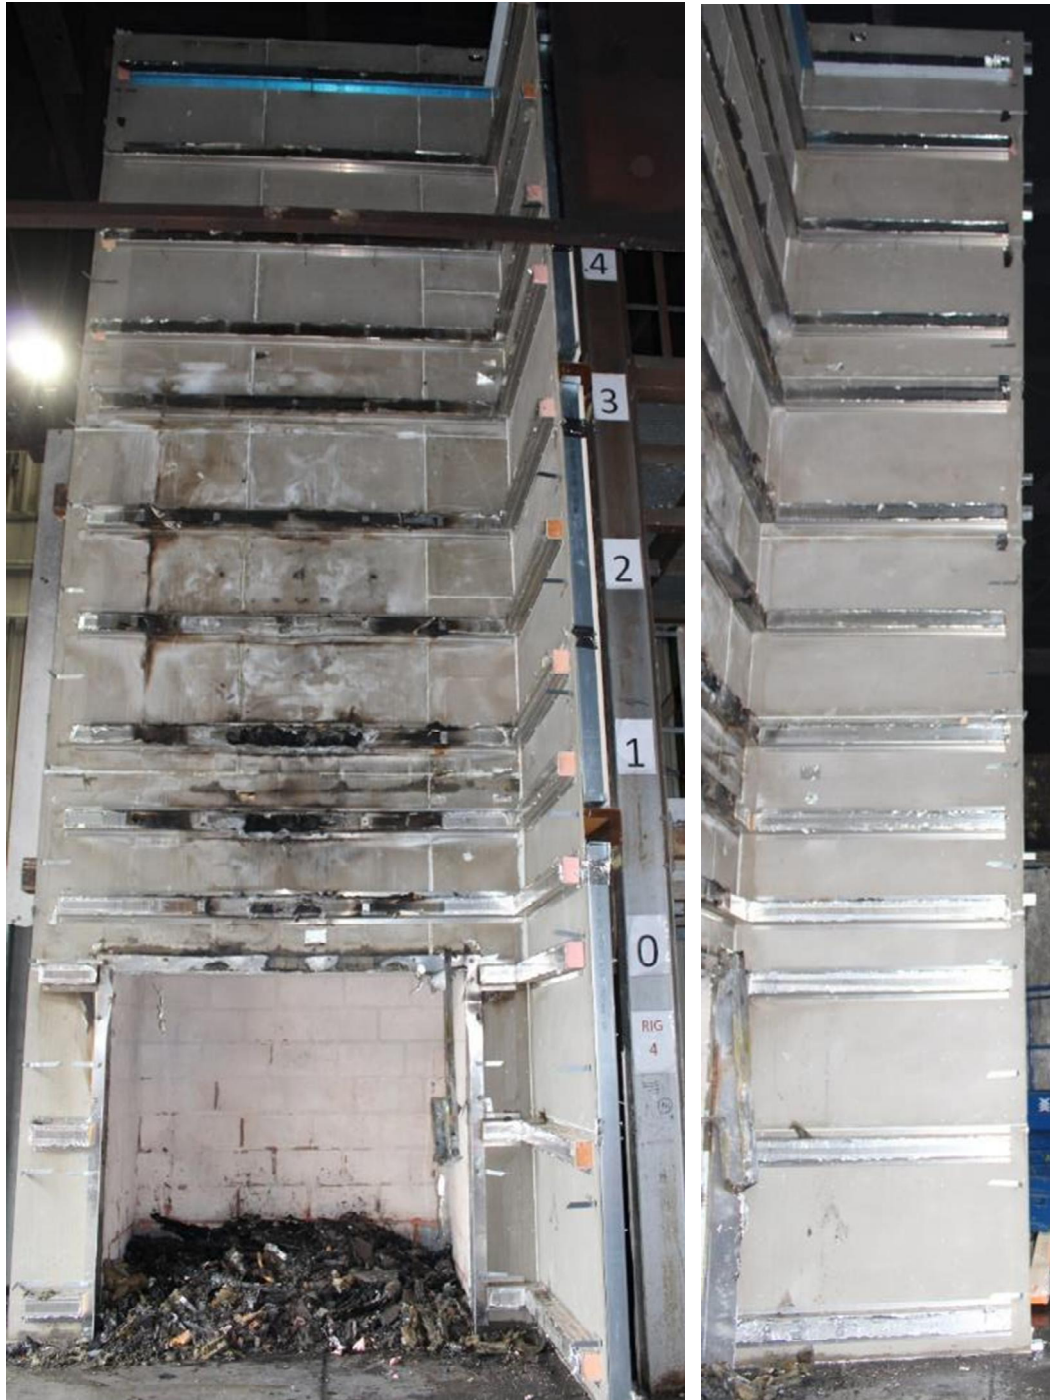
Figure 60. Full-height photograph following removal of cavity barriers.

On the wing wall, the top hat channels had no visible signs of damage.

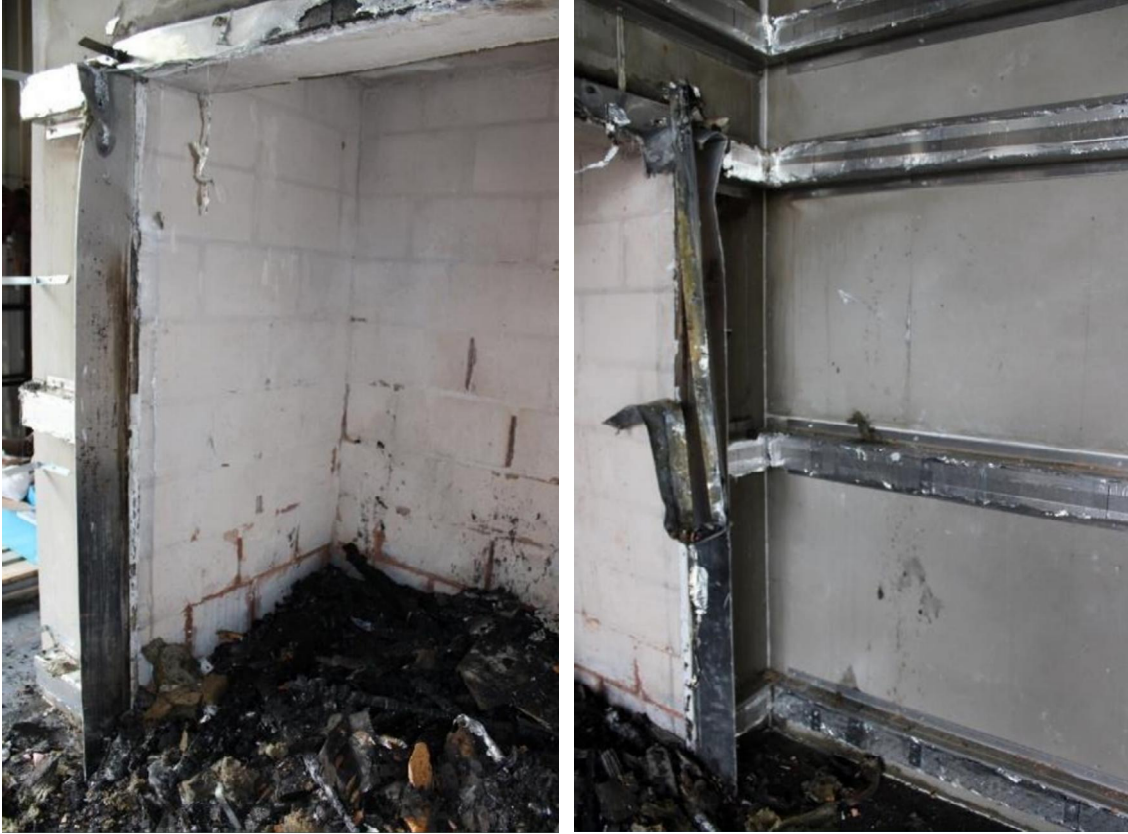
Figure 61. Photograph of combustion chamber surround flashing.

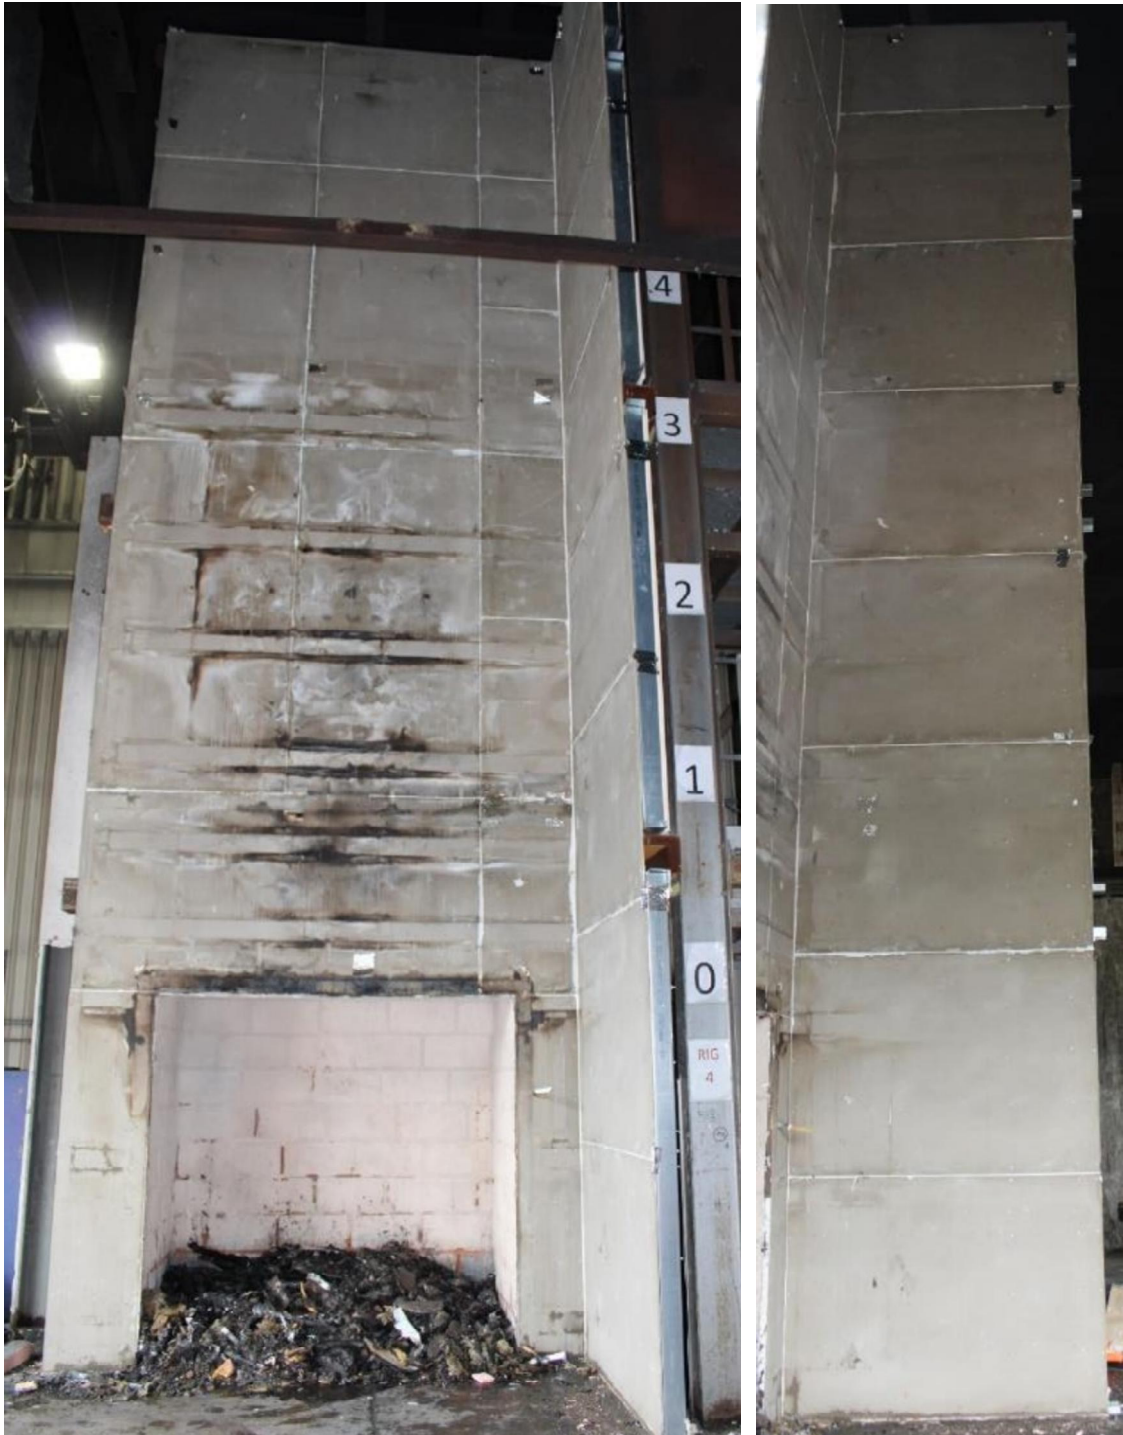
Figure 62. Full-height photograph following removal of the top-hat channels.

On the wing wall, the cement board had no visible signs of damage.

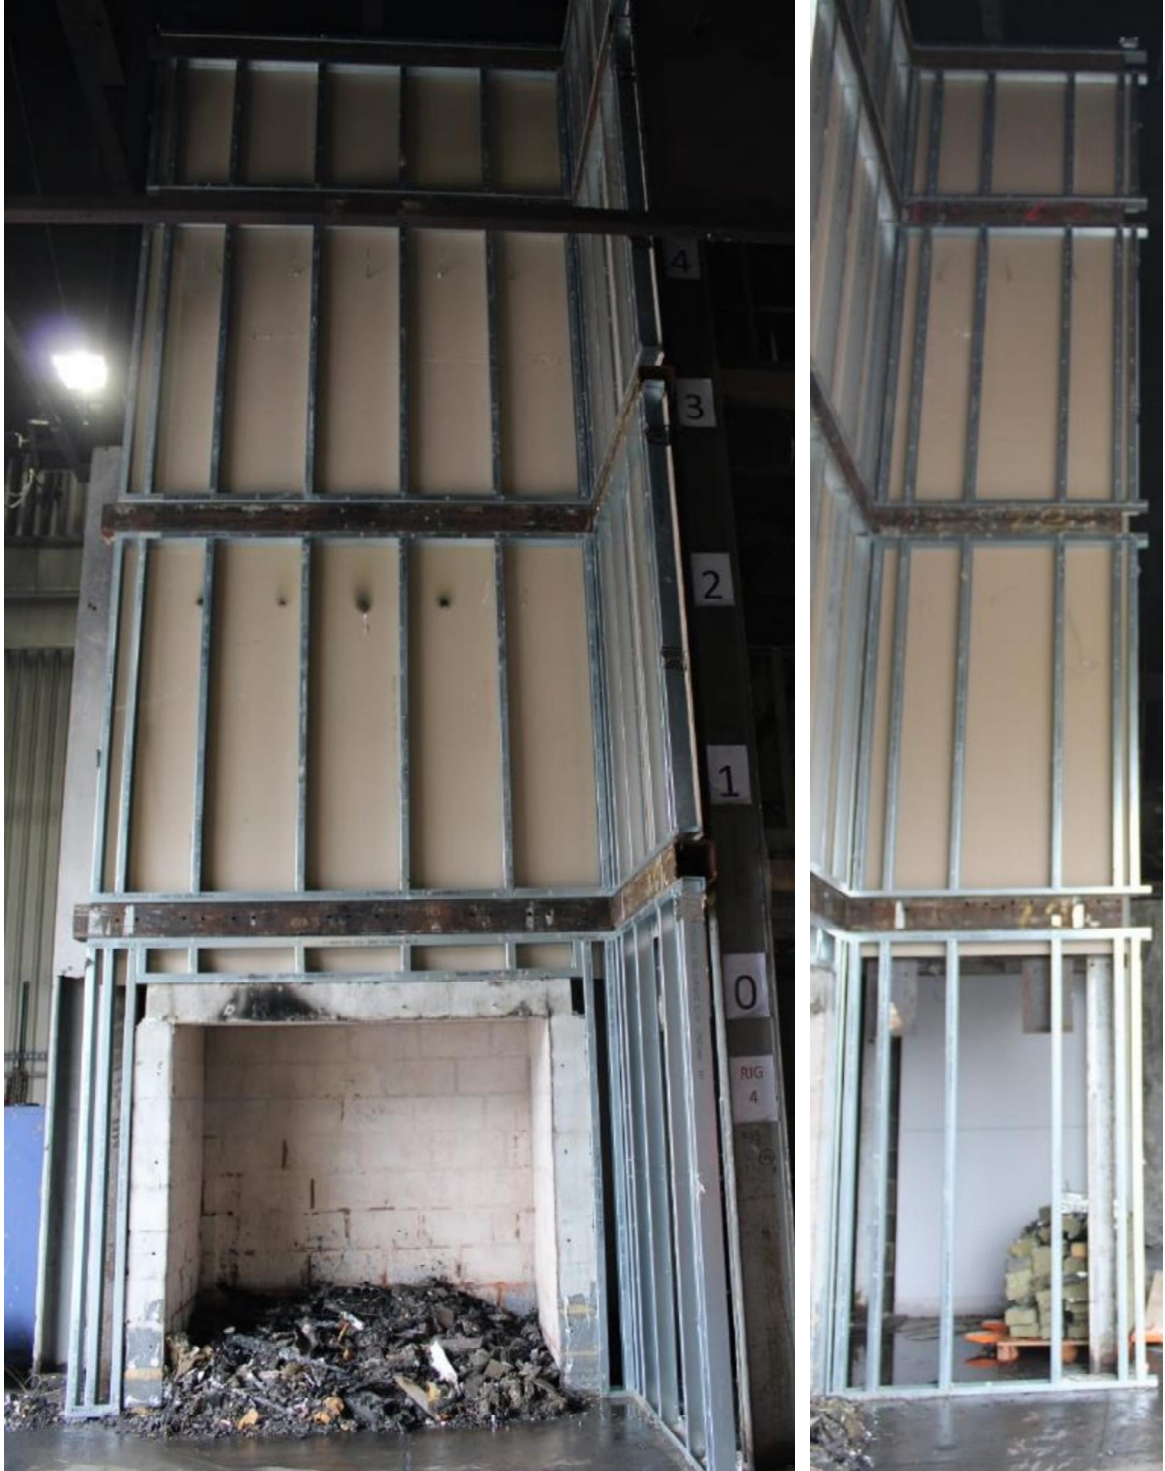
Figure 63. Full-height photograph of the steel framing system and plasterboard (exposed face).

The SFS and plasterboard remained intact and in place with no visible damage. There was some smoke staining localised to the Level 1 thermocouple holes.

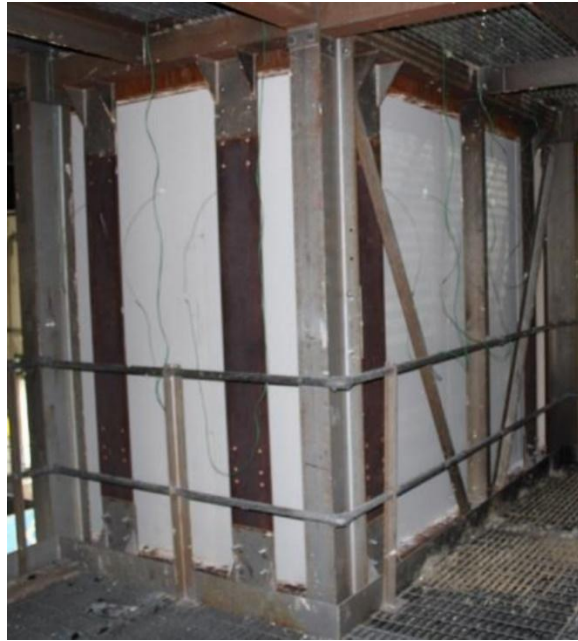
Figure 64. Post-test photograph of the plasterboard (unexposed face) - Level 1 thermocouples.

The unexposed face of the plasterboard remained intact and in place with no visible damage.

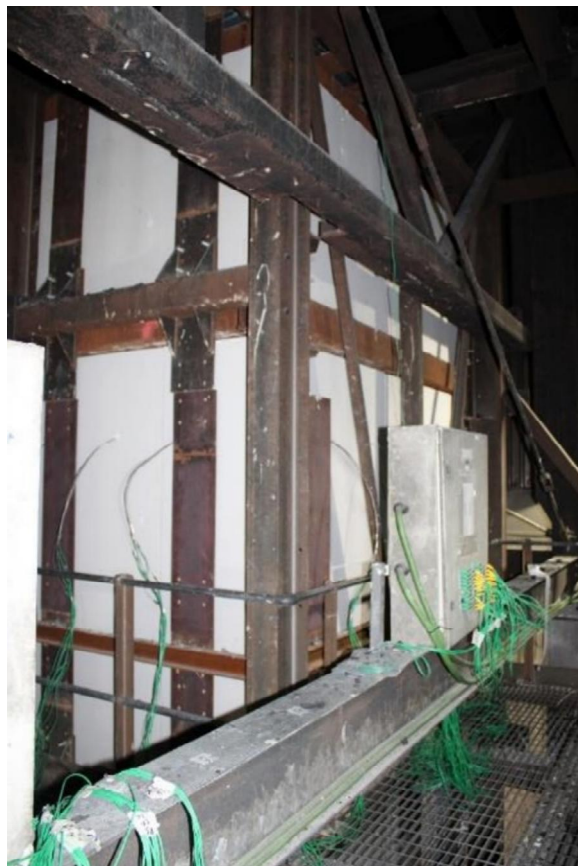
Figure 65. Post-test photograph of the plasterboard (unexposed face) – Level 2 thermocouples.
