# BRE Global Test Report

**BS 8414-2:2015 + A1:2017 Test on a brickwork cladding system with Kingspan Kooltherm K15 insulation.**

**Date:** 26th October 2018

**Report Number:** P112065-1000 Issue: 1

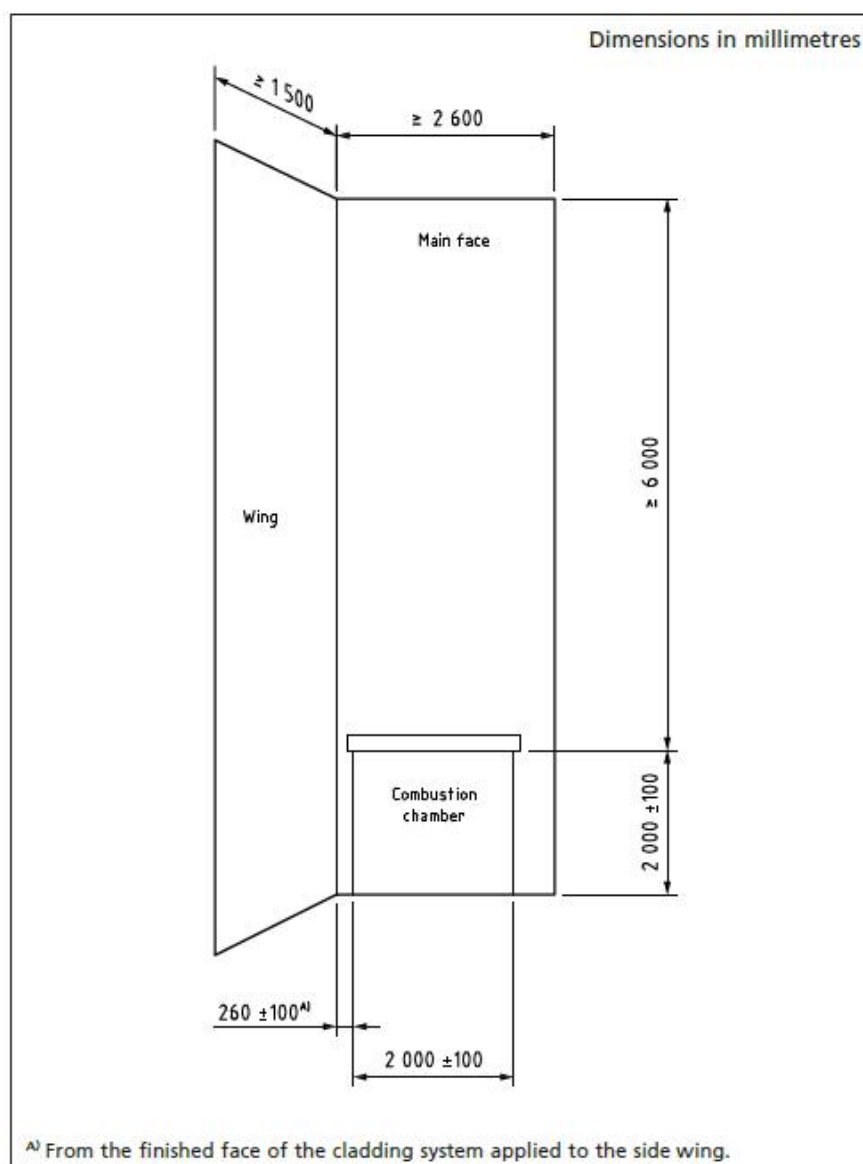
Figure 1. Test apparatus dimensions as specified by test Standard<sup>[1]</sup>.

The product was installed on to wall number 4 of the BRE Global test facility. This apparatus is representative of a structural steel framed building and consists of a structural steel test frame with a vertical main test wall and a vertical return wall at a 90° angle to and at one side of the main test wall - see *Figure 1*. The main wall includes the combustion chamber.

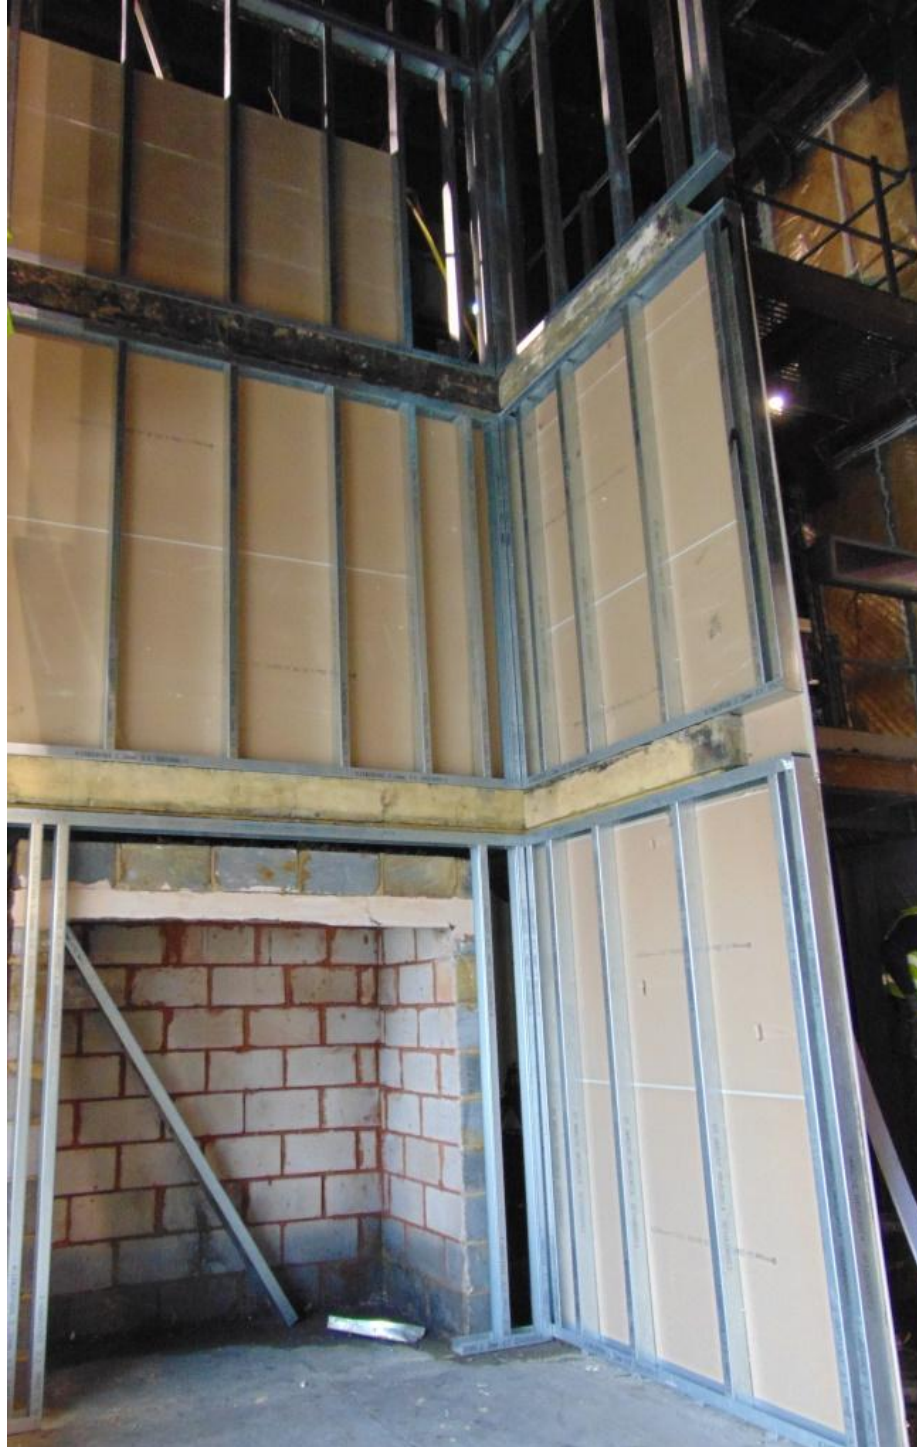
Figure 3. Lightweight steel framework partition with plasterboard fitted to rear.

A Kingframe SFS (Steel Framing System) was constructed using Items 2-4 in *Table 1*. The partition was fitted flush with the front face of the floor slabs, fixed to the slabs and ground using 6×70mm countersunk Tapcon self-drilling screws at 100-400mm centres.

The vertical studs of the partition were set at 600mm centres and fixed to the horizontal channels using 4×25mm self-drilling screws. The stud spacing was reduced to 90mm at edge of framing.

A double layer of British Gypsum Gyproc Wallboard was fitted to the internal face of the partition (long edge horizontal) using Easydrive 3.5×50mm drywall screws at nominal 500mm vertical centres for the first layer, 230-600mm vertical centres for the second layer with horizontal centres in line with the studs of the partition.

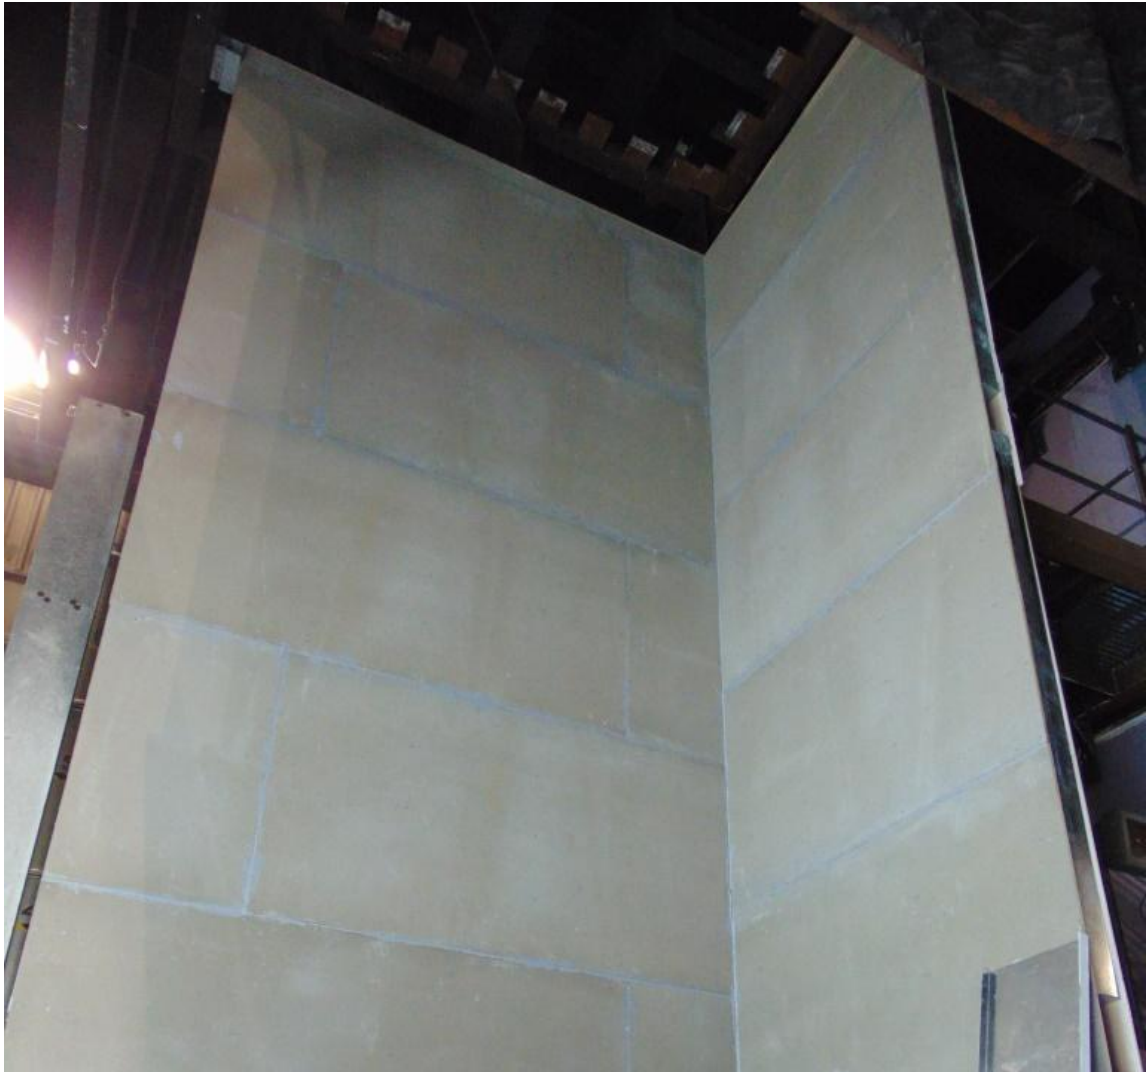
Figure 4. Cement particle board.

A single layer of Euroform Versapanel cement particle board was fitted to the external face of the partition (long edge horizontal) and around the combustion chamber surround using 5.5×50mm self-drilling screws with horizontal centres in line with the studs of the partition and 100-300mm vertical centres (five fixings per column per board).

There was a 5-8mm gap between adjacent cement particle boards.

Euroform Versaseal-FS grey sealant was applied to gaps between adjacent cement particle boards.

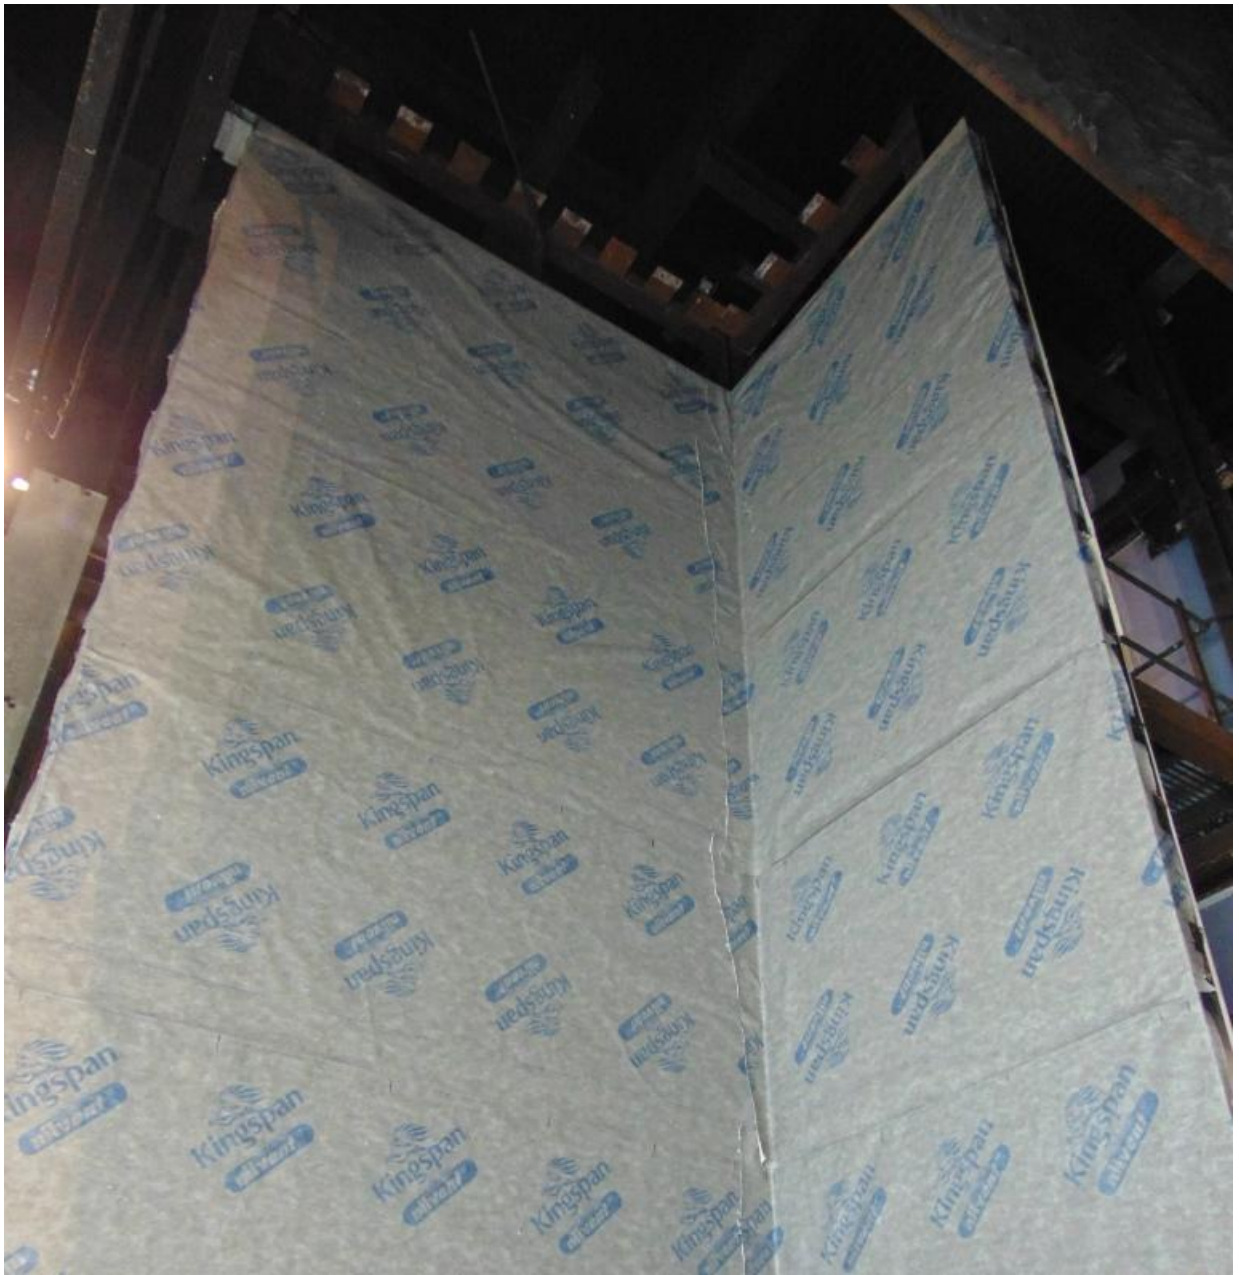
Figure 5. Breather membrane.

Kingspan nilvent breather membrane was fitted to the external face of the cement particle board using Arrow 14mm T50 staples.

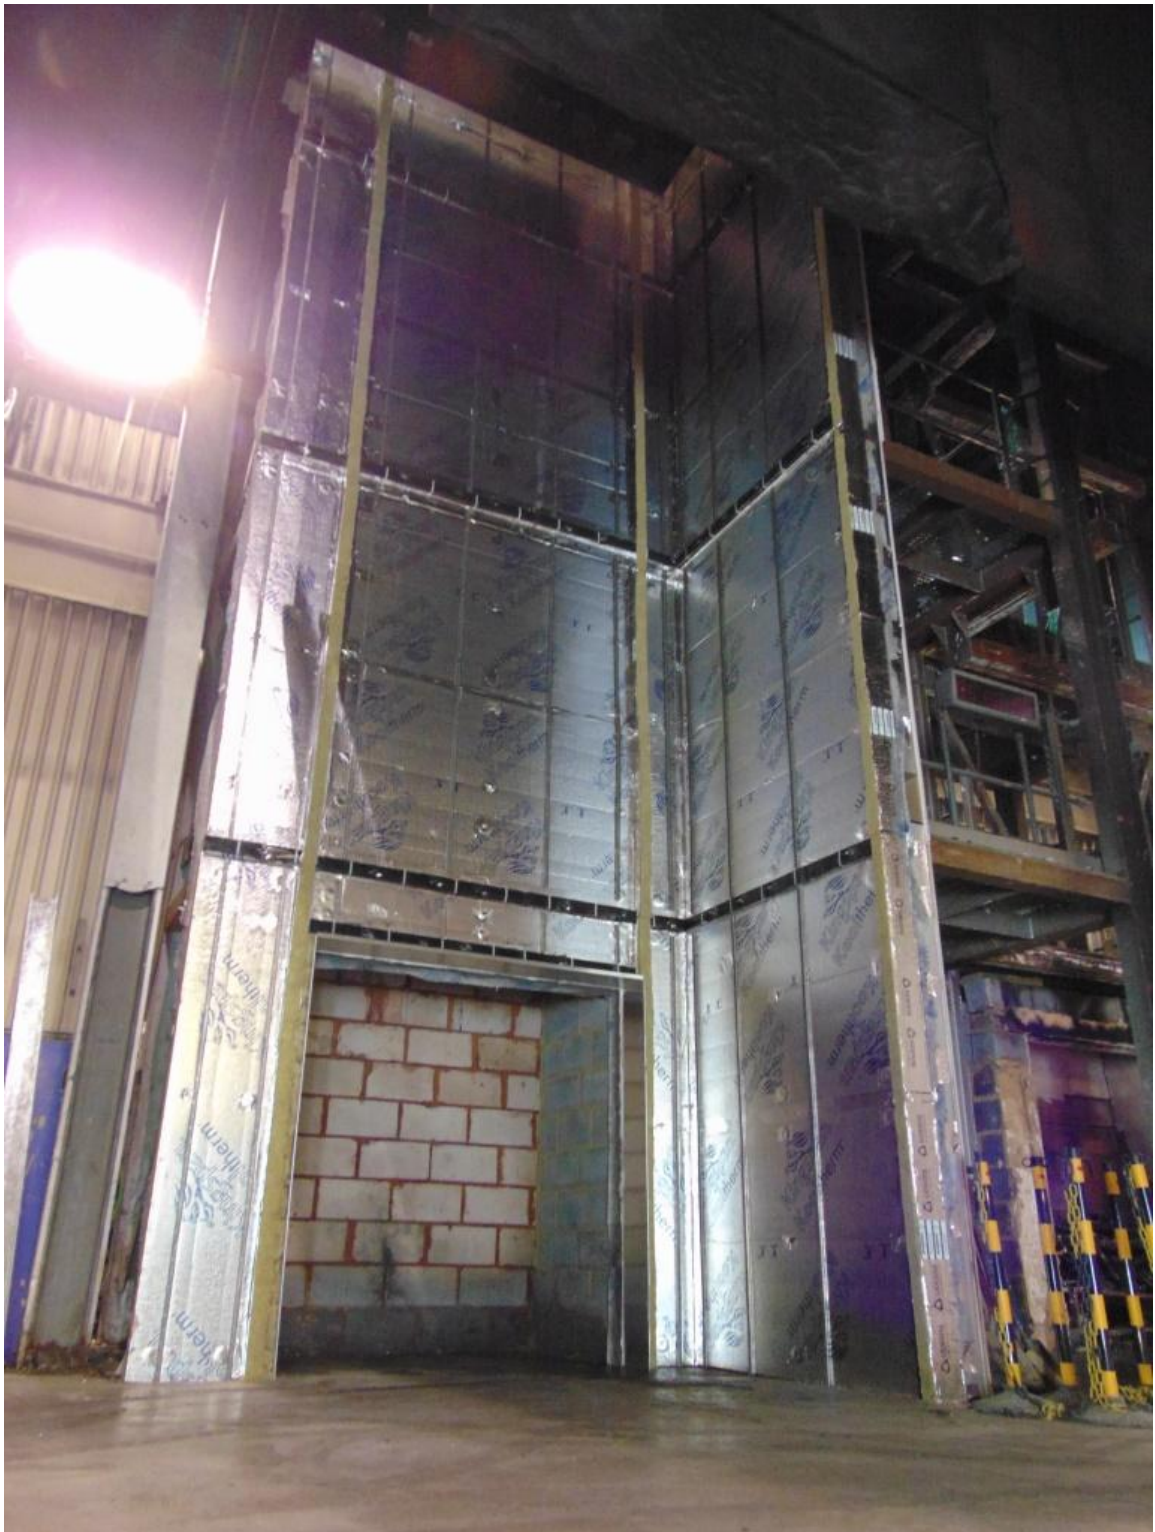
Figure 6. Cavity barriers, insulation and rails.

Siderise EW-CB30 stone wool vertical cavity barriers were pressed onto the skewers in columns.

Siderise RH25G-090/030 stone wool horizontal open state cavity barriers with intumescent strip were pressed onto the skewers in rows. A cut was made along the length of the skewers local to the tip and the ends were folded to opposite sides to secure the horizontal cavity barriers in place. Each row was interrupted by the vertical cavity barriers. All gaps between insulation boards and cavity barrier were sealed with aluminium tape.

A single layer of 100mm-thick Kingspan Kooltherm K15 insulation was fixed to the cement particle board using 4.8×100mm self-drilling screws with Ø75mm plastic insulation retaining discs and 5.5×150mm self-drilling screws with Fixfast SP-SS-50-F1 Ø50mm metal insulation retaining discs. Aluminium tape was applied over the heads of insulation fixings and gaps between insulation boards.

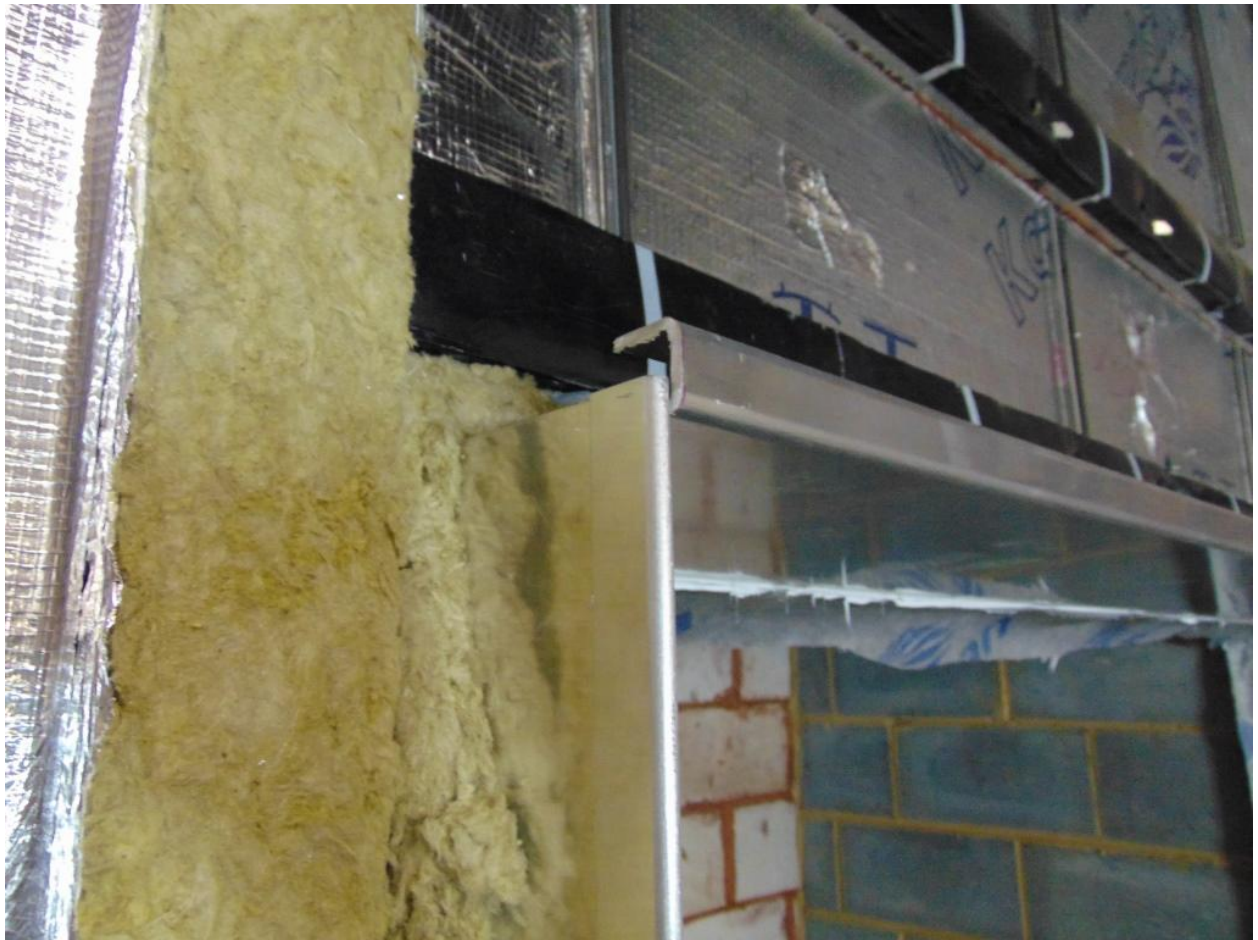
Figure 7. Combustion chamber surround flashing.

Note: stone wool insulation packed between flashing and cavity barriers.

Aluminium flashing (Items 15 and 16 in *Table 1*) was fitted around the combustion chamber opening. The flashing was fixed to the external face of the cement particle board using 5.5×50mm self-drilling screws at 380mm centres. The flashing was fixed with 10mm-thick spacers and stone wool packed within the gap between the cement particle board and the flashing. Intumescent acrylic sealant was also used to seal the 10mm gap. Stone wool insulation was packed into the 20-30mm gap between the aluminium flashing and the cavity barriers surrounding the combustion chamber.

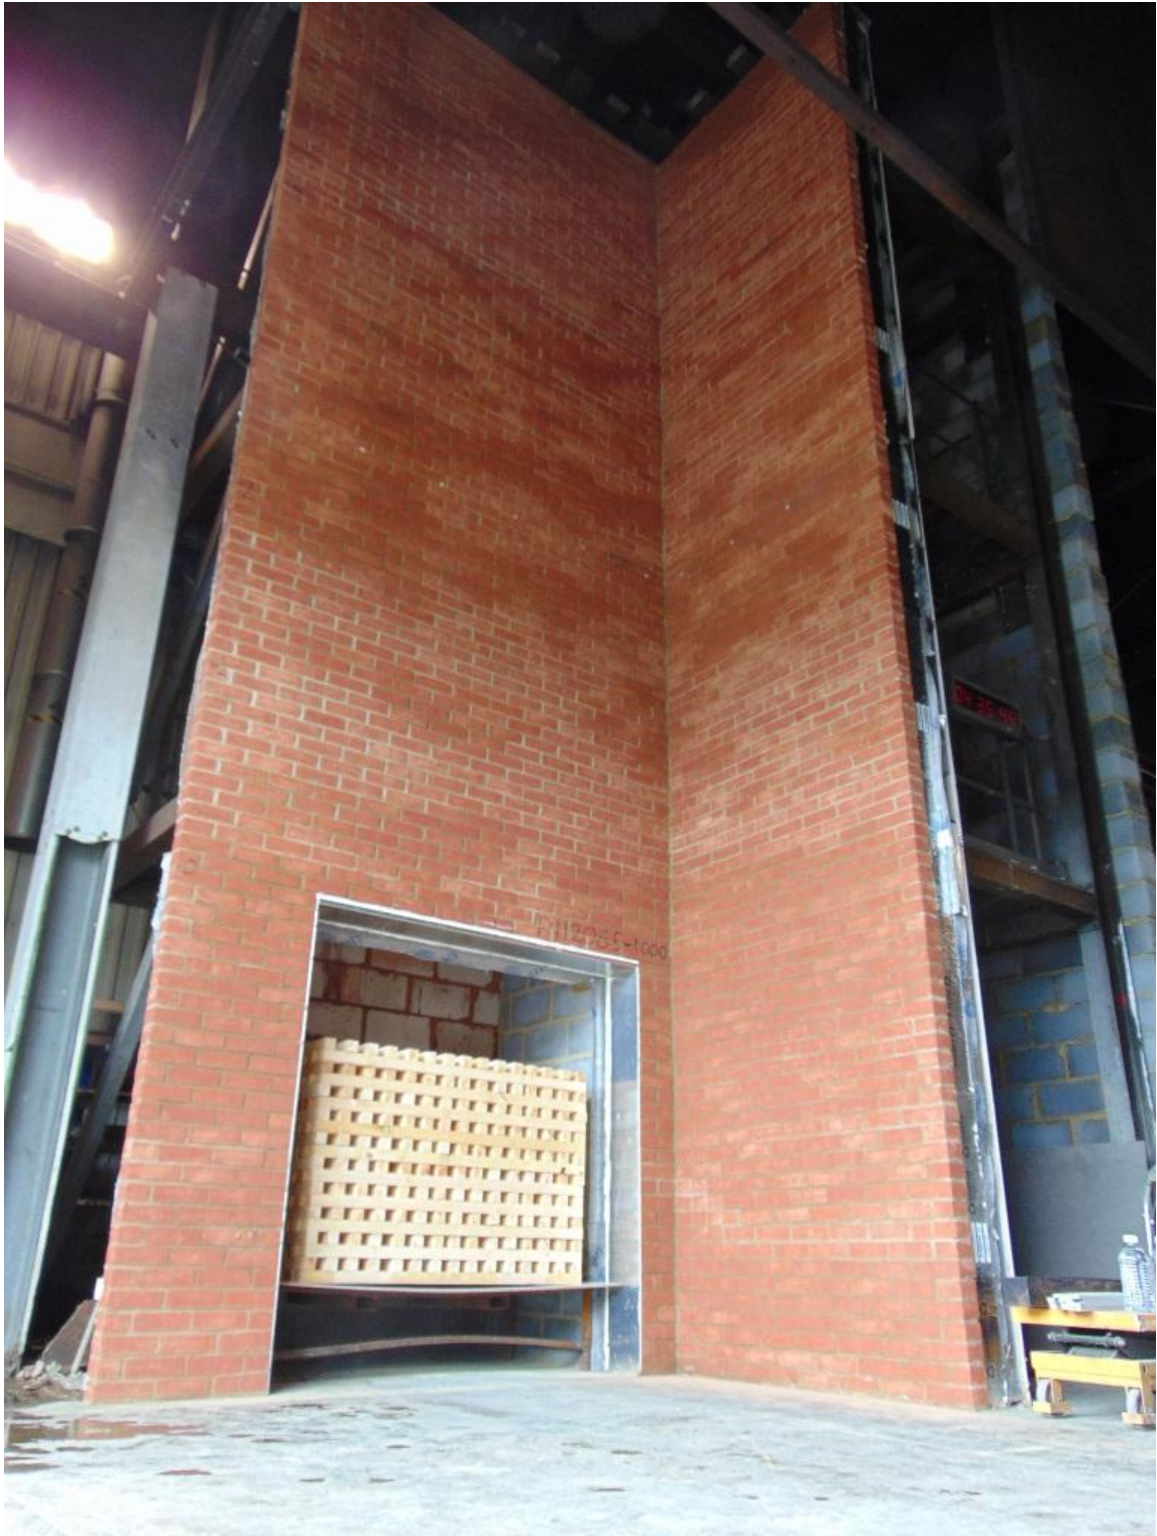
Figure 8. Full-height photograph of cladding system prior to test.

*Figures 13-20* provide the temperature profiles recorded during the test. *Figure 8* shows the system before the test.

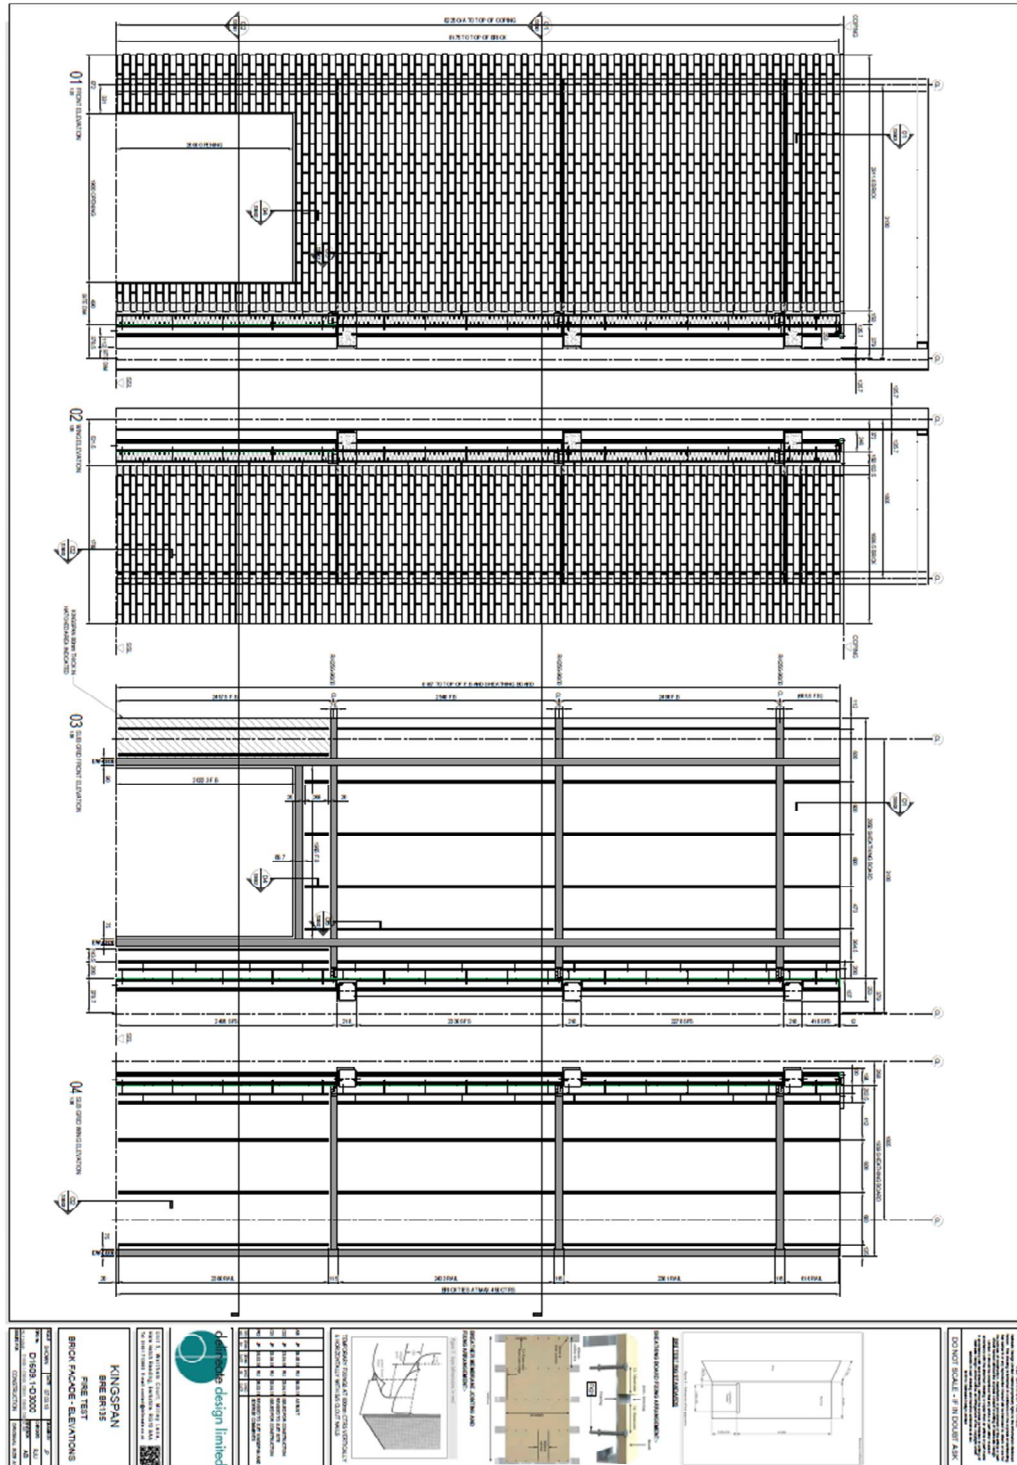
Figure 9. Brick façade and locations if barriers (supplied by Test Sponsor).

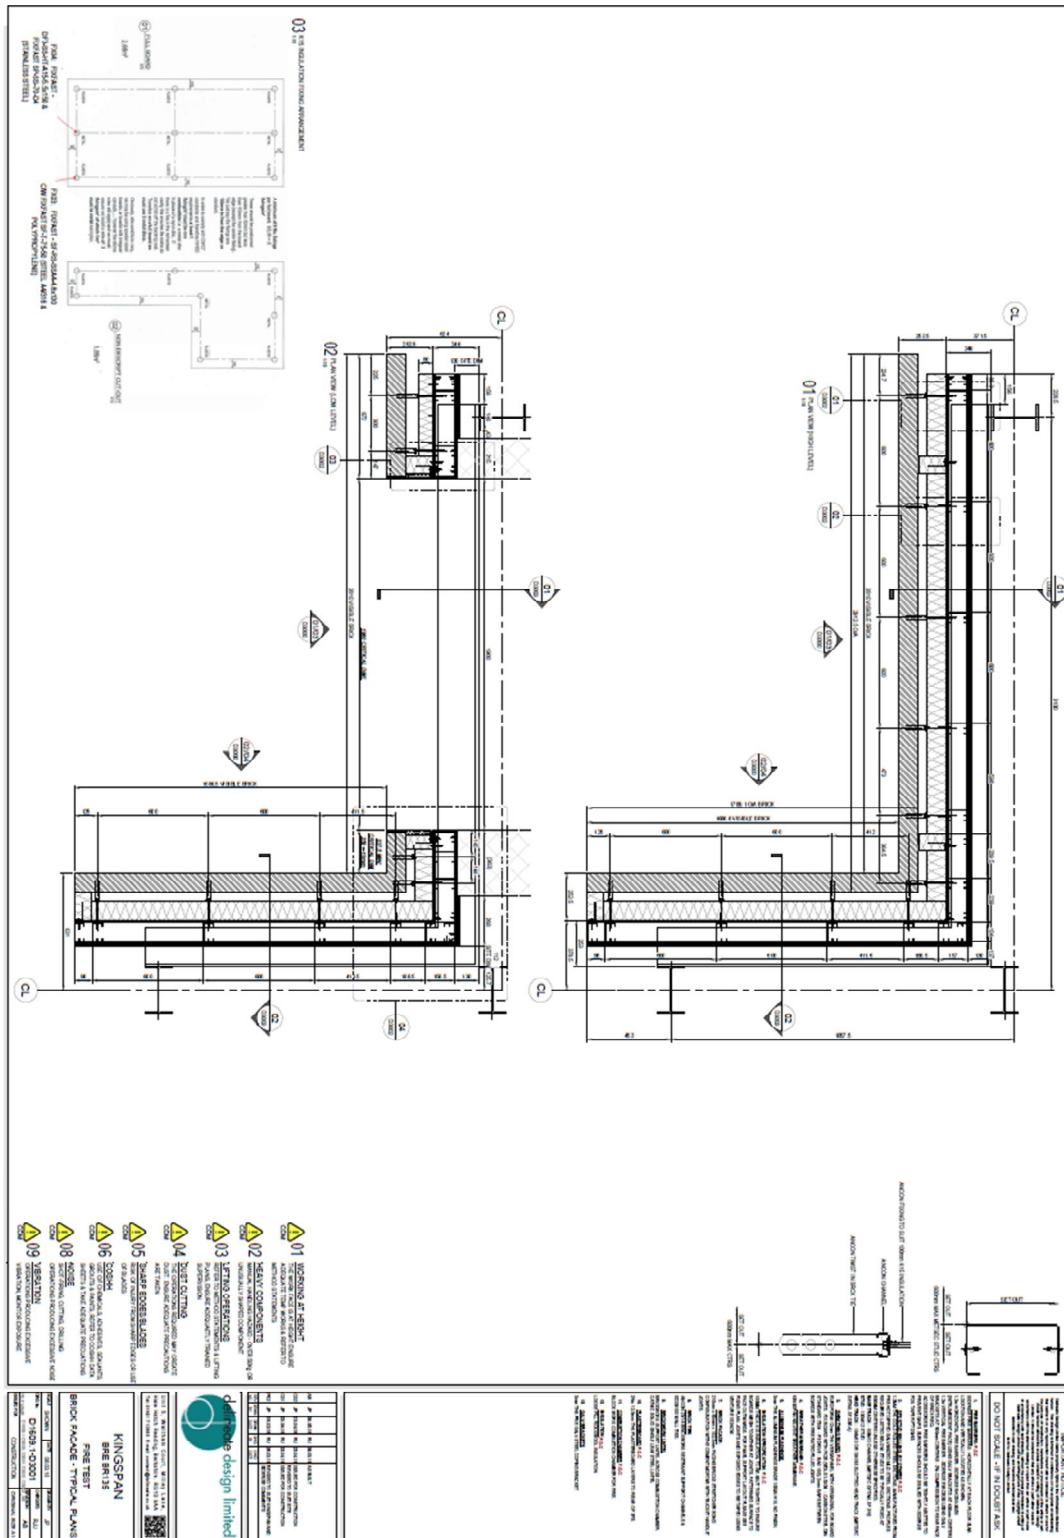
Figure 10. Plan view cross sections (supplied by Test Sponsor).

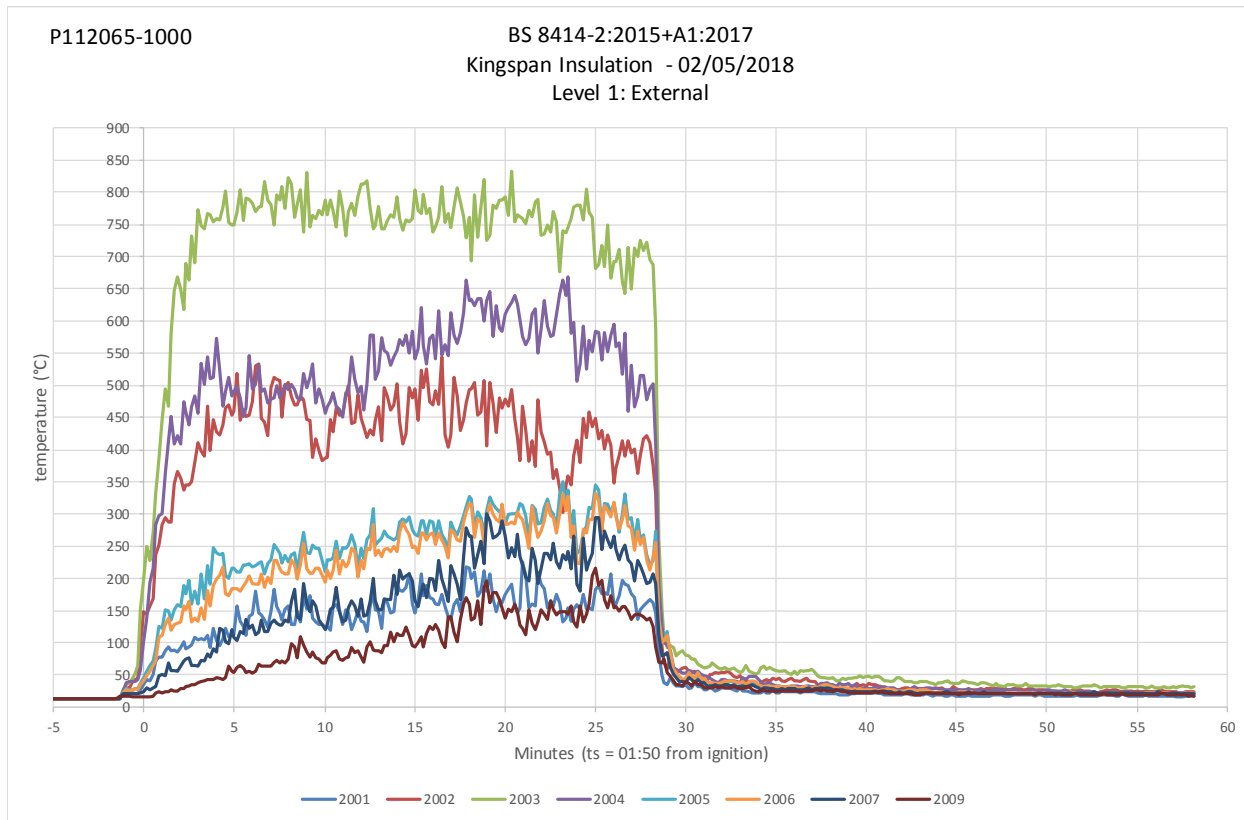
Figure 13. Level 1 external thermocouples.

ts=1 mins 50 secs after ignition of the crib.

Parameter	Result (whole test)	Result (t <sub>s</sub> +15mins)
T <sub>s</sub> , Start Temperature	13°C	n/a
t <sub>s</sub> , Start time	01:50 after ignition of crib.	n/a
Peak temperature / time at Level 2, External	423°C (t <sub>s</sub> +04:20).	423°C (t <sub>s</sub> +04:20).
Peak temperature / time at Level 2, Brick	61°C (t <sub>s</sub> +46:40).	23°C (t <sub>s</sub> +15:00).

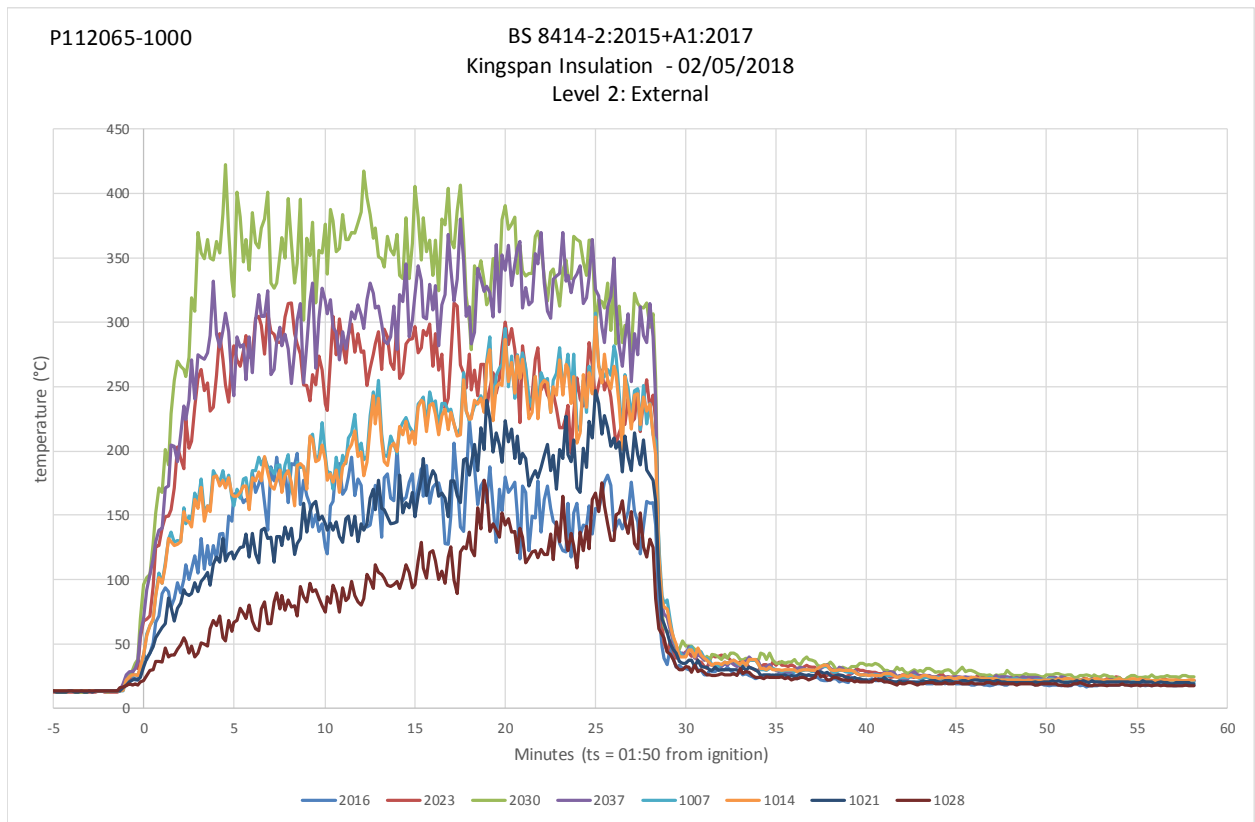
Figure 14. Level 2 external thermocouples.

$t_s=1$  mins 50 secs after ignition of the crib.

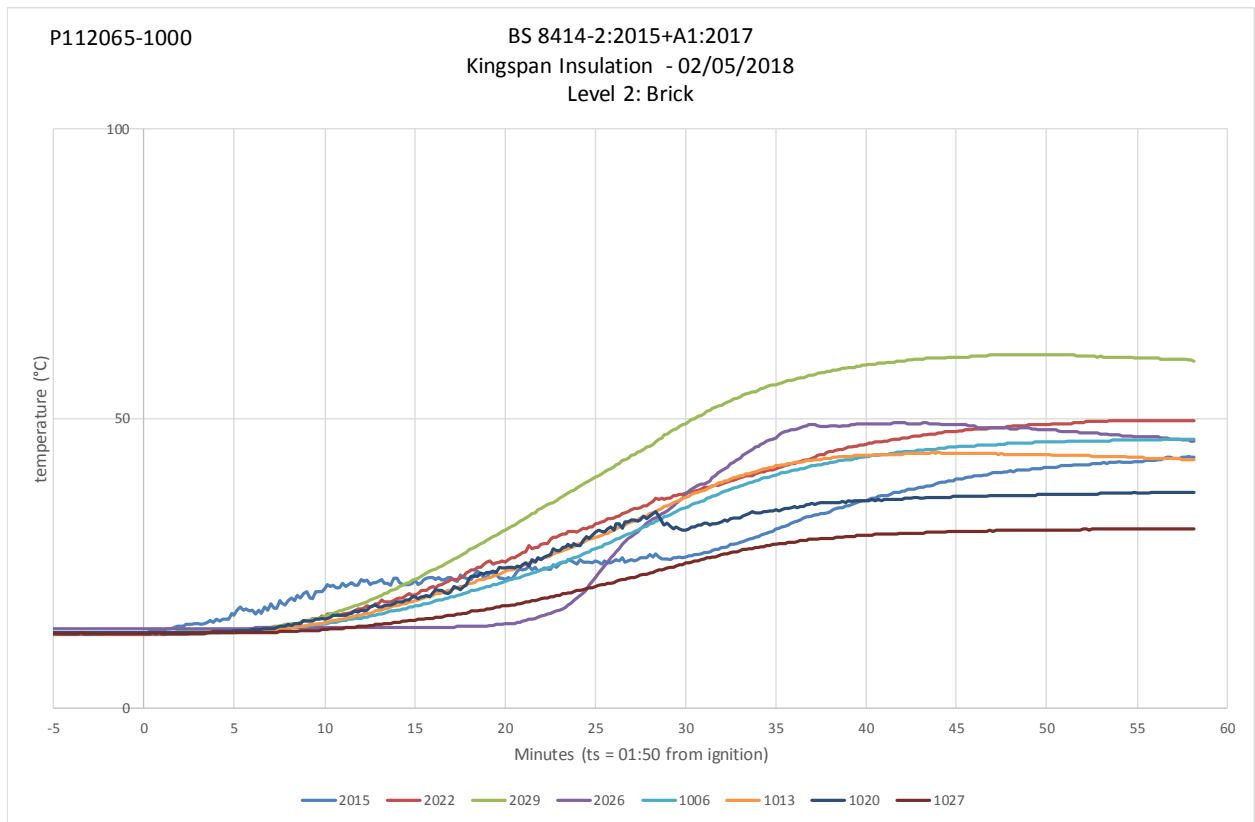
Figure 15. Level 2 brick thermocouples.

$t_s=1$  mins 50 secs after ignition of the crib.

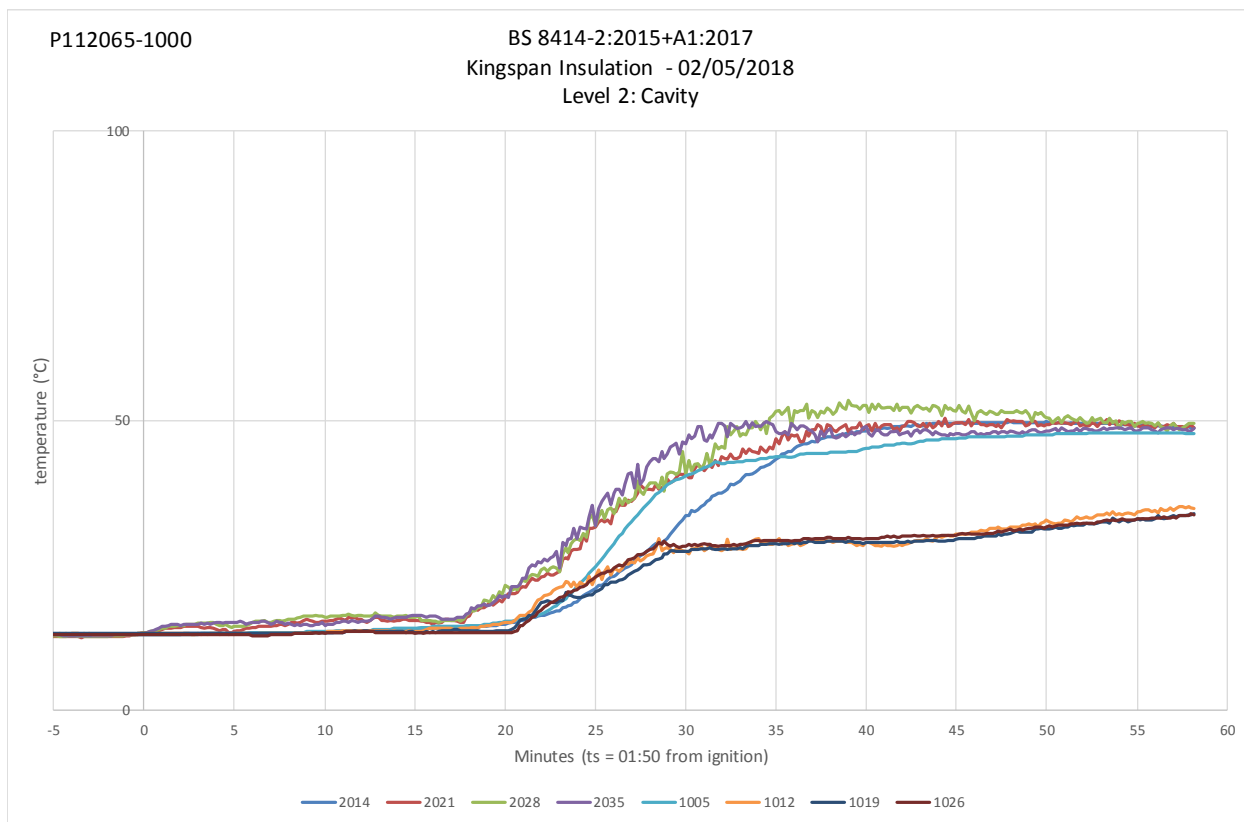
Figure 16. Level 2 cavity thermocouples.

$t_s=1$  mins 50 secs after ignition of the crib.

Peak temperature / time at Level 2, Cavity	54°C (t <sub>s</sub> +38:50).	17°C (t <sub>s</sub> +12:40).
Peak temperature / time at Level 2, Insulation	51°C (t <sub>s</sub> +41:10).	14°C (t <sub>s</sub> +12:50).
Peak temperature / time at Level 2, Cement Particle Board	49°C (t <sub>s</sub> +41:20).	14°C (t <sub>s</sub> +13:30).
Peak temperature / time at Level 2, Partition	45°C (t <sub>s</sub> +39:10).	15°C (t <sub>s</sub> +14:40).
Peak temperature / time at Level 2, Plasterboard	18°C (t <sub>s</sub> +56:10).	15°C (t <sub>s</sub> +14:50).

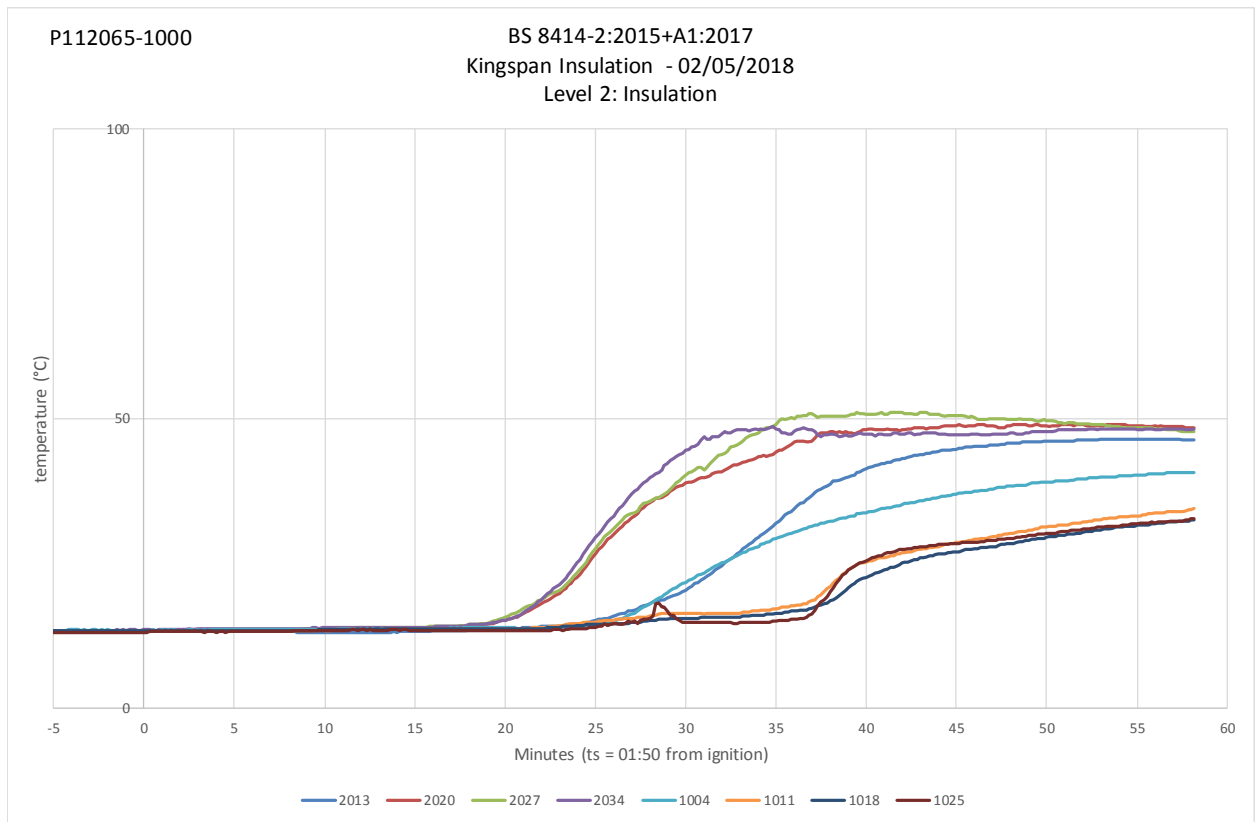
Figure 17. Level 2 insulation thermocouples.

$t_s=1$  mins 50 secs after ignition of the crib.

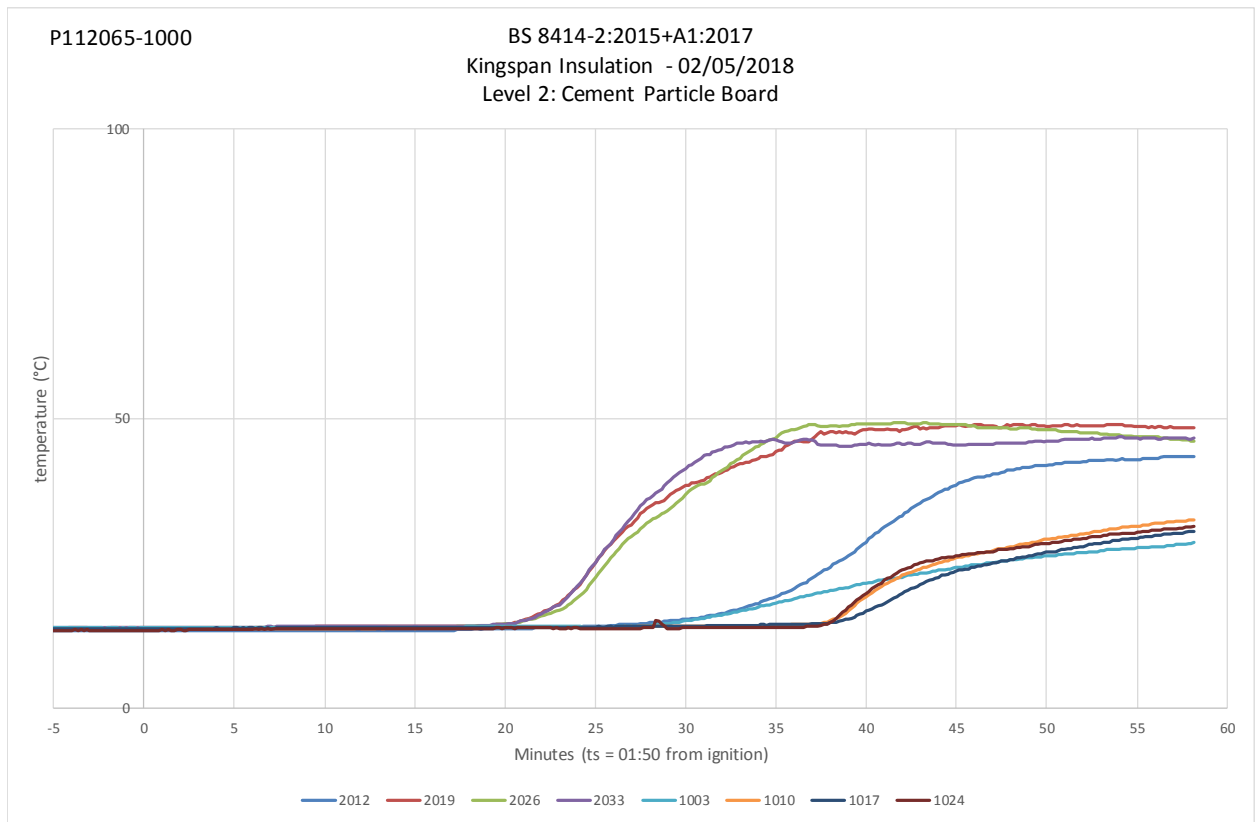
Figure 18. Level 2 cement particle board thermocouples.

$t_s=1$  mins 50 secs after ignition of the crib.

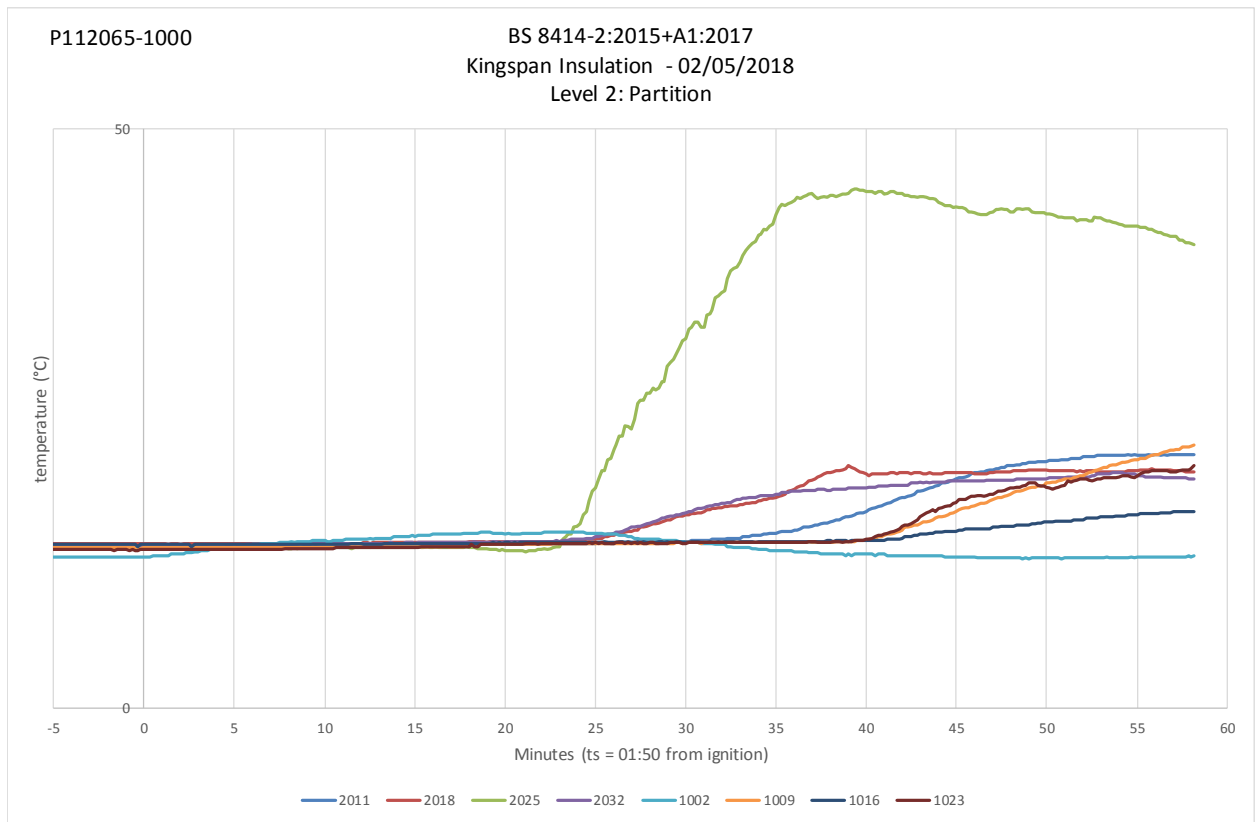
Figure 19. Level 2 lightweight steel framework partition thermocouples.

$t_s=1$  mins 50 secs after ignition of the crib.

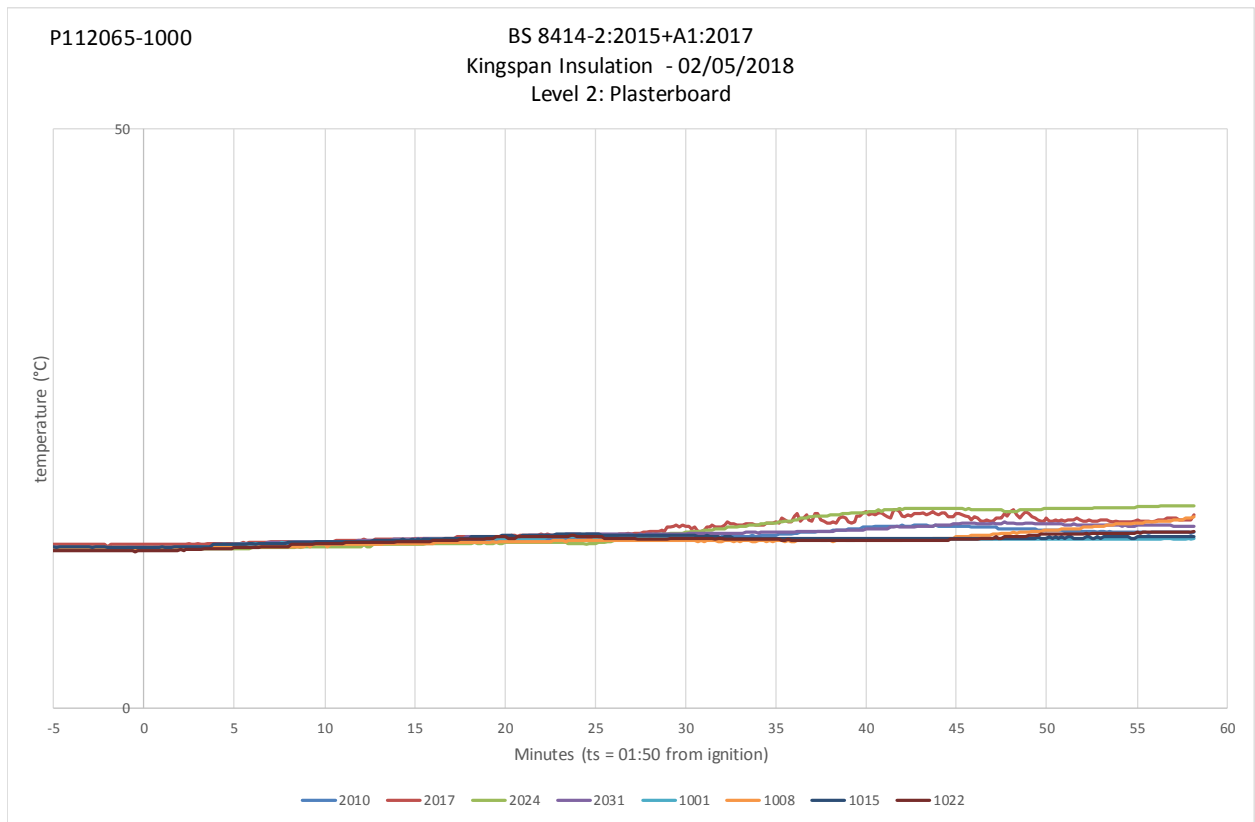
Figure 20. Level 2 plasterboard thermocouples.

$t_s=1$  mins 50 secs after ignition of the crib.
