# BRE Global Test Report

**BS 8414-2:2015 + A1:2017 Test on a brickwork cladding system with Kingspan Kooltherm K15 insulation.**

**Date:** 26th October 2018

**Report Number:** P112065-1000 Issue: 1

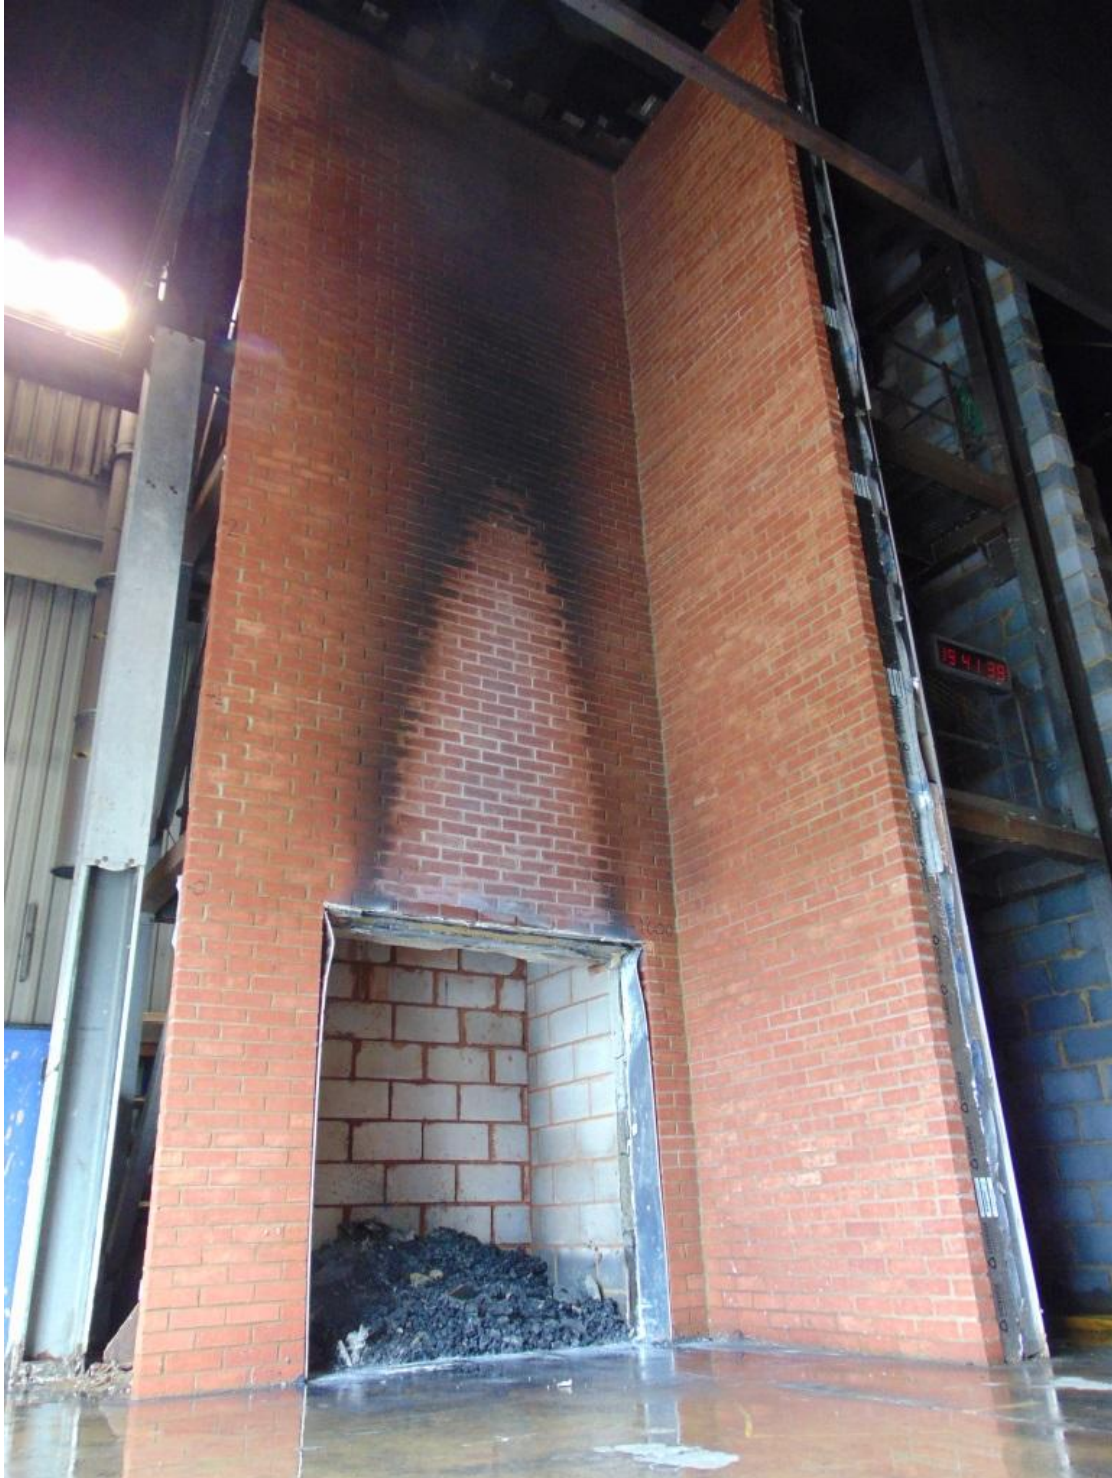
There was discolouration from the top of the combustion chamber to the top of the main wall tapering up from approximately 1900mm to 1500mm-wide. See *Figure 21*.

Figure 21. Full-height photograph of cladding system after test.

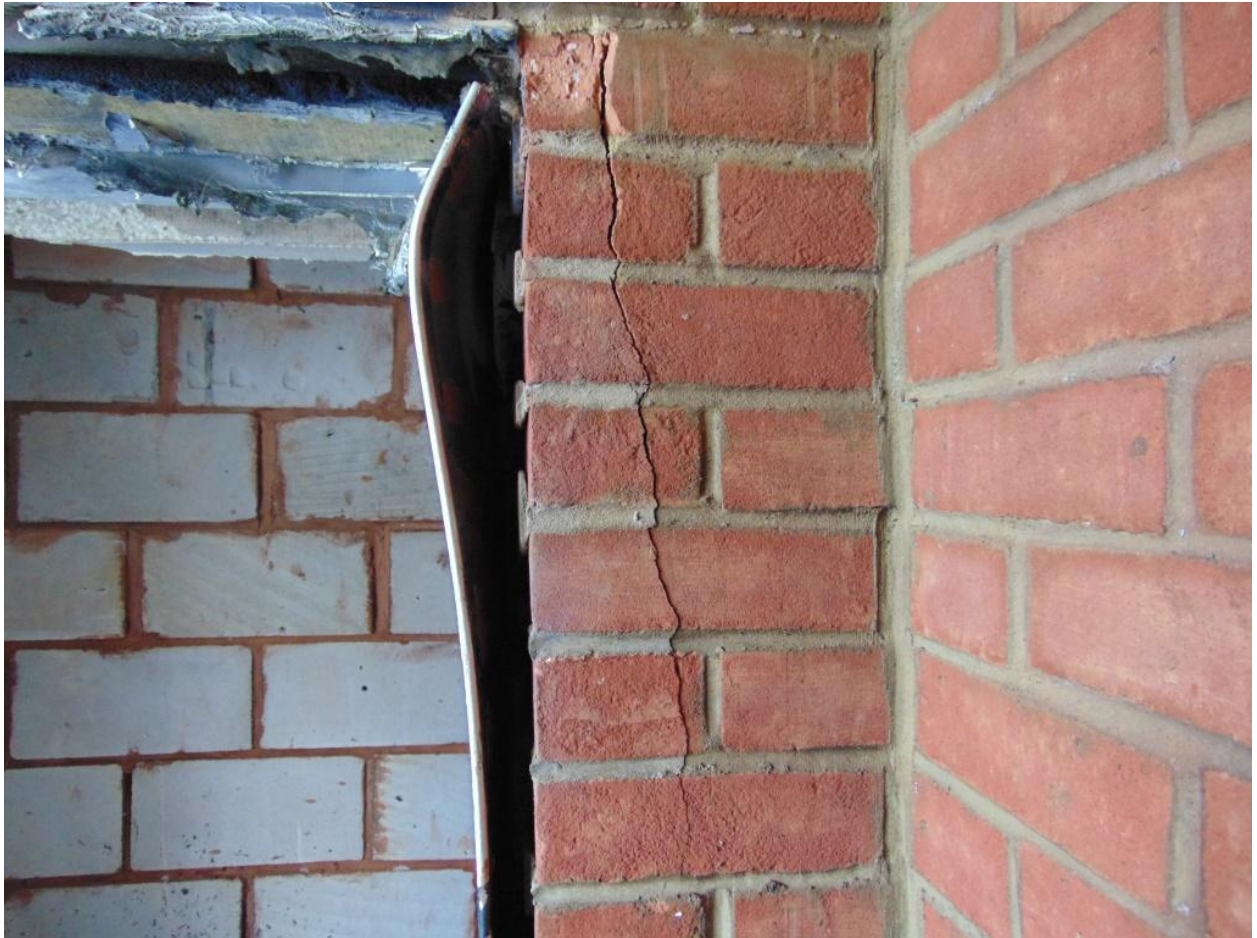
There was cracking in the brickwork and mortar surrounding the combustion chamber. There was a 700mm-long vertical crack in the brickwork adjacent to the inside edge of the combustion chamber. See *Figure 22*. There was minor cracking along the mortar from each corner of the combustion chamber joining at approximately 1m above the centre line of the combustion chamber. See *Figure 23*. There were vertical hairline cracks in the bricks from approximately 1-1.4m above the top of the combustion chamber. See *Figure 24*.

Figure 22. Cracking local to inside edge of combustion chamber opening.

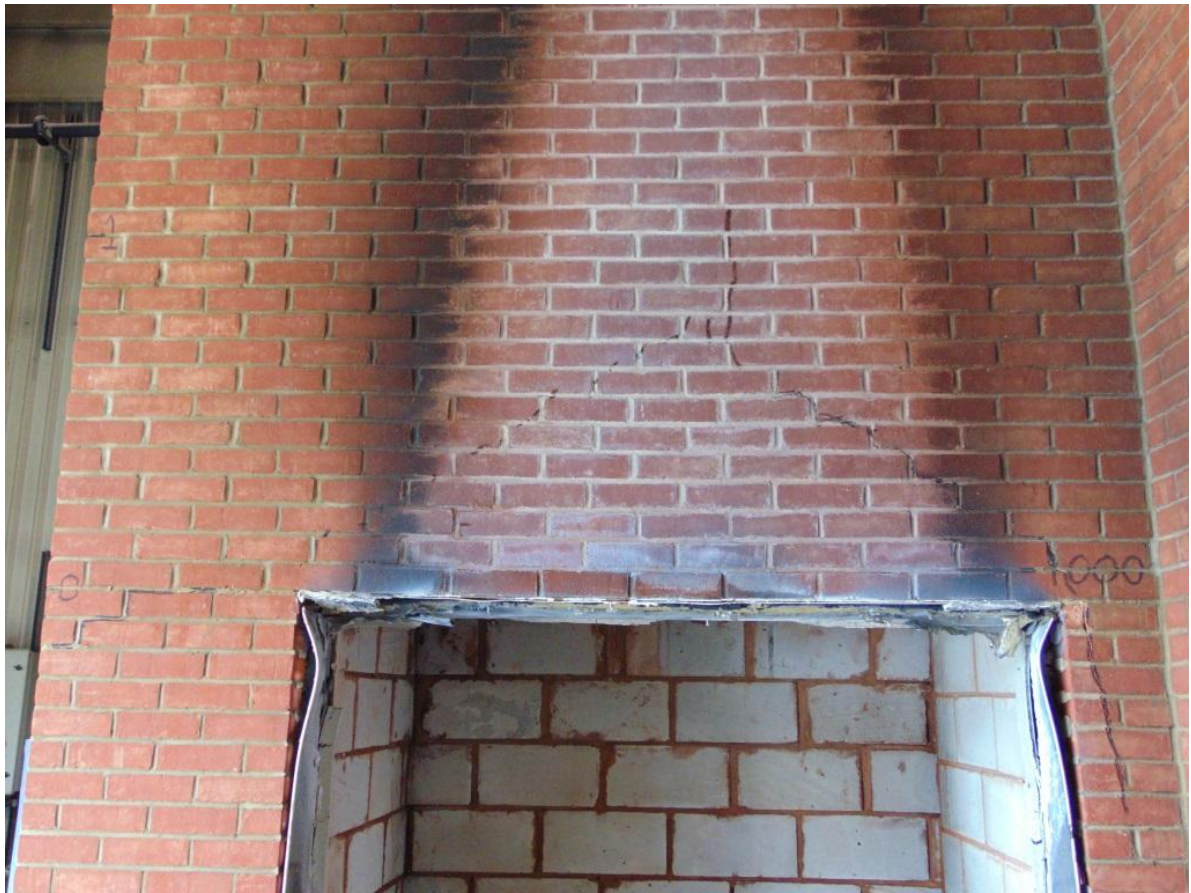
Figure 23. Cracking in brick façade.

Note: crack pattern highlighted using marker pen.

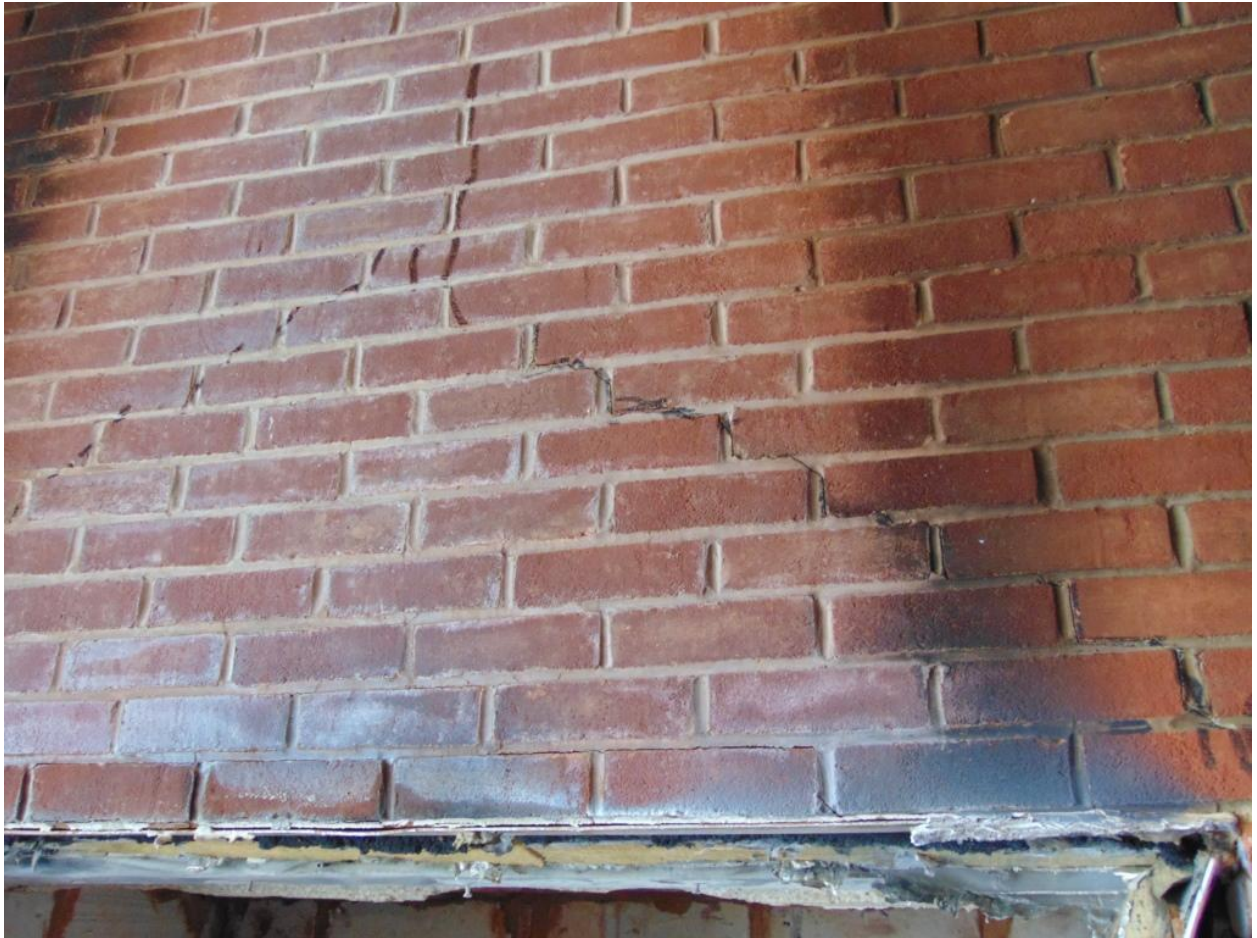
Figure 24. Cracking in brick façade above combustion chamber.

Note: crack pattern highlighted using marker pen.

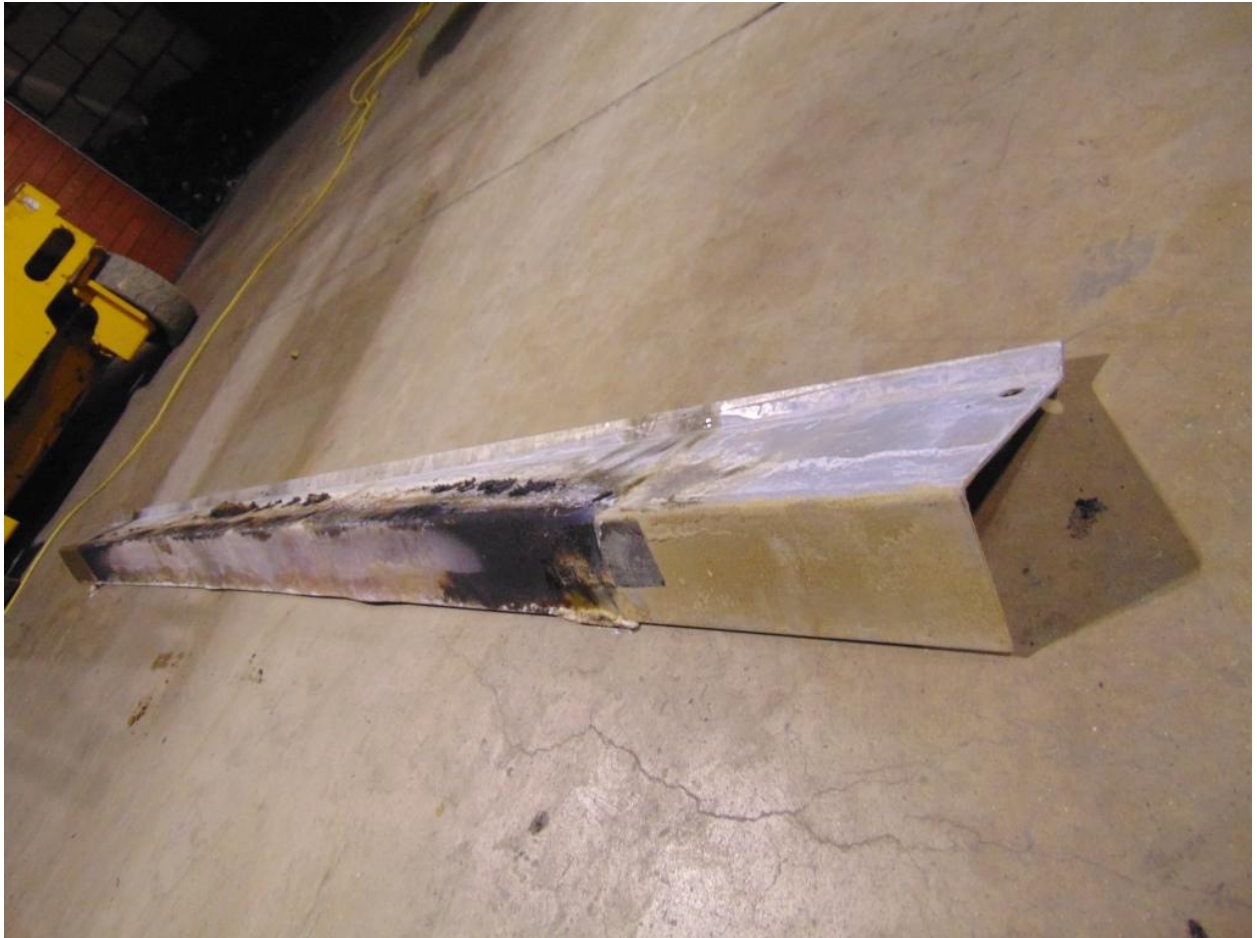
Discolouration across full-width with minor distortion. See *Figure 25*.

Figure 25. Photograph of steel lintel after test.

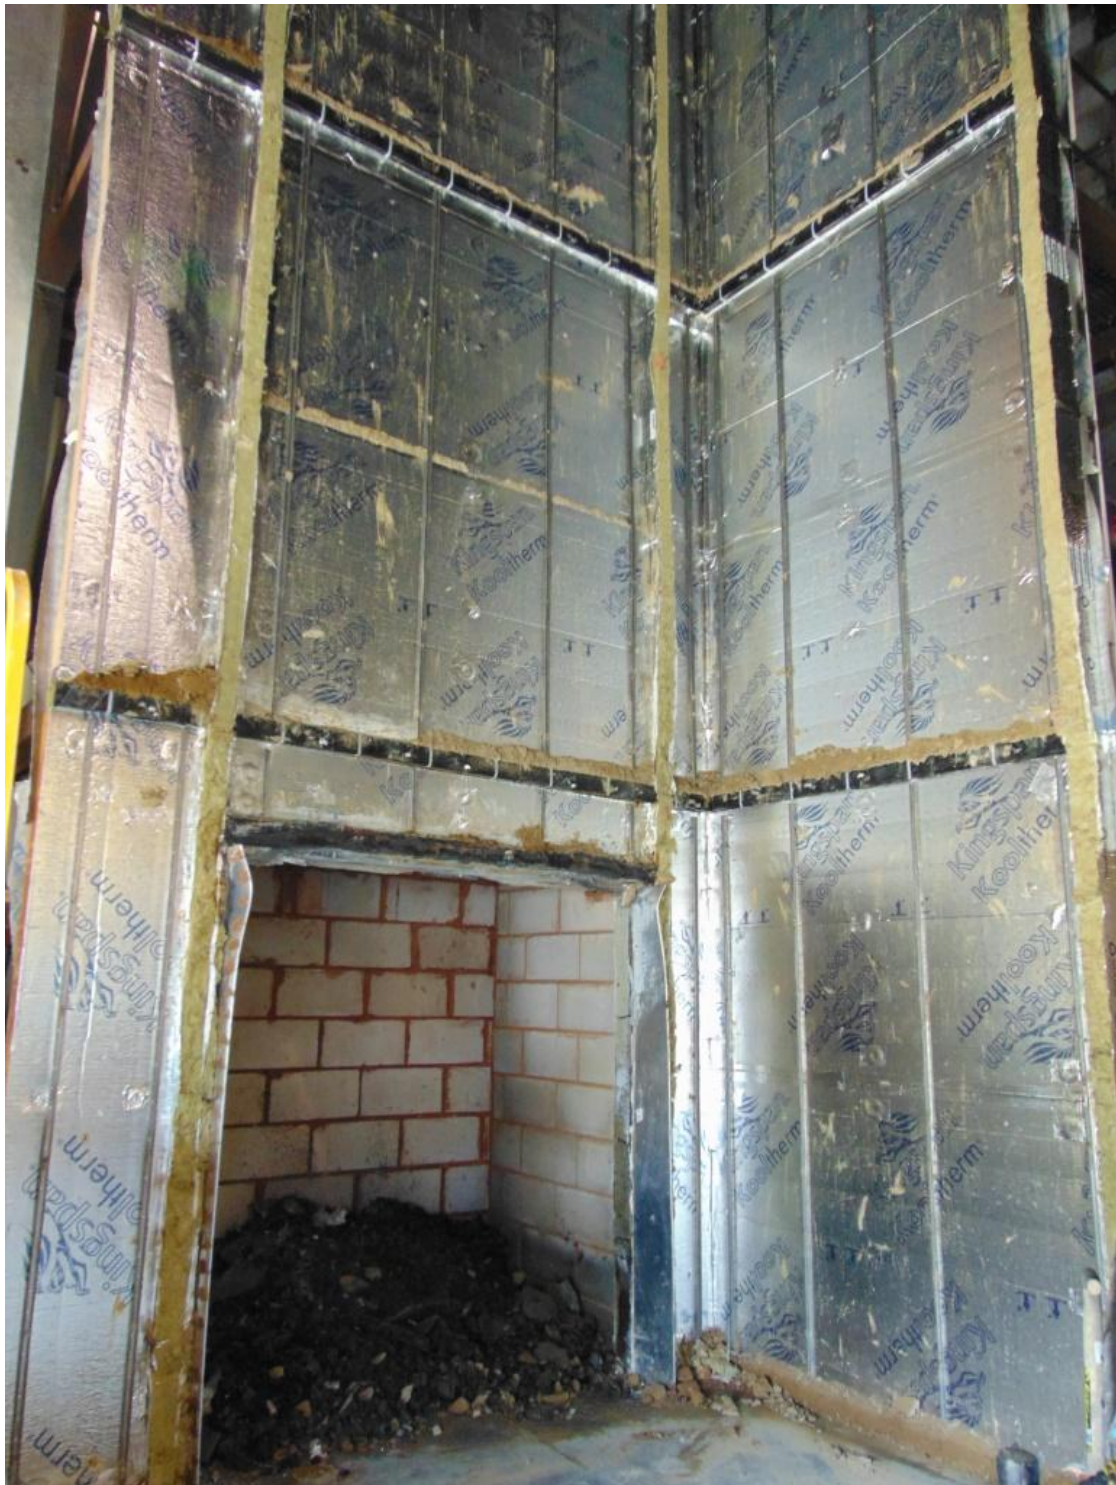
Insulation remained intact and in place with localised areas of discolouration to surface of outer foil immediately above the combustion chamber opening. See *Figure 26*.

Figure 26. Photograph of insulation from ground to a height of third row horizontal cavity barrier.

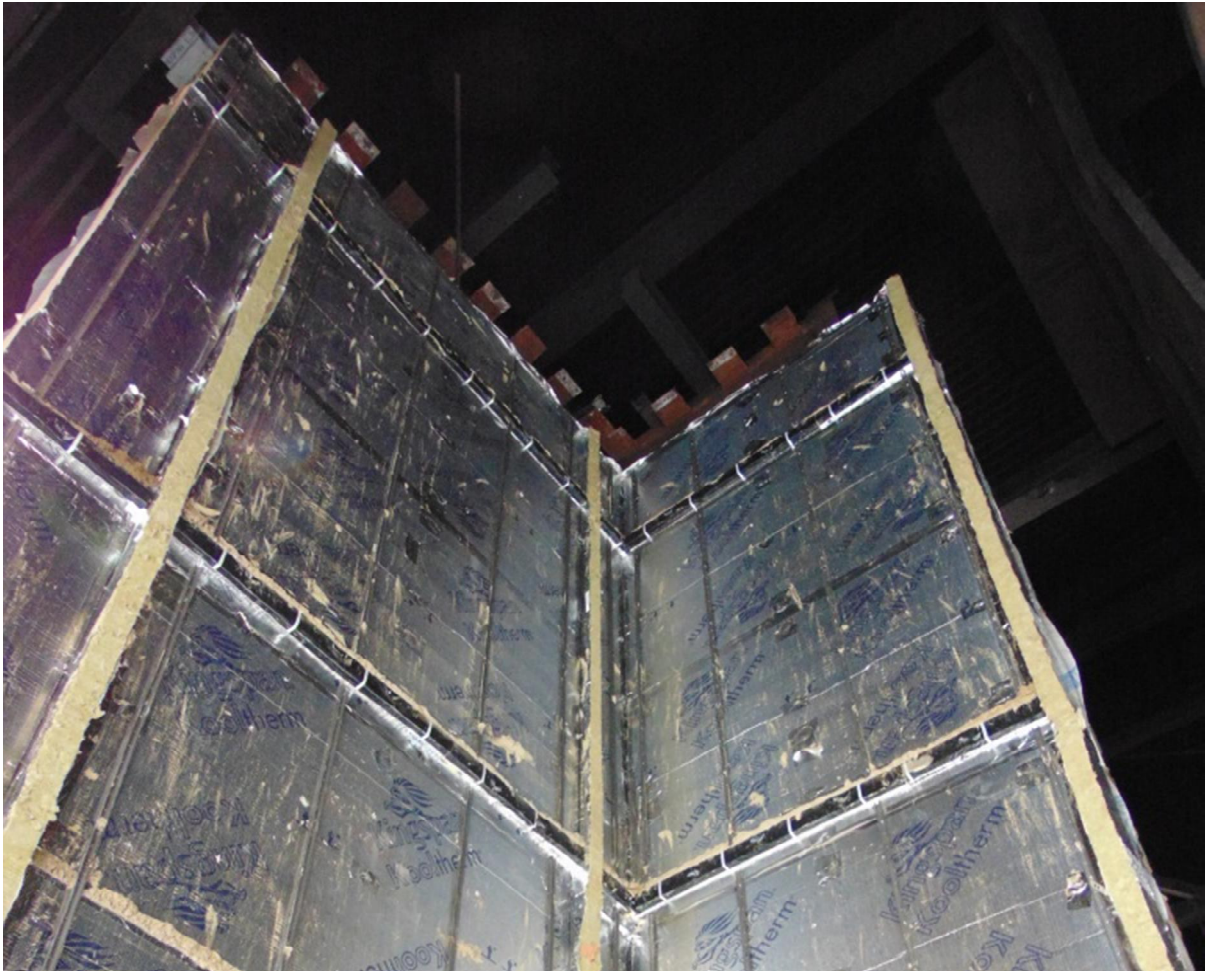
Figure 27. Photograph of insulation from a height of third row horizontal cavity barrier to top of cladding system.

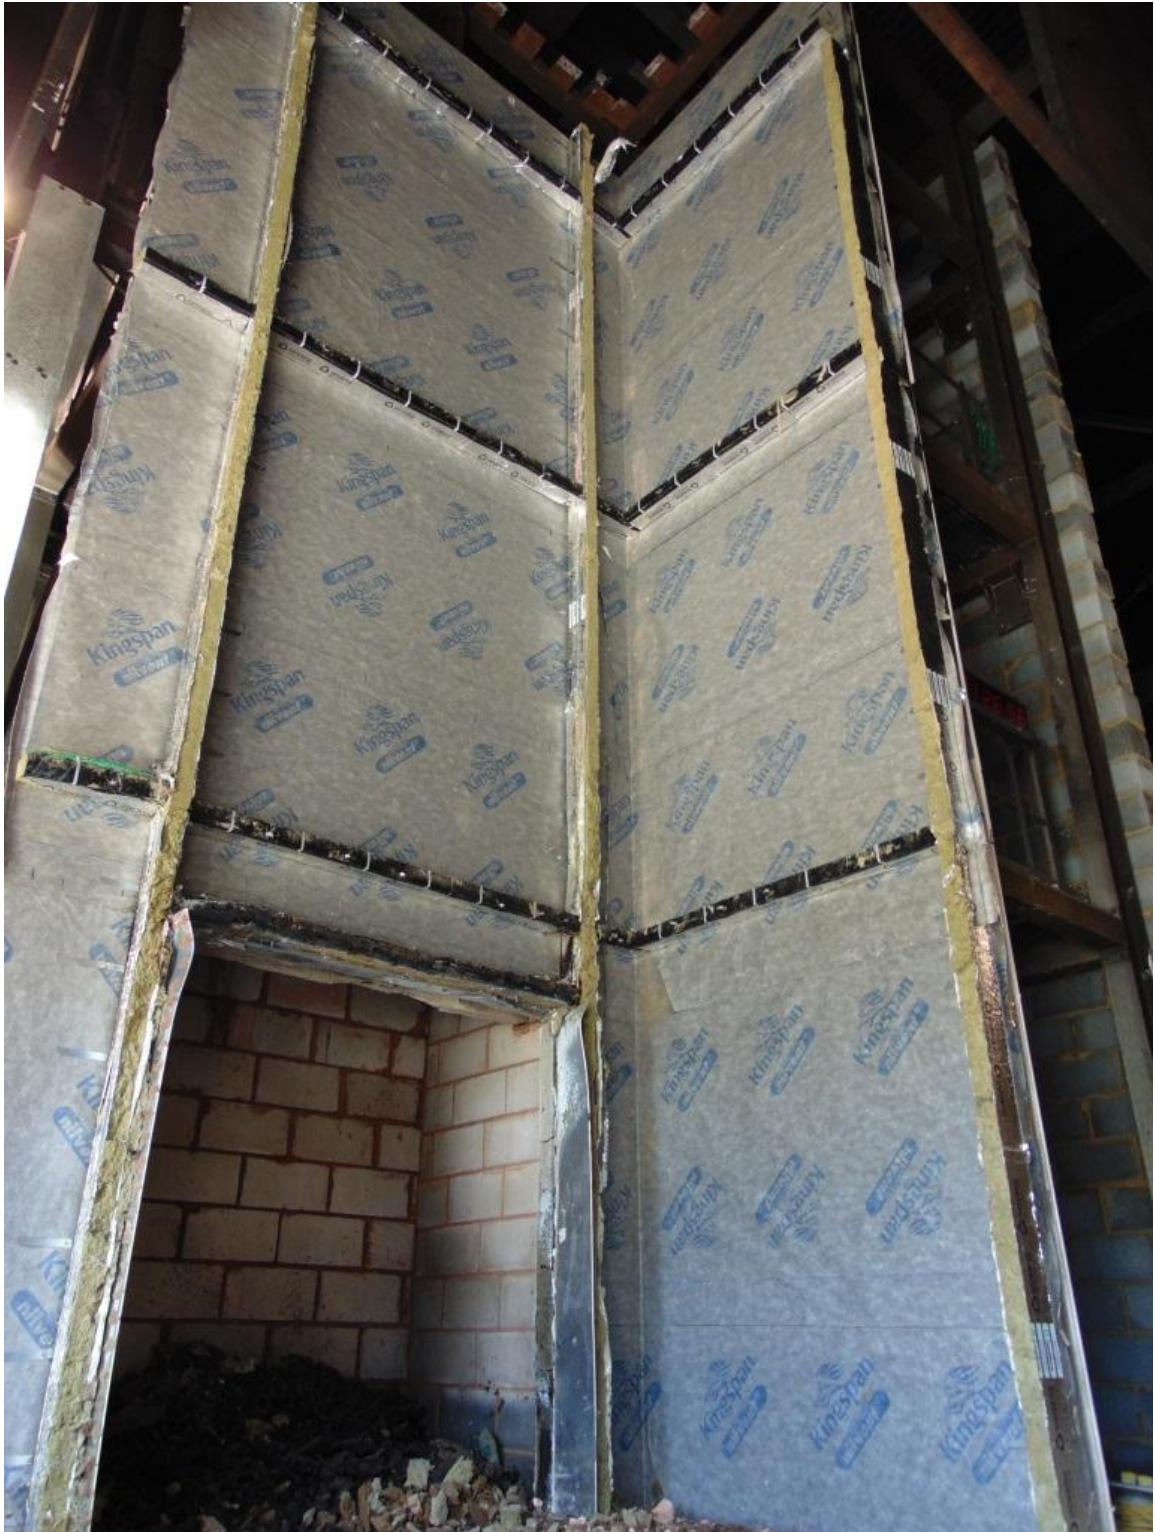
All horizontal cavity barriers remained intact and in place. Evidence of intumescent expansion was observed on the first and second rows. See *Figure 28*.

All vertical cavity barriers remained intact and in place. There were localised areas of discolouration on the main wall vertical cavity barriers from the ground to the height of the first row horizontal cavity barrier. See *Figure 28*.

Figure 28. Photograph of horizontal and vertical barriers after test.

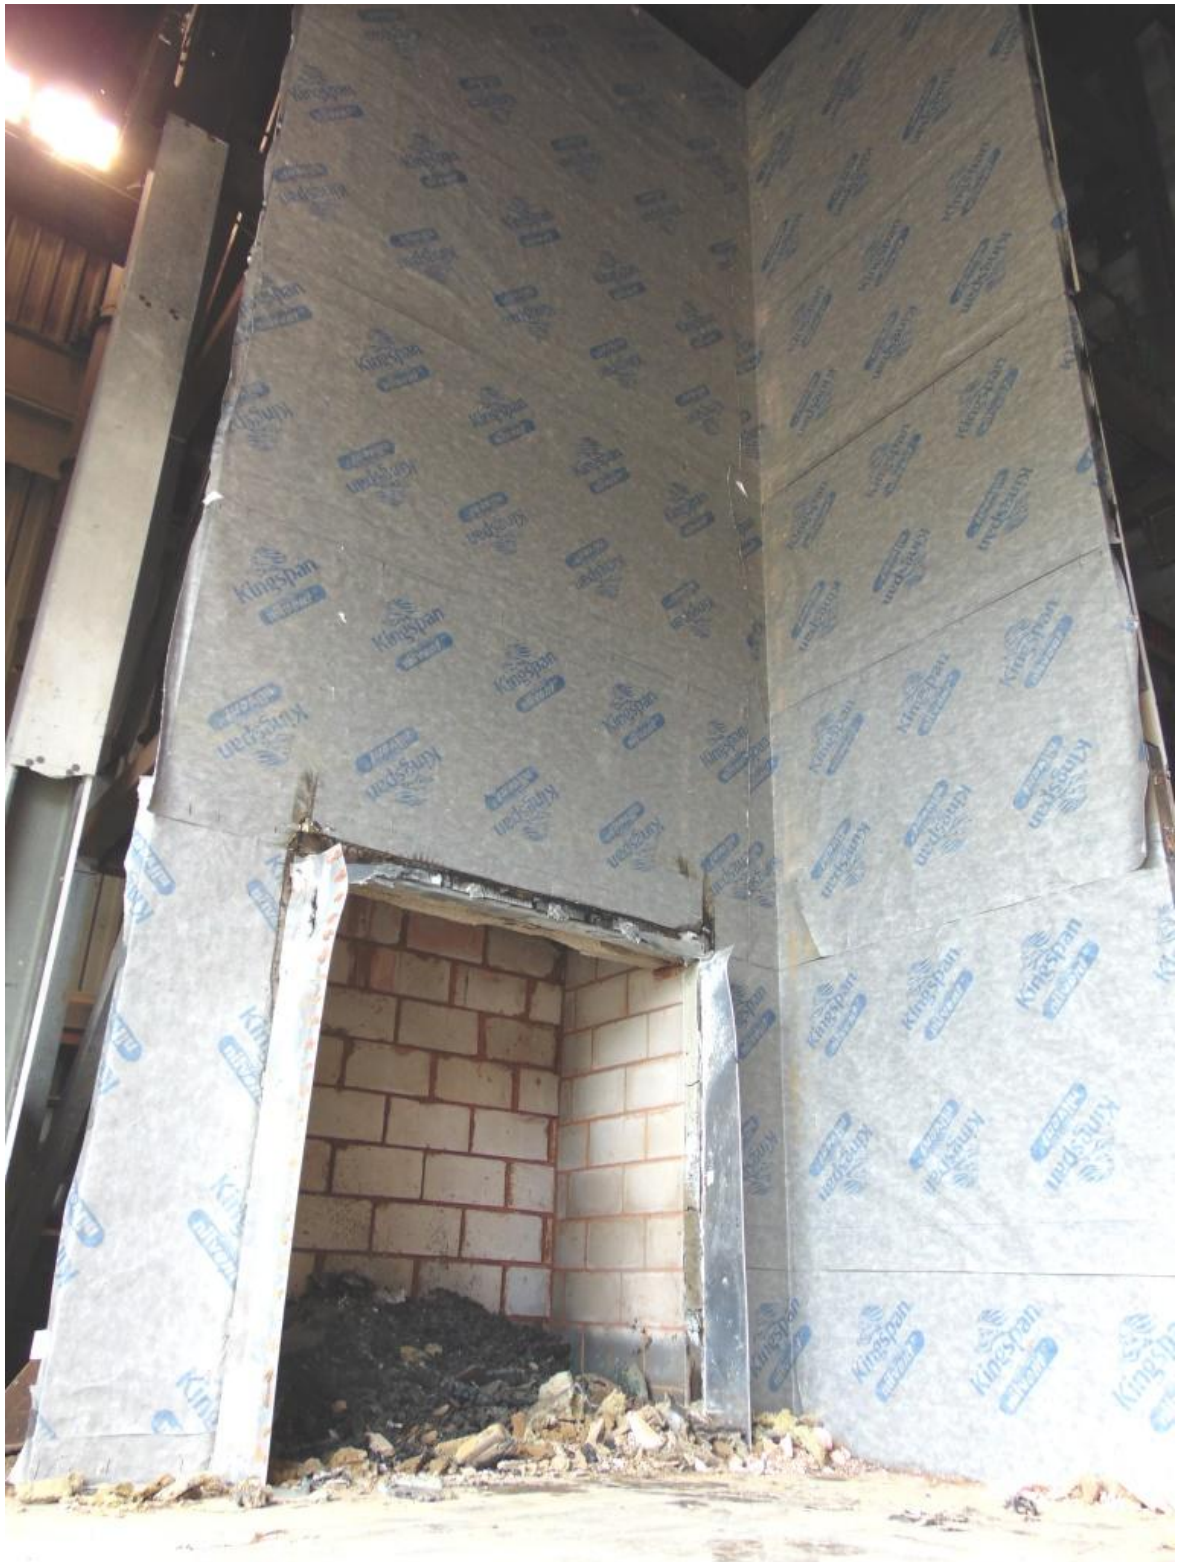
The top edge was more than 90% consumed. See *Figure 29*.

The breather membrane remained intact and in place with localised areas of discolouration around the combustion chamber opening. See *Figure 29*.

Figure 29. Photograph of breather membrane after test.

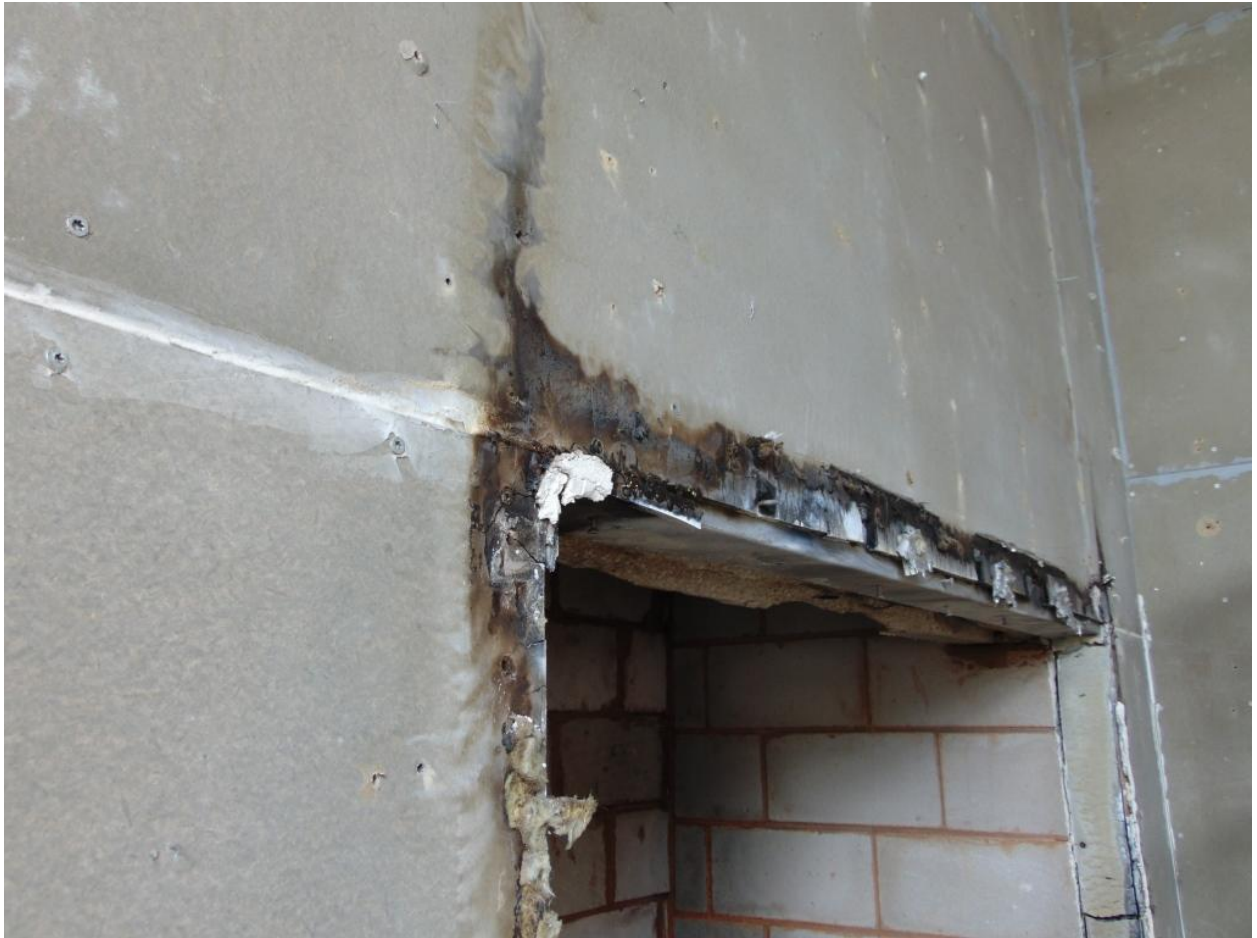
The cement particle board remained intact and in place with localised areas of discolouration around the combustion chamber opening. See *Figure 30*.

Figure 30. Cement particle board immediately surrounding combustion chamber.

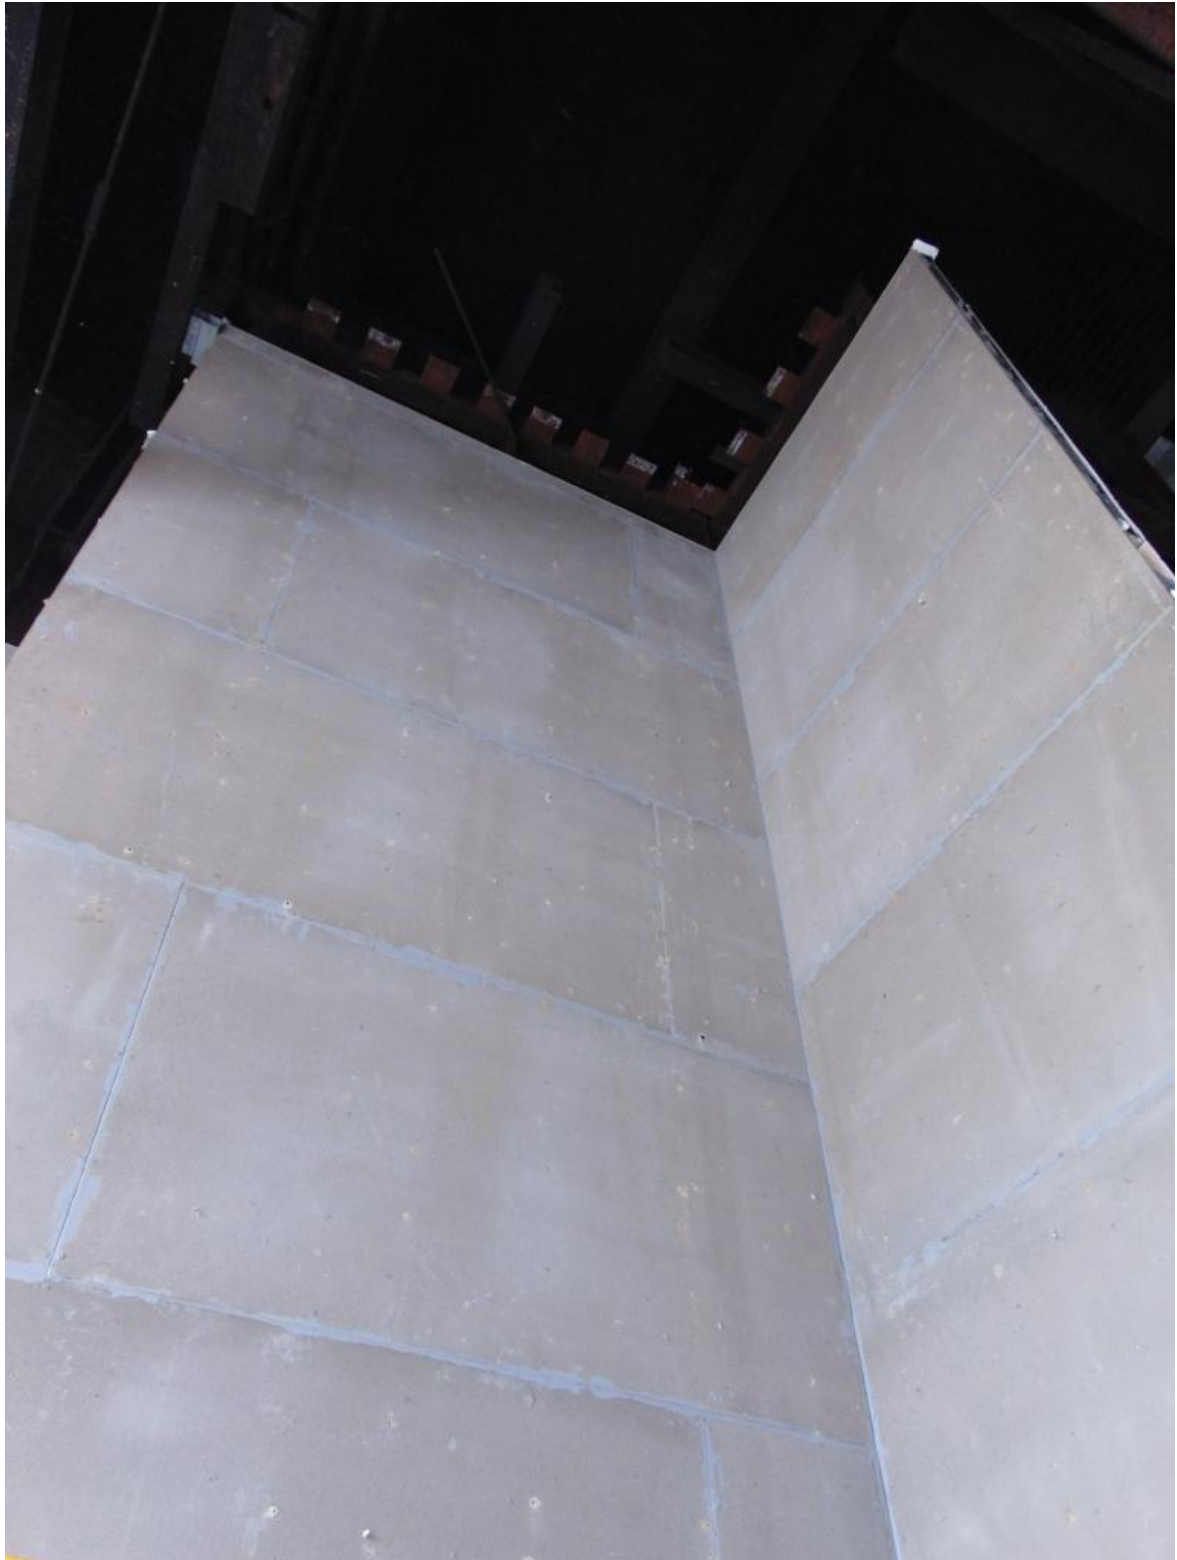
Figure 31. Cement particle board from a height of approximately 2000mm above the top of the combustion chamber to the top of the cladding system.

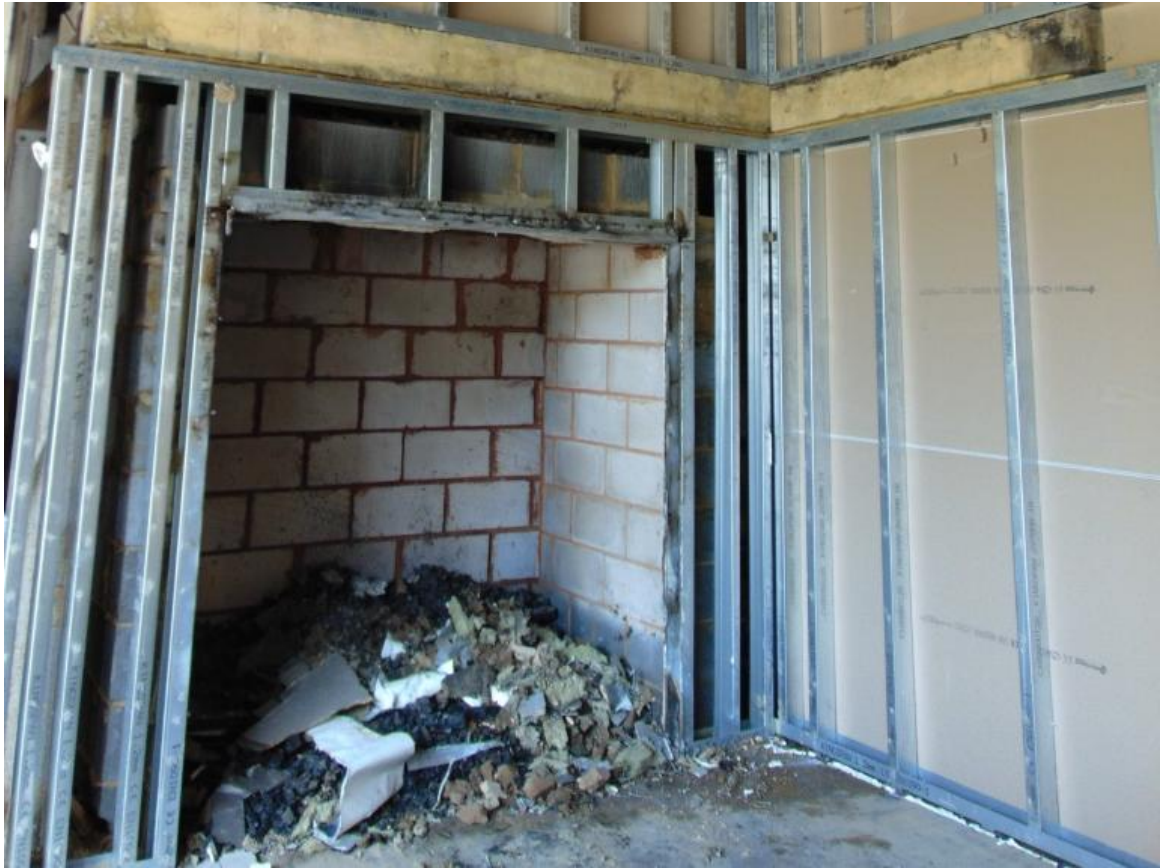
The lightweight steel framework partition remained intact and in place with localised areas of discolouration around the combustion chamber opening. See *Figure 32*.

Figure 32. Lightweight steel framework partition from ground to first row floor slabs.

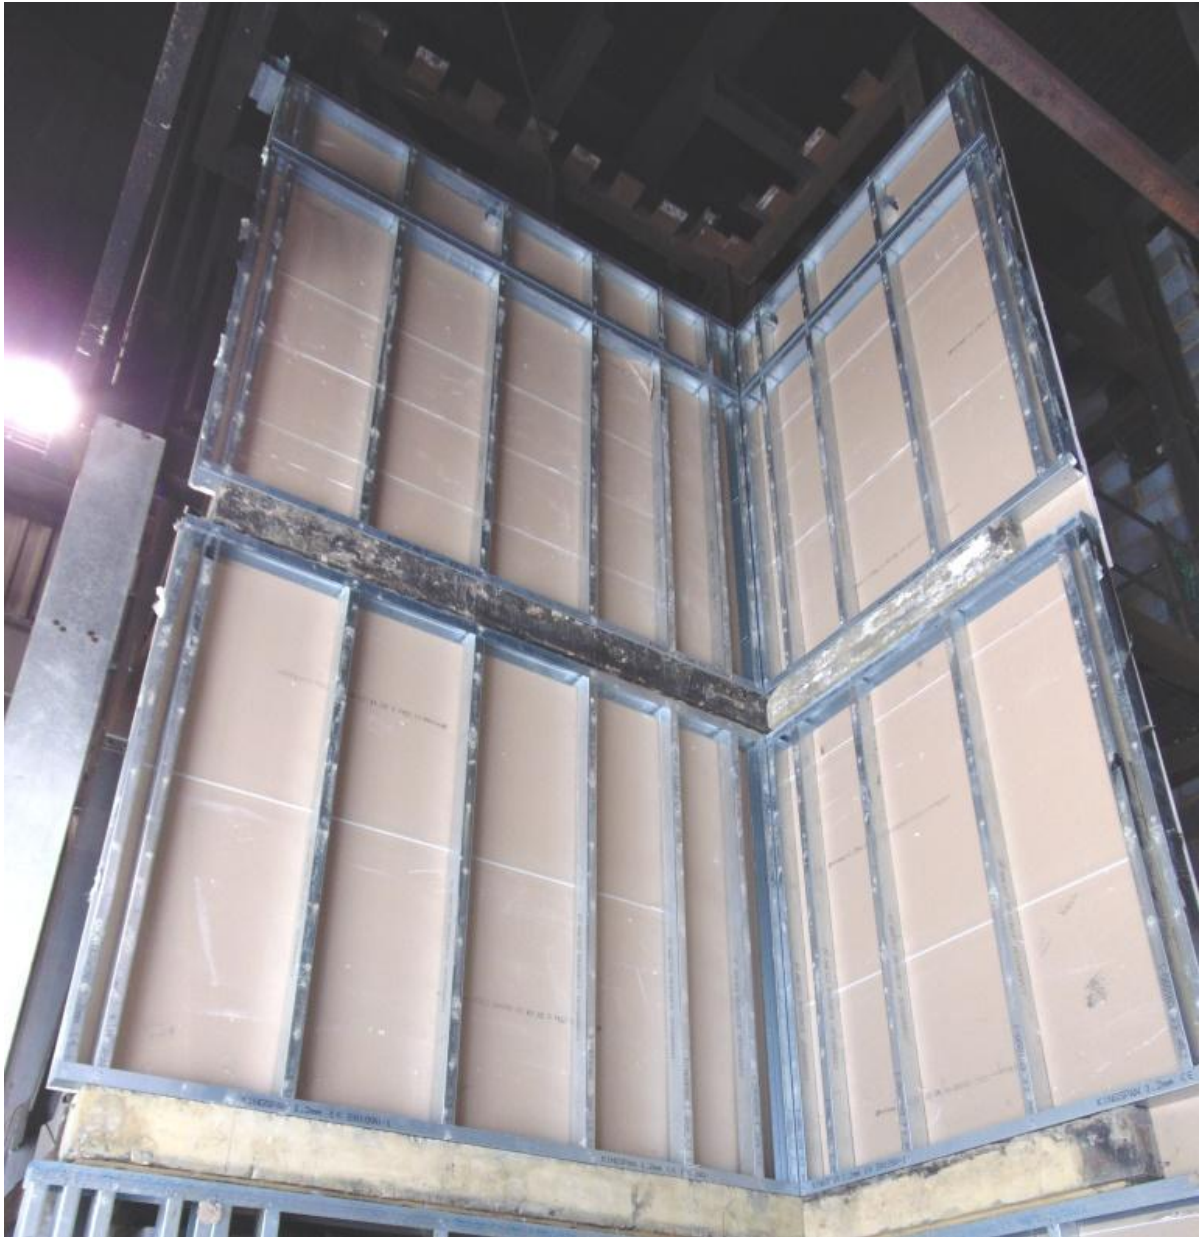
Figure 33. Lightweight steel framework partition from first row floor slabs to top of cladding system.
