## **FIRE TEST REPORT EUI-21-B-000335-A – Revision 1**

According to BS EN 1363-1:2020 and BS EN 1364-1:2015

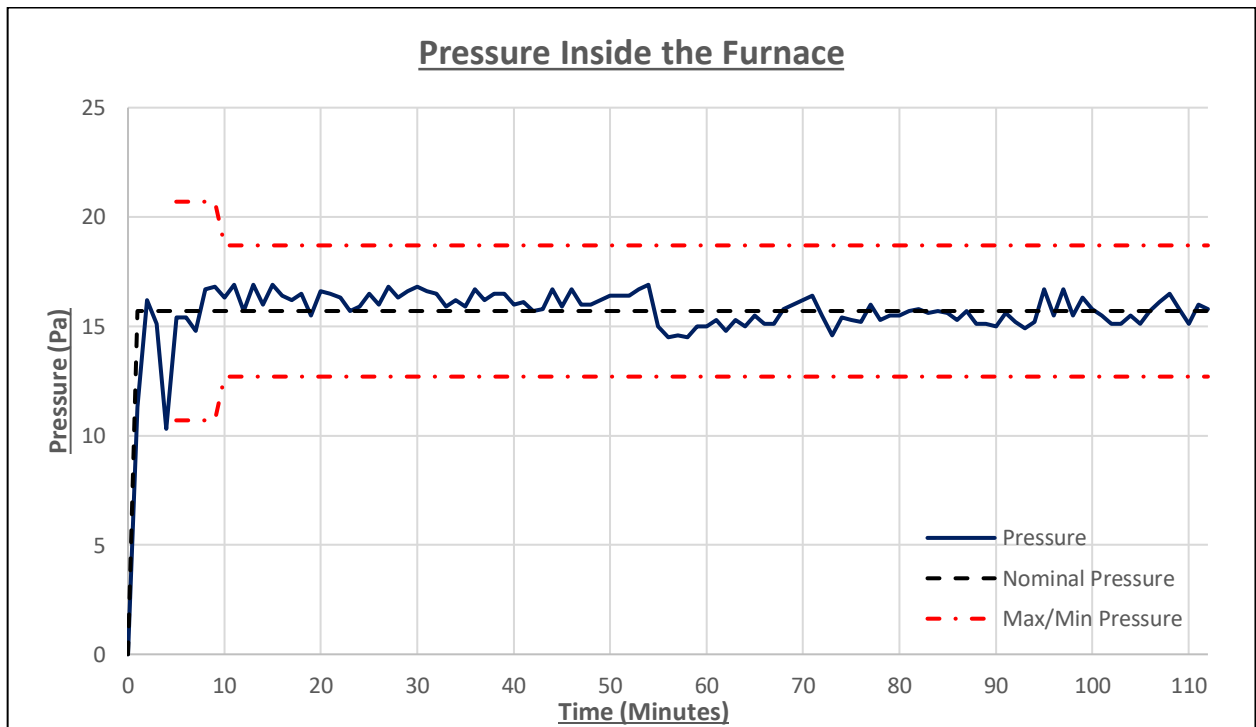
Chart 4 - Pressure conditions inside the furnace

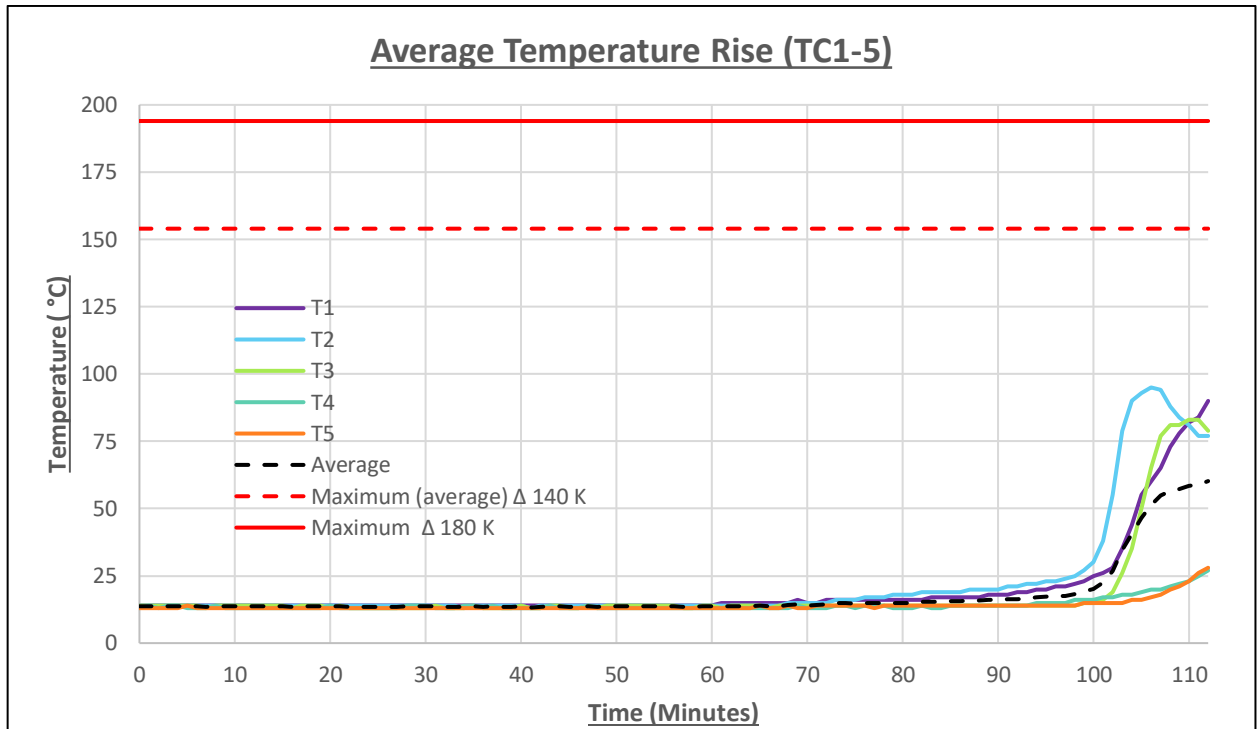
Chart 5 - Average temperature rise on unexposed surface of the specimen

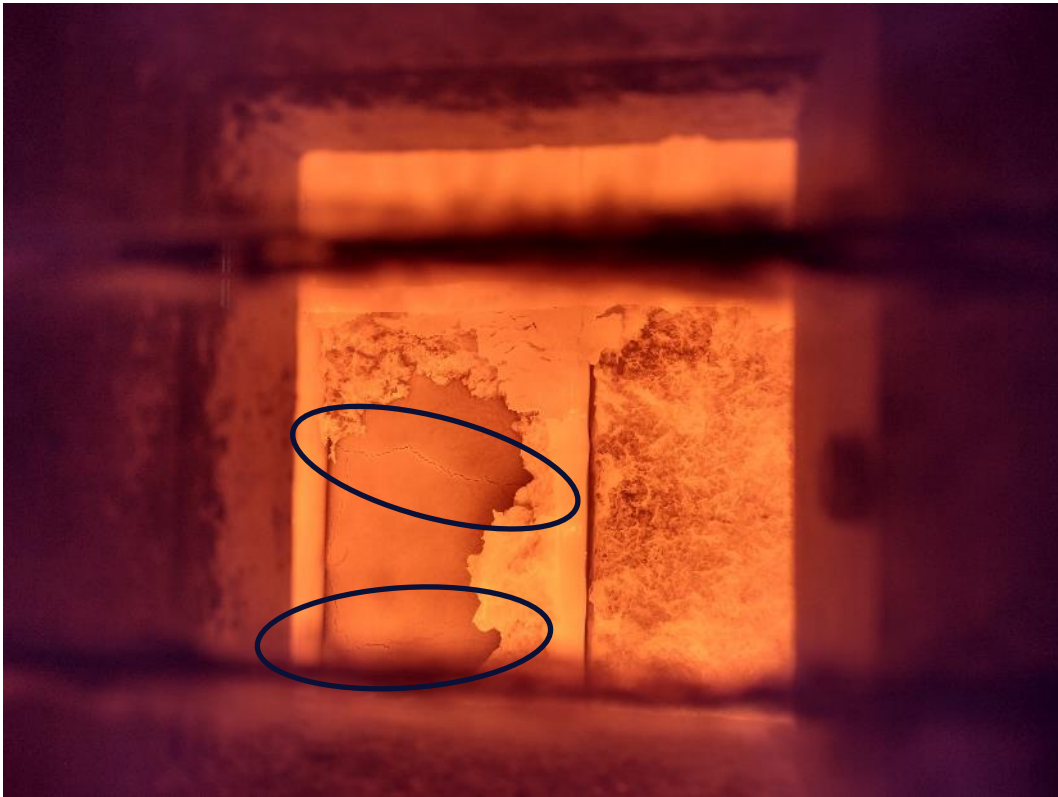
Photograph 11 – Detail of the exposed side of the sample during the test. Note the cracks on the sheathing board (highlighted). Photograph taken during minute 105.

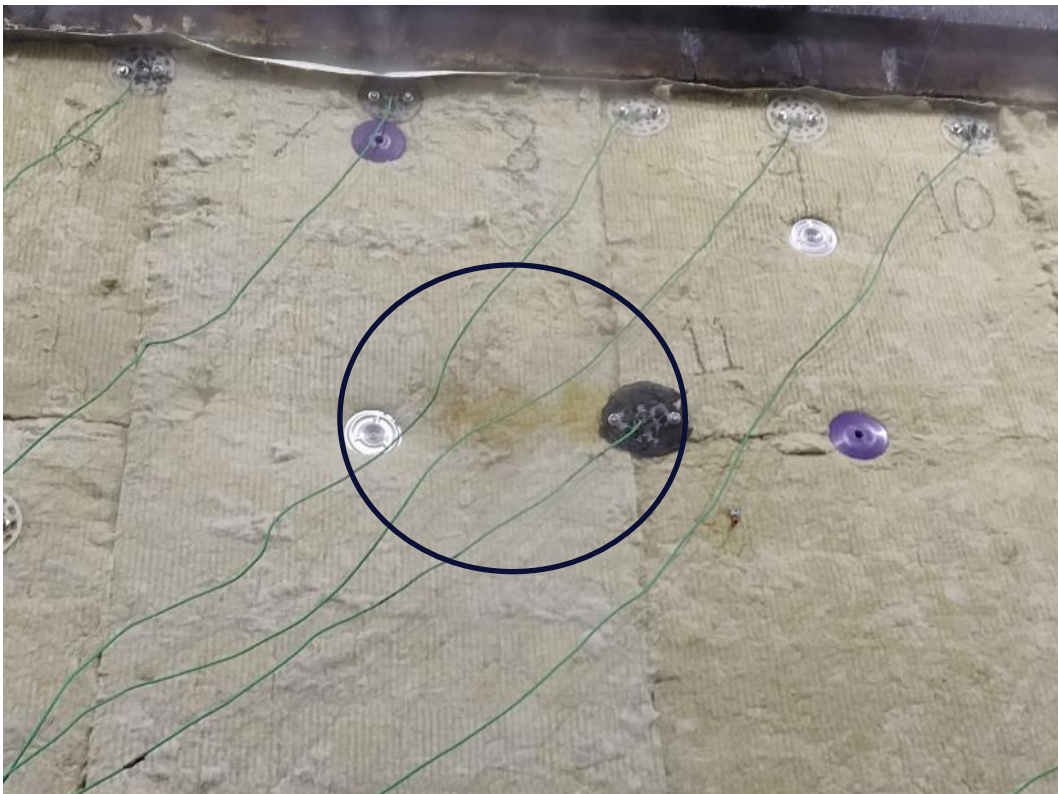
Photograph 12 – Detail of the unexposed side of the sample. Note discolouration of the surface of the rainscreen slabs. Photograph taken during minute 110.
