REACTION TO FIRE TEST REPORT No EUI - 18 - FF - 000131

Test Standard: **BS 8414-2:2015+A1:2017** – Fire performance of external cladding systems
Part 2: Test method for non-loadbearing external cladding systems fixed to and supported by a structural steel frame

Product referenced: Façade system incorporating 90 mm Kooltherm K15 Rainscreen and 90 mm K15 Black Kingspan Insulation, cavity and Branco Michaela Granite stone cladding panels

Test sponsor : KINGSPAN INSULATION LTD
Bree Industrial Estate, Castleblayney
Co Monaghan
AK75 X966, Ireland

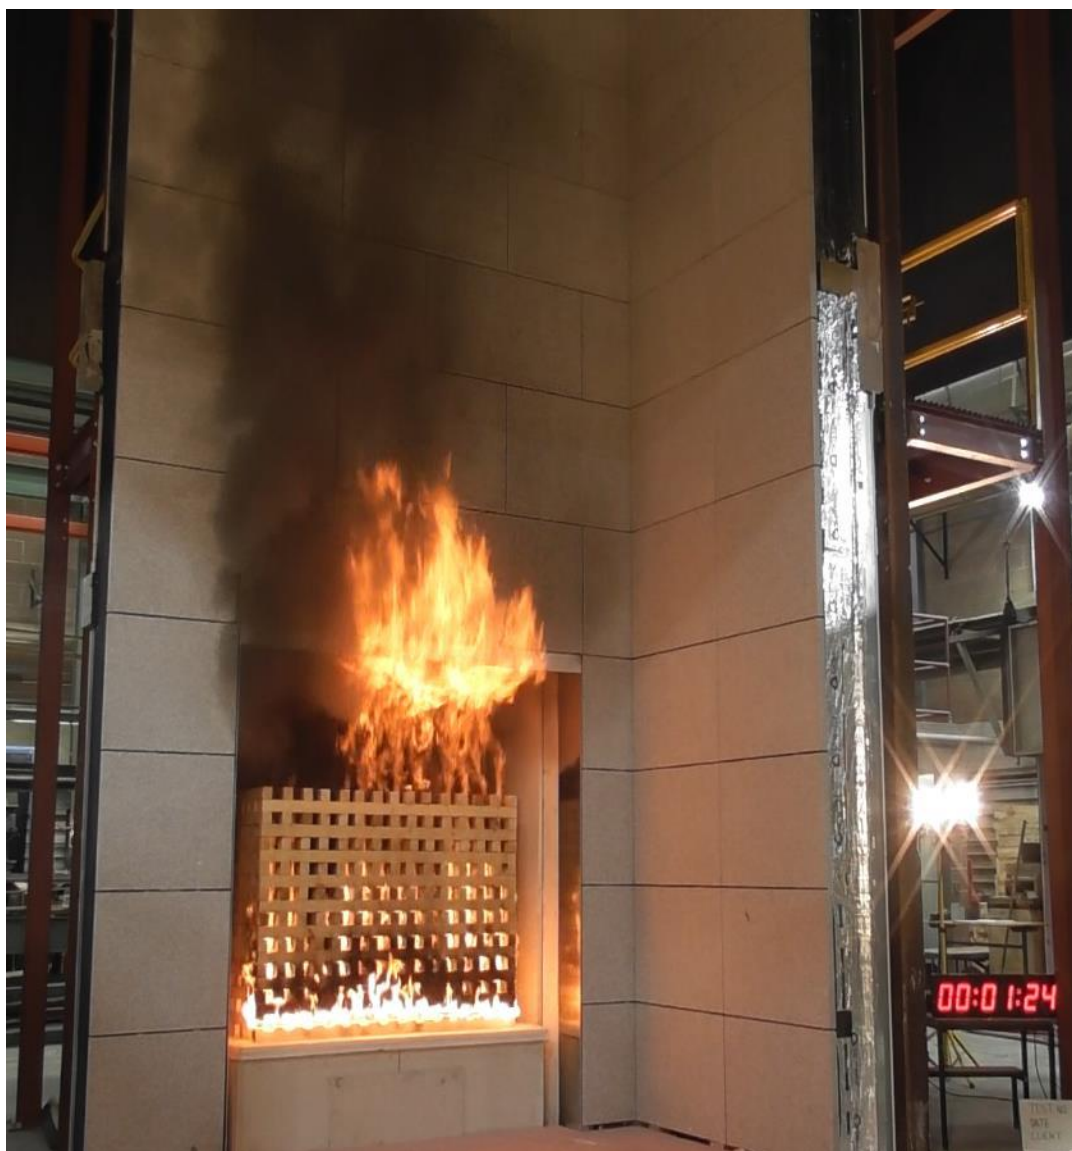
Figure 4.11. Cladding system during the fire test at start time t_s (01 min 24 sec after ignition of crib).

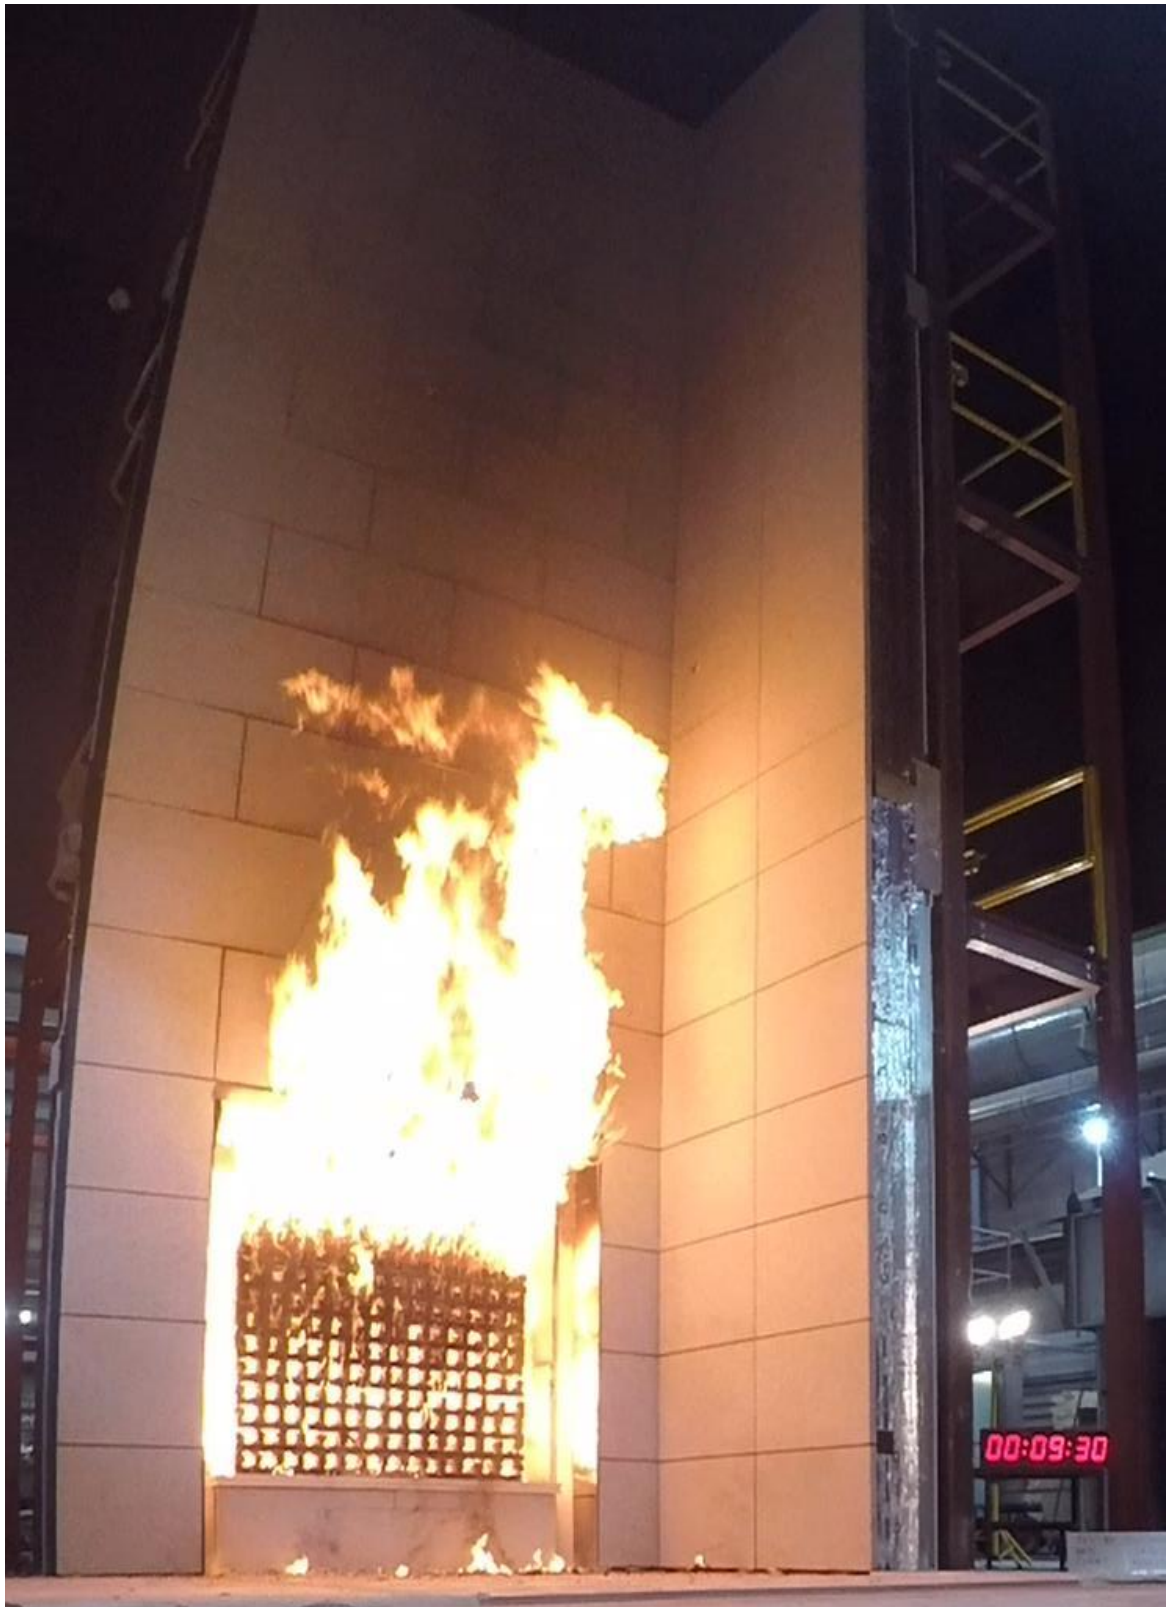
07:00	05:36	Flames constantly located at Level 1
07:30	06:06	Pod-frame bended on top Crack visible on 2 nd row's stone panel at the left side of centreline above chamber

Figure 4.12. Cladding system during fire test (09 min 30 sec after ignition of the crib).

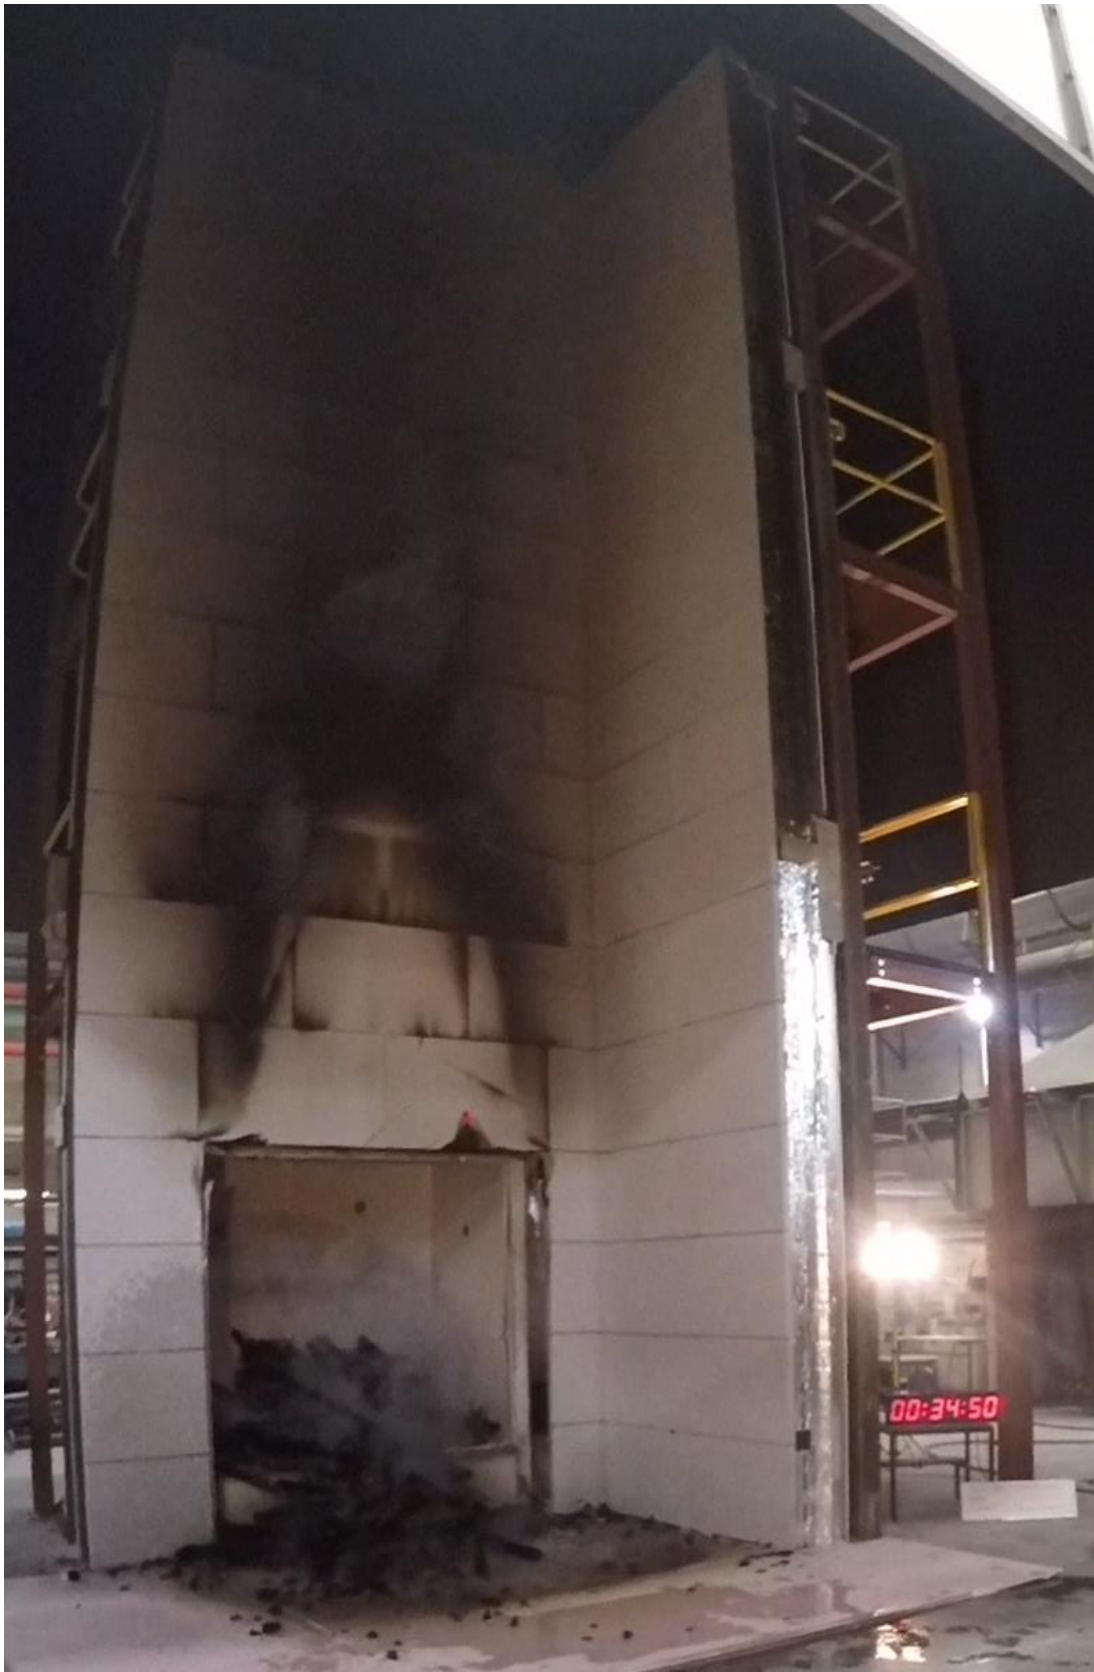
On the main face of the cladding system, all panels were in-place after testing. Some cracks were observed on three panels located just above the combustion chamber's opening. Discolouration was observed up to a height of 3000 mm.

Figure 4.13. Cladding system after fire extinguishment (34 min 50 sec after ignition of the crib).

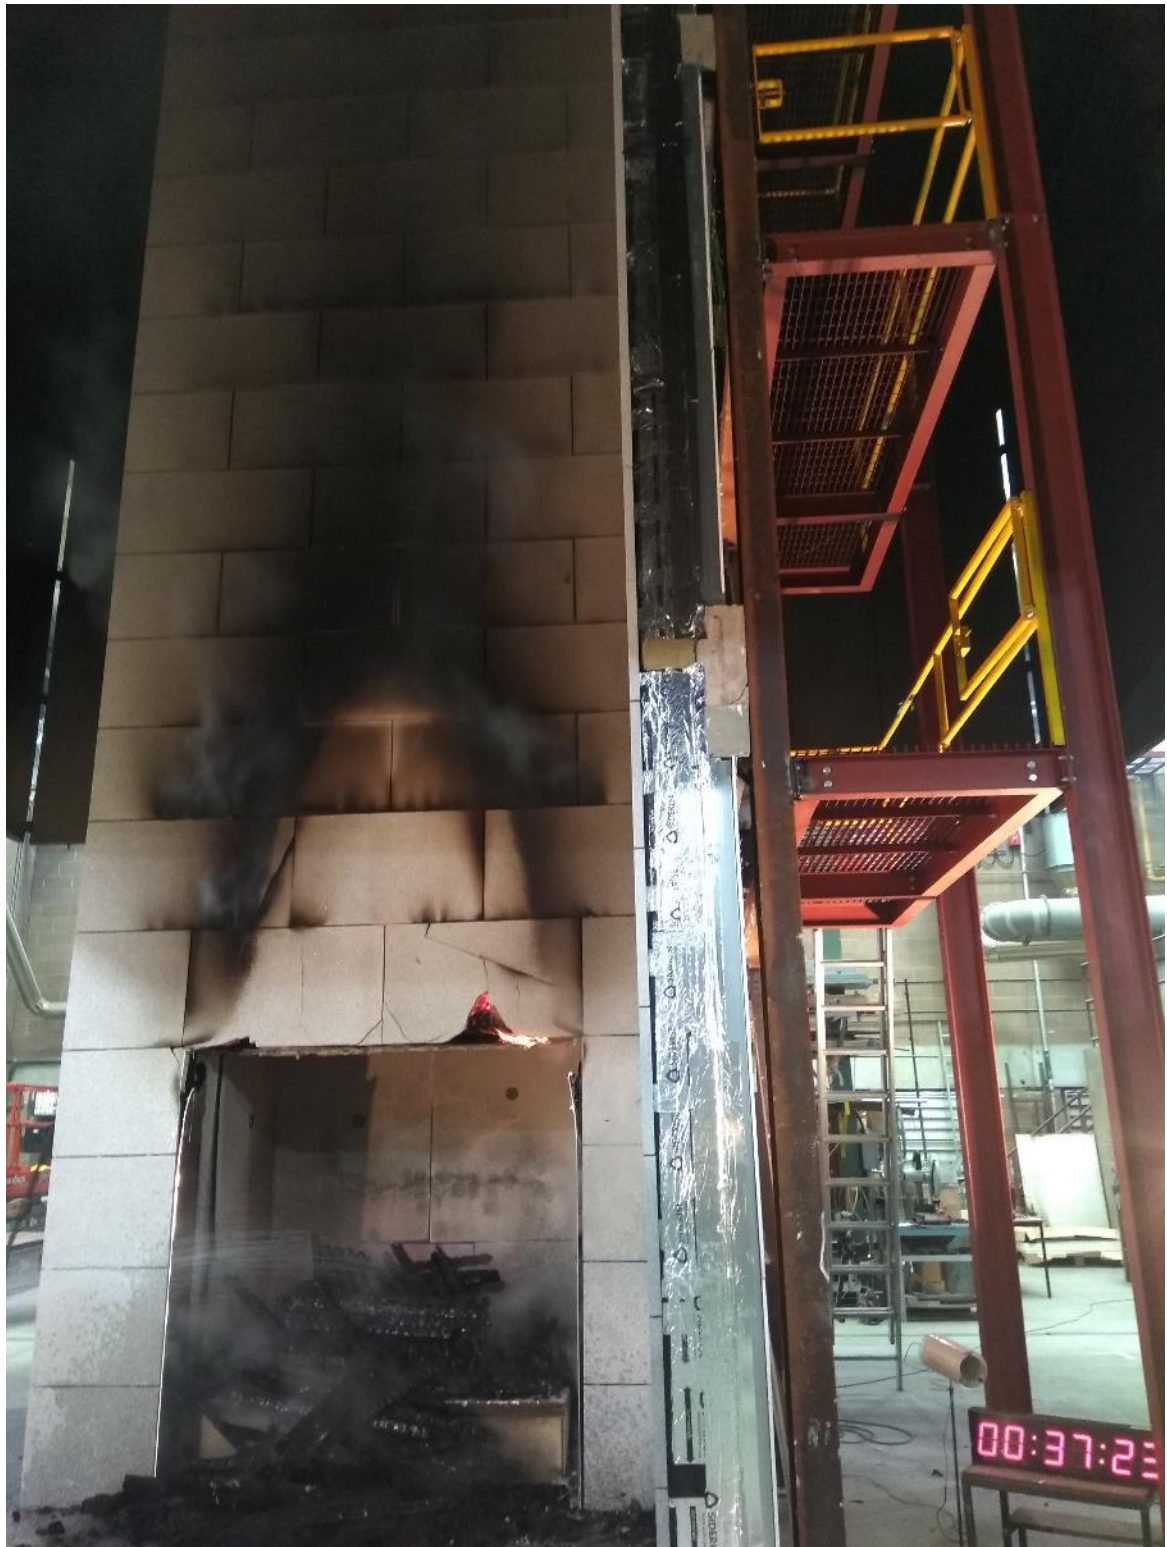
Figure 4.14. Cladding system after fire extinguishment (37 min 23 sec after ignition of the crib).
