BRE Global Test Report

BS 8414-1:2015 + A1:2017 test on a ventilated façade system with Kingspan Kooltherm K15 insulation and Alpolic/fr panels.

Prepared for: Kingspan Insulation Limited

Report Number: P107017-1000 Issue: 1

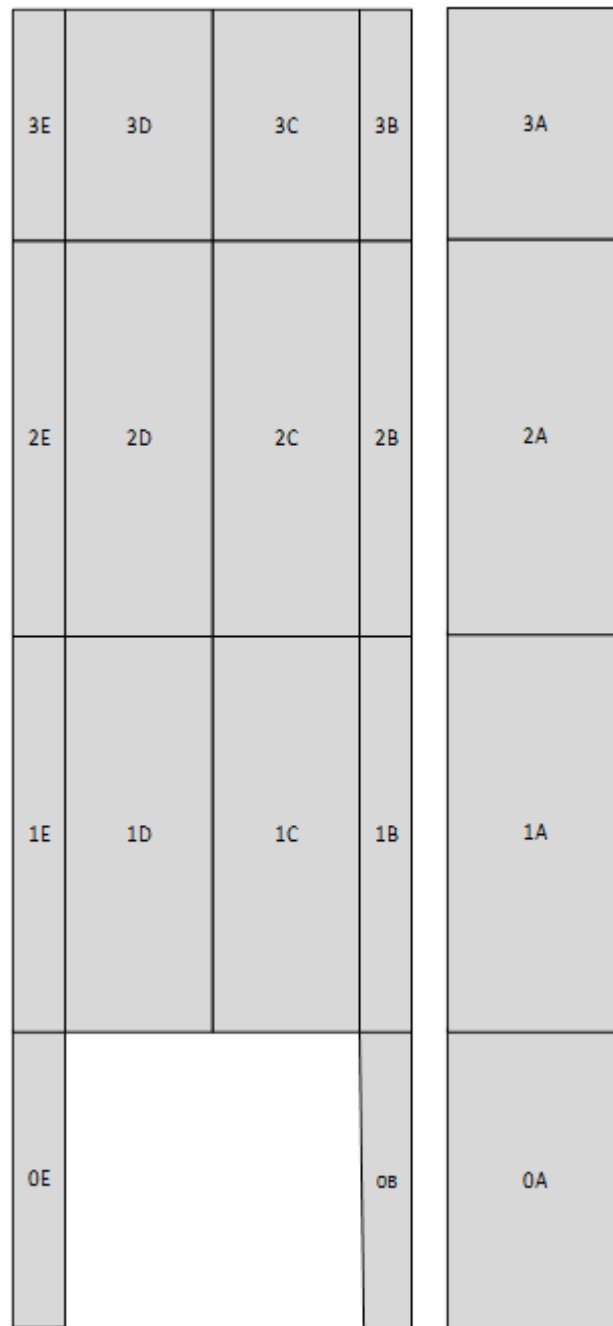
Figure 2. Layout of panels and numbering system used for reporting. Not to scale.

Row 0 – Panel 0A was significantly distorted and discoloured (approximately 70% panel coating removed, 25% dark discolouration). On panel 0B there was a small area (approximately 300mmx150mm) of dark discolouration in the top left hand corner of the panel (adjacent to the combustion chamber). Panel 0E was not visibly damaged.

Row 2 – Panel 2A was distorted and discoloured (<10% panel coating removed, 50% dark discolouration). Panel 2B was distorted and discoloured at the base of the panel (small areas of panel coating removed, 40% dark discolouration). Panels 2C and 2D were damaged across the full panel surface: panel consumed (55% and 40% respectively), distorted and discoloured across the remaining panel. An area approximately 1500mm x 400mm of panel 2D remained loosely attached with consumption of the panel core. Small holes approximately 50mm x 300mm and 50mm x 50mm were observed in panel 2D approximately 3750mm above combustion chamber. Panel 2E was distorted and slightly discoloured.

Row 3 – Panels 3A&3B had minor distortion. Panel 3C was distorted and discoloured (small areas of panel coating removed, approximately 30% dark discolouration). Panel 3D was distorted and discoloured (small areas of panel coating removed, approximately 25% dark discolouration). Panel 3E had minimal visible damage.

- 2D. Damage to the insulation was similar to that observed beneath panel 2C, however; a band of significant insulation consumption and detachment extended from approximately mid-height to approximately 300mm below the third cavity barrier. The blockwork was exposed in an approximately 300mm-width which would have been directly below the damaged edge of the remains of panel 2D.
- 2E. Insulation appeared to be undamaged.
- 3B. Insulation appeared to be undamaged.
- 3C&3D. Discolouration of the foil facing most pronounced along centre line of combustion chamber opening.
- 3E. Insulation appeared to be undamaged.

- 0A. The foil facing on the insulation remained intact.
- 1A. Blistering and slight discolouration of the foil facing up to mid-width adjacent to the main wall. Minimal damage from outside edge of wing wall to mid-width.
- 2A. Minor blistering and discolouration was observed in patches directly adjacent to the main wall
- 3A. Insulation appeared to be undamaged.
