Fire Performance Testing of an External Cladding System
BS 8414-2:2015 + A1:2017

Test Report

Prepared for : Kingspan Insulation Ltd.
Project : System Development
Report No. : DLR1547 Rev.0
Sample : 100mm Kingspan Kooltherm K15 with Dri-Design Aluminium Cassette

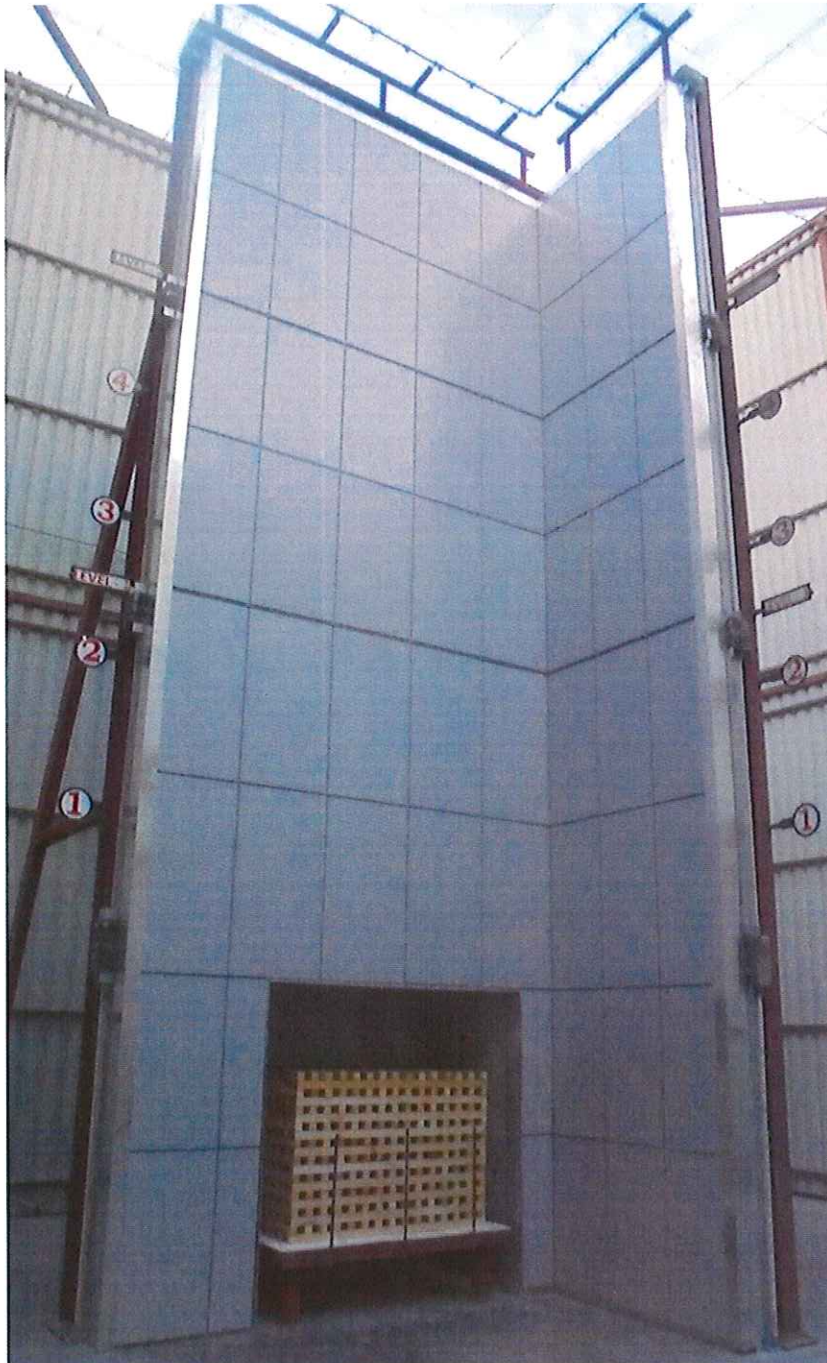
Figure 1 Photo DLP C2753J/2731 External View of the Test Sample

Photo DLP C2753J/2731 below shows an external view of the sample.

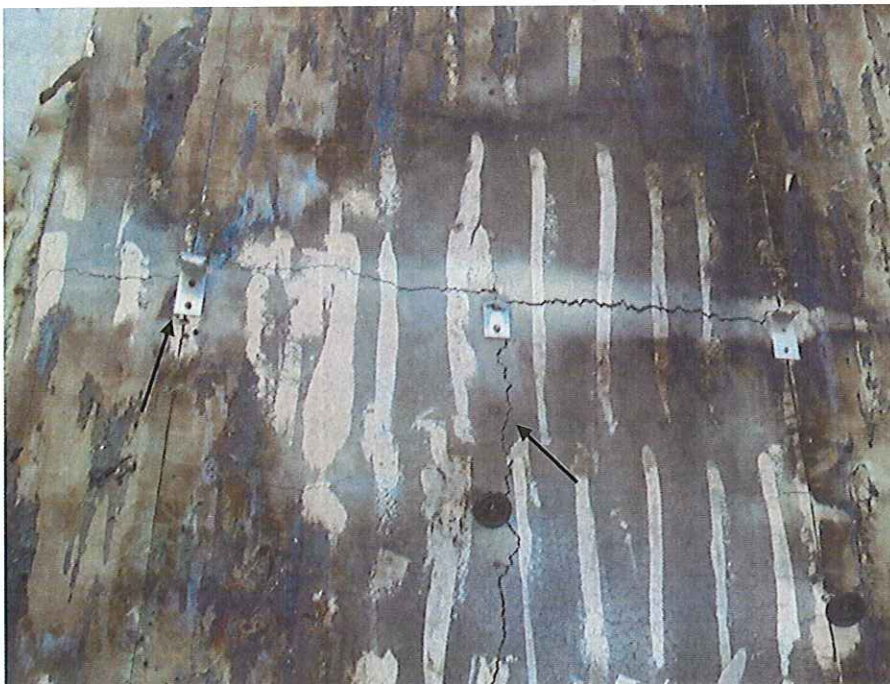
Sl. No.	Components	Observation	Photo Reference
5.	Brackets and Breather membrane	<p>Brackets:</p> <p>Approximately 10% of the Helping Hand brackets on the main wall were partially melted.</p> <p>All other brackets on the main wall and wing wall were in place and no damage was observed.</p> <p>Breather membrane:</p> <p>Material loss and discolouration to the Nilvent breathable membrane on the main wall and wing wall.</p>	DLP C2753J/0013, & DLP C2753J/0018.
6.	12mm Versapanel cement particle board	Minor damages and discolouration to the Versapanel cement particle board on the main wall and no significant changes to the Versapanel cement particle board on wing wall.	DLP C2753J/0013, & DLP C2753E/0018.
7.	Kingframe SFS and plaster boards	No significant changes.	DLP C2753J/0014.

DLP C2753J/0018 Brackets and cement particle board
